Follow Up Report: #19-494

December 31, 2019 Hydraulic Oil Spill

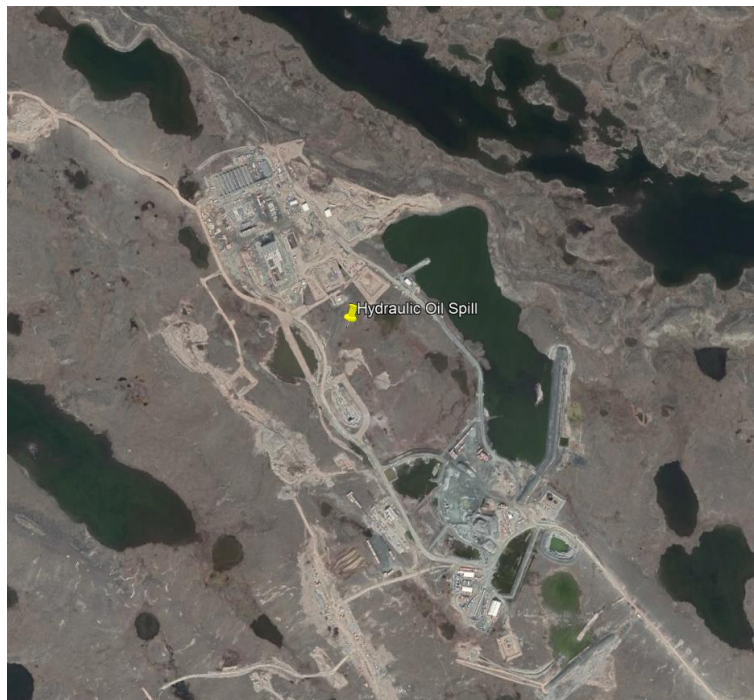
The initial investigation completed by the environment department indicated that the contaminated surface area was approximately 15m² with the spill located at 63°02'4.28"N, 92°13'12.31"W which is estimated to be approximately 780m from the closest natural water body. A drip tray was placed under the damaged hose, which collected approximately 20L of oil. Discussions with the maintenance department indicated that the size of the hydraulic tank was approximately 280L. It is estimated that approximately 200L of oil was spilled to the ground based on the hydraulic oil remaining in the tank and the oil contained in the spill tray.

Figure 1: Approximate location of 200L hydraulic oil spill.

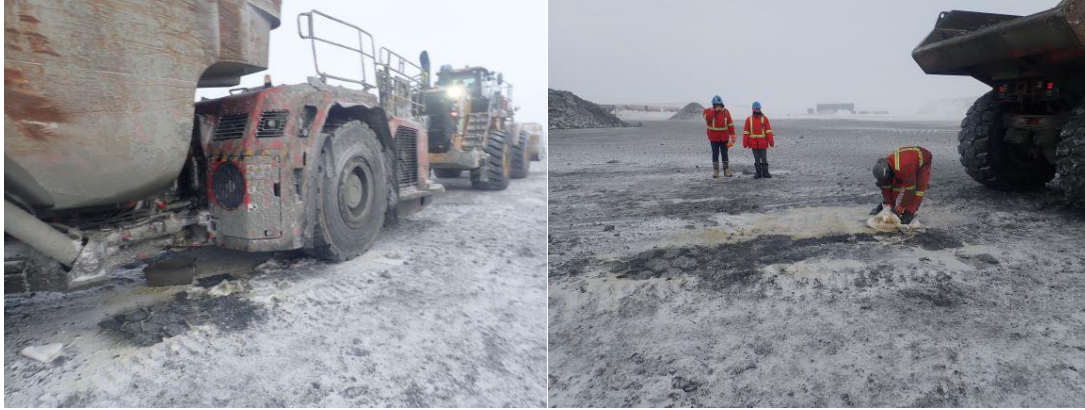
On December 31st at approximately 2am, Sandvik Haul Truck #17 left Portal #2 and had engaged the hydraulics to raise the box of the truck to offload ore at Ore Pad #2. When this occurred, the high-pressure hydraulic hose failed releasing the majority of the hydraulic oil contained in the oil tank, with the oil being released within a few minutes. The operator ceased operation immediately and used spill equipment to absorb as much of the material as possible. Assistance was called for and maintenance put secondary containment under the truck to catch any residual oil that was leaking out of it. The environment department was notified of the incident around 7am on January 31st and completed a preliminary investigation.

Figure 2: Spill and initial clean-up efforts at ore pad 2.

Spill equipment was used to absorb the oil and a drip tray was placed under the equipment to catch any remaining oil leaking from the truck. An excavator was used to remove the contaminated material. It is estimated that 2.5 m³ of material was placed in the landfarm. The clean-up was completed at 4pm on December 31st.

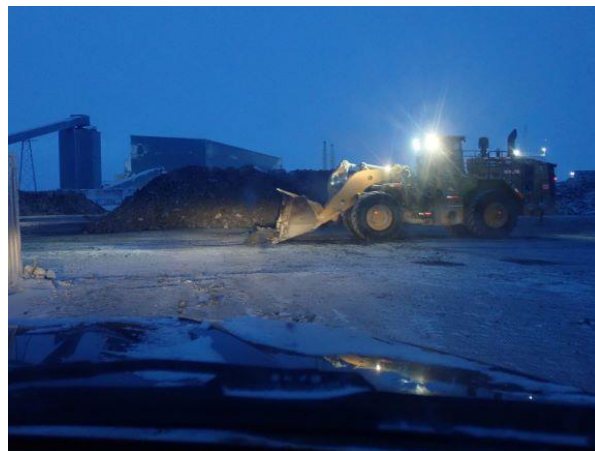
Figure 3: Spill location following clean up.
