Follow Up Report: #20-010

January 14, 2020 Hydraulic Oil Spill

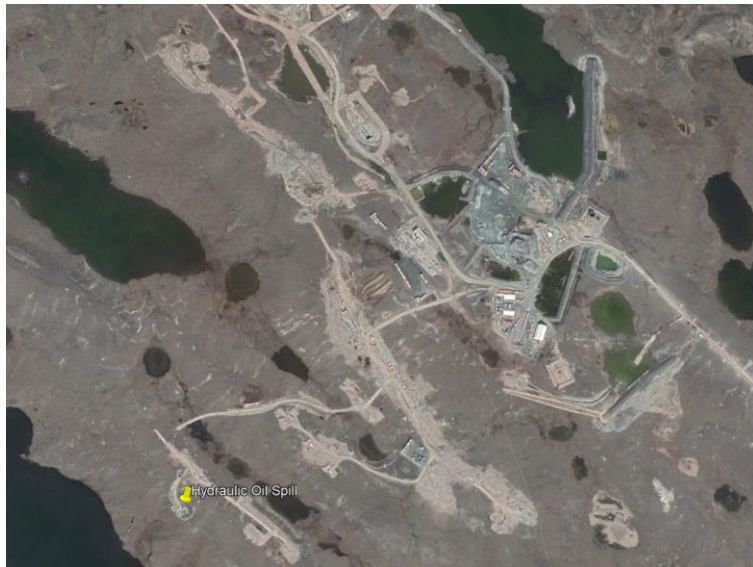
Figure 1: Approximate location of 200L hydraulic oil spill.

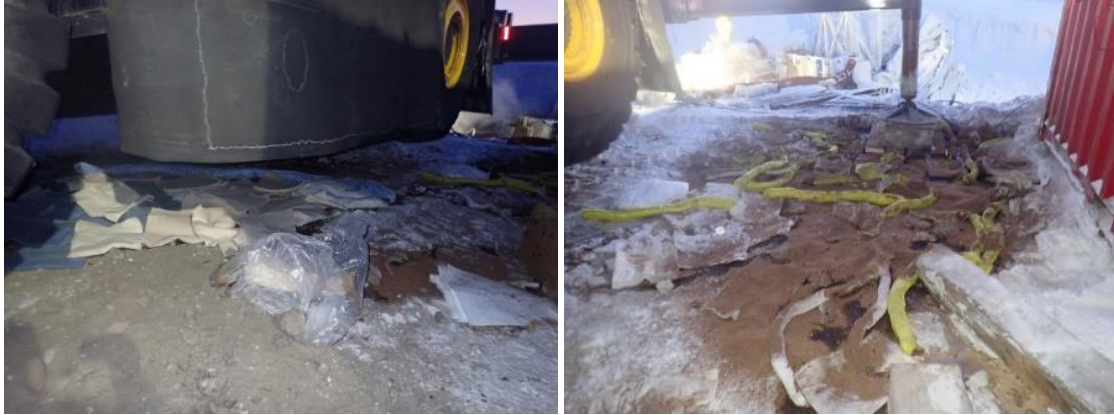
On January 14th at approximately 7 am, the 130 tonne Grove Crane was started up at the West Exhaust Raise and the crane operator began warming up the hydraulic components. The operator was notified that there was oil leaking from the crane enclosure. The operator shut the crane down immediately and went outside to investigate. It was noticed that a hydraulic line had ruptured.

Figure 2: Spill and initial clean-up efforts at West Exhaust Raise.

The crane operator shut down the engine, placed absorbent spill pads and contacted the Maintenance Department to provide further assistance. Comprehensive cleanup was delayed until the crane could be removed. Once the crane was removed, the Energy and Infrastructure department completed the cleanup, using an excavator bucket to break the ice and collect the contaminated snow. Spill pads were disposed of as hazmat and contaminated snow was transported to the landfarm.

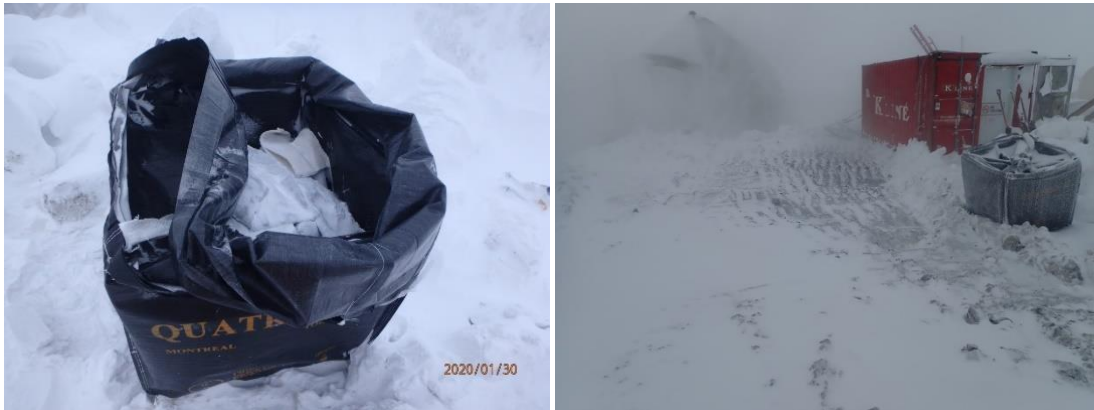
Figure 3: Spill location following clean up, 30th January and 2nd February (left to right).
