# Follow Up Report: #20-023

## January 24<sup>th</sup>, 2020 Calcium Hydroxide Spill

The following information refers to spill 20-023 reported by Agnico Eagle Mines Ltd. January 24<sup>th</sup>, 2020, and is being provided in accordance with:

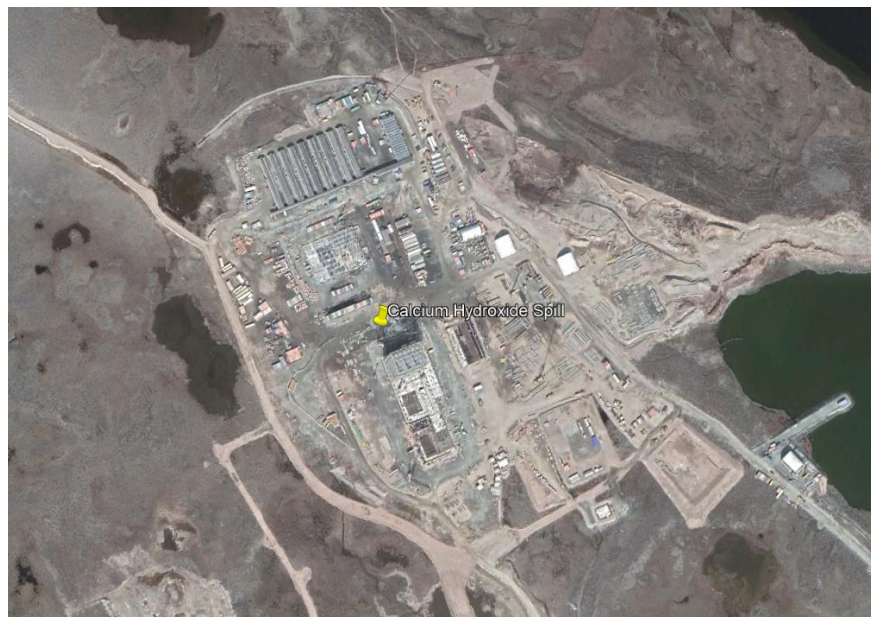
On January 24<sup>th</sup> the Environment Department was contacted by a worker at the Process Plant informing that 50 L of 20 % liquid calcium hydroxide had spilled to the ground. A dosing pipe seal ruptured on a pressurized line, causing the solution to spray onto the interior wall of the process plant above the concrete secondary containment. As the solution flowed down the aluminum cladding walls to the concrete containment, some seeped out between the cladding and the concrete, which then flowed onto the industrial pad.

**Figure 1:** Location of 20 % calcium hydroxide solution spill on the northern side of the process plant.

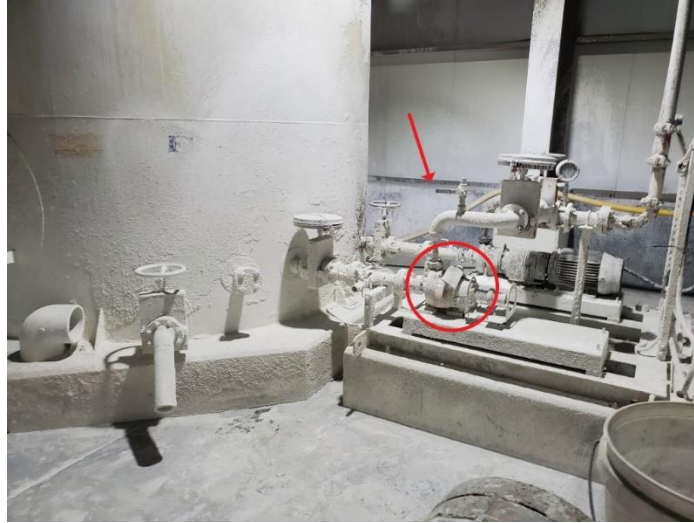
**Figure 2:** Calcium Hydroxide solution sprayed from the ruptured seal (circled) and seeped out between the cladding and concrete (arrow).

Parts are on order to replace the damaged seal. The pump was removed and reinstalled on the backup dosing line. The installation of spray guards has been recommended and feasibility is being evaluated.

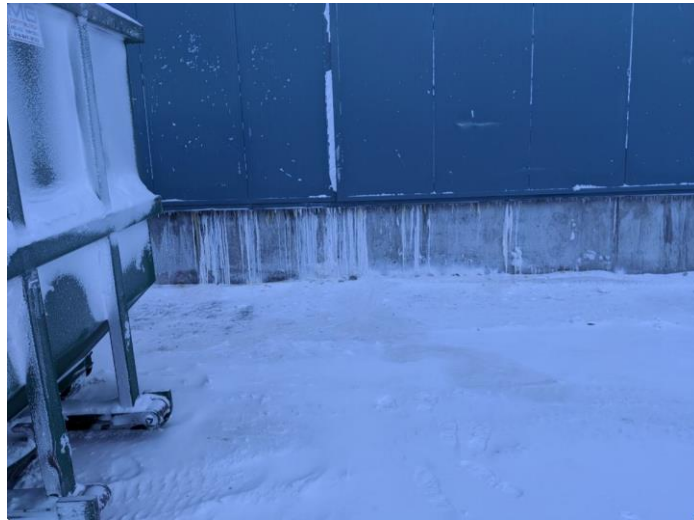
**Figure 3:** 50 L of 20 % Calcium Hydroxide prior to clean-up.

Mill personnel shut down the pump and tagged out the system to prevent further spillage. Material spilled outside of the building was collected using a telehandler, and placed in the mill sump. This material reentered the process and no further disposal considerations were required.
