Follow Up Report: #20-052

February 19, 2020 Saline Water Spill

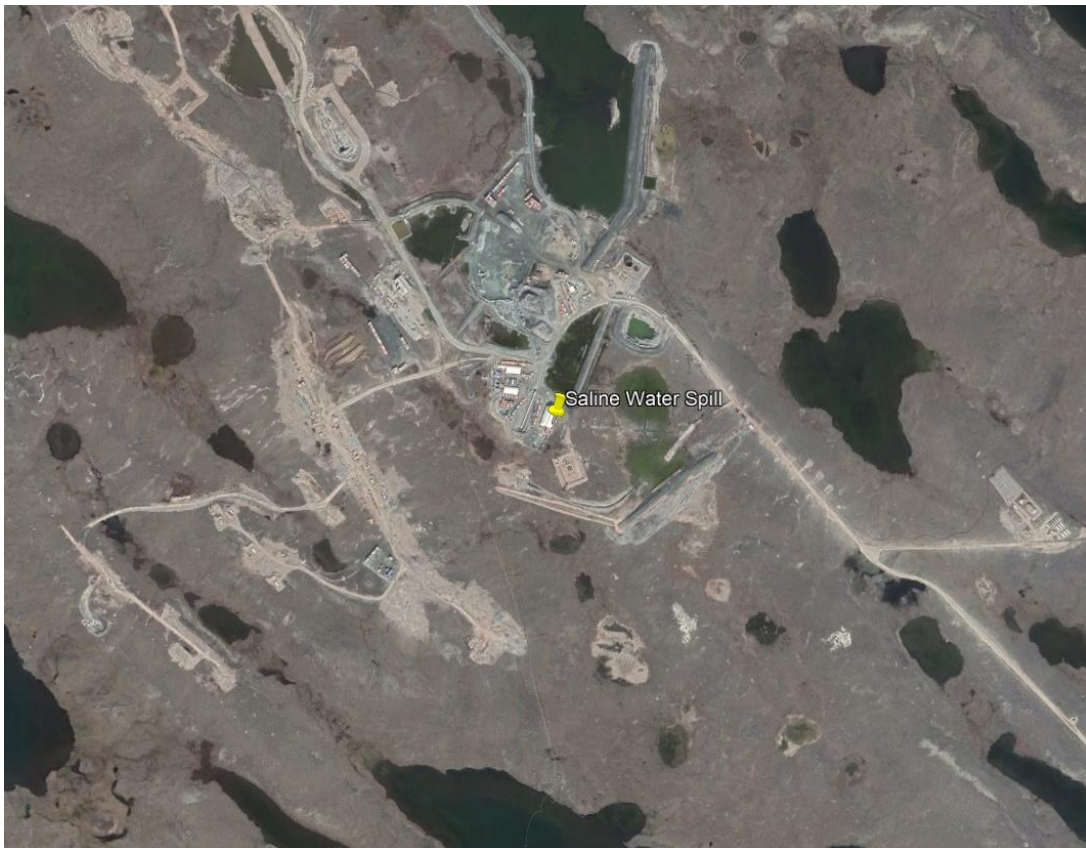
On February 19th the Environment Department was informed that a crack in the floor of the Saline Water Treatment Plant (SWTP) had been identified which allowed saline water to seep through the foundation. It is estimated that a cumulative volume of approximately 300 m³ of saline water may have seeped through the building's secondary containment over a period of approximately 6 months. The spill occurred at the final tank in the salt removal process when a level sensor malfunctioned causing the tank to overflow.

Figure 1: Location of saline water spill on eastern side of Saline Water Treatment Plant.

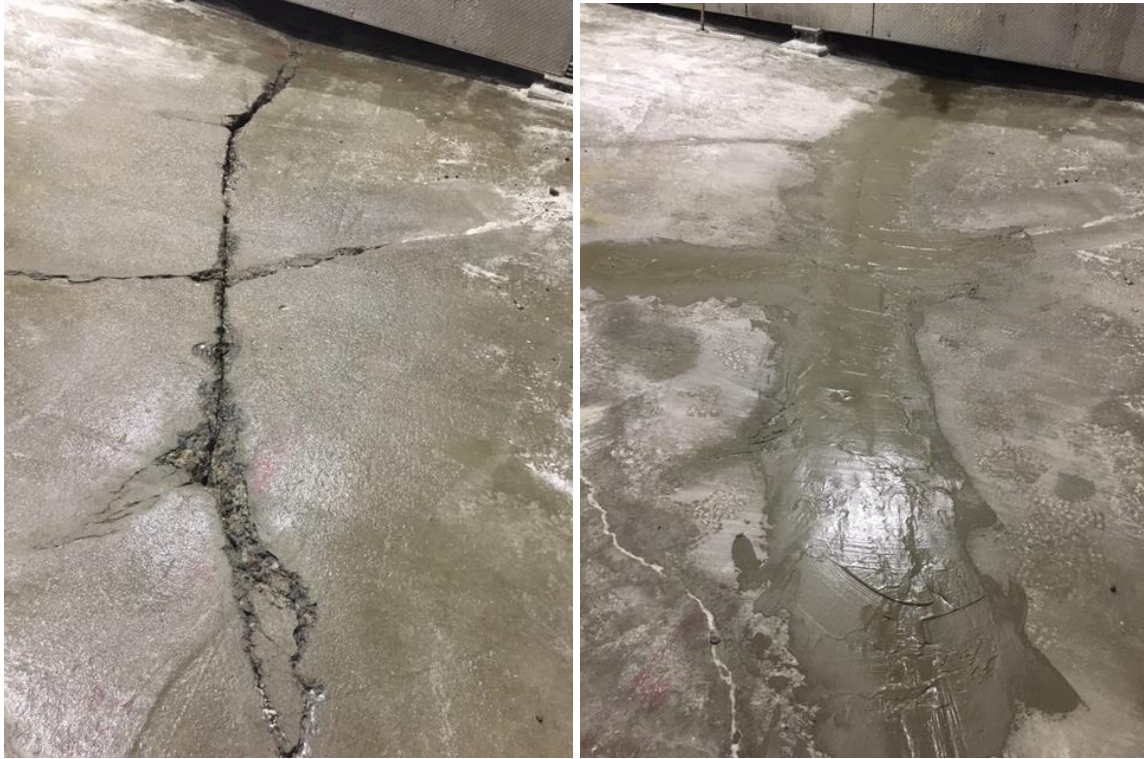
Figure 2: Cracked concrete foundation saline water flowed through (left) and repairs made 1st March 2020 (right).

A building inspection was completed by a contracted engineer, who identified a cavity beneath the concrete flooring. Holes were drilled through the flooring to examine the extent of the cavity to remove any free standing water, if present. No free standing water was observed during the time of the inspection.

Repairs were completed 1st March 2020, to prevent any future saline water spillage entering the active layer. Concrete grout was pumped into the cavity and will be finished with a waterproof epoxy coating to prevent further damage to the foundation. Adjustments were made to level sensors and communication to workers included the importance of respecting the levels in the process tanks. Preventative maintenance will be performed to ensure sensors are clean and free of salt build-up.
