Follow Up Report: #20-073

March 8, 2020 Engine Oil Tote Spill

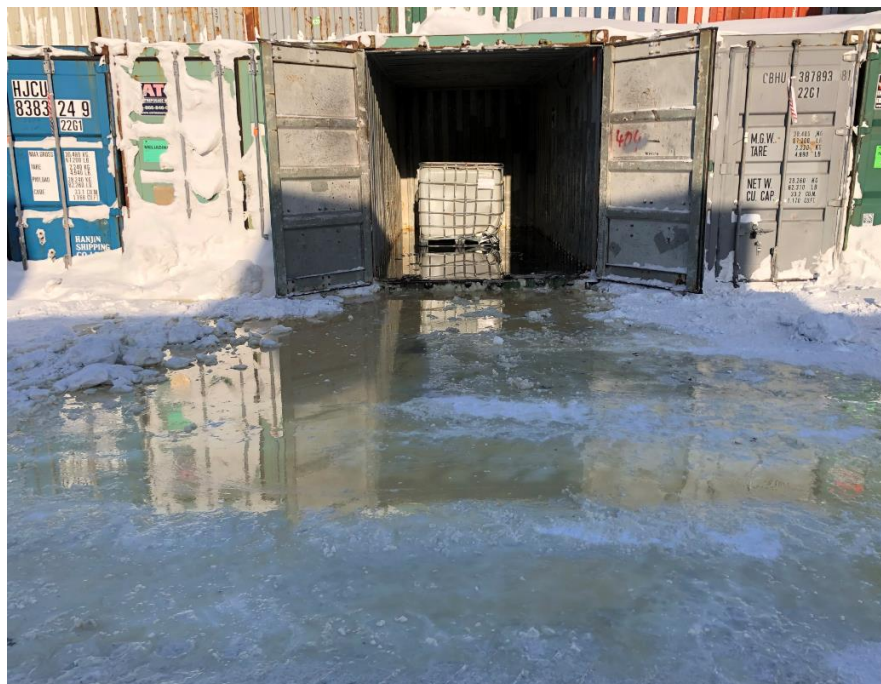
The incident occurred when a warehouse worker was attempting to retrieve a full, 1000 L tote containing engine oil, from inside a sea-can. While attempting to align the equipment's forks into the tote, the operator accidentally crushed and punctured a corner of the tote, which led to the release of the contents inside the sea-can. The tote was located in the back of the sea-can, so a large amount of oil settled on the floor inside, while the rest slowly flowed outside onto the gravel pad.

Figure 1: Spill site the morning of March 9, 2020.

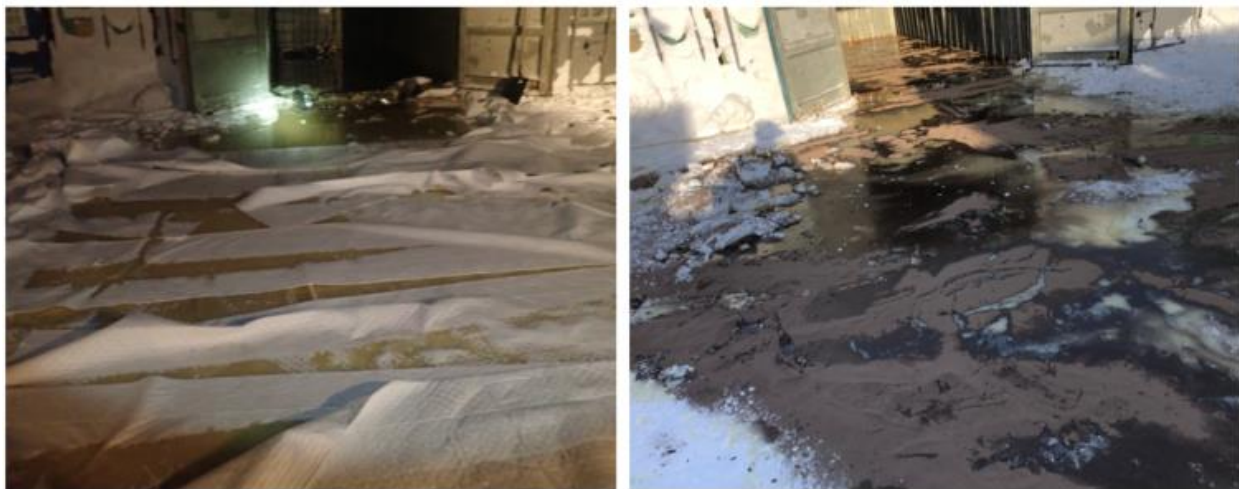
Figure 3: Initial clean up response, absorbing and slowing the spread of the oil.

The worker involved used absorbent pads to soak up the material prevent further spillage (Figure 3, left). Low temperatures increased the viscosity of the oil, slowing the flow, which reduced the effectiveness of the absorbent pads. Oil-Dri Quicksorb powder was then used to help coagulate the remaining standing oil (Figure 3, right).

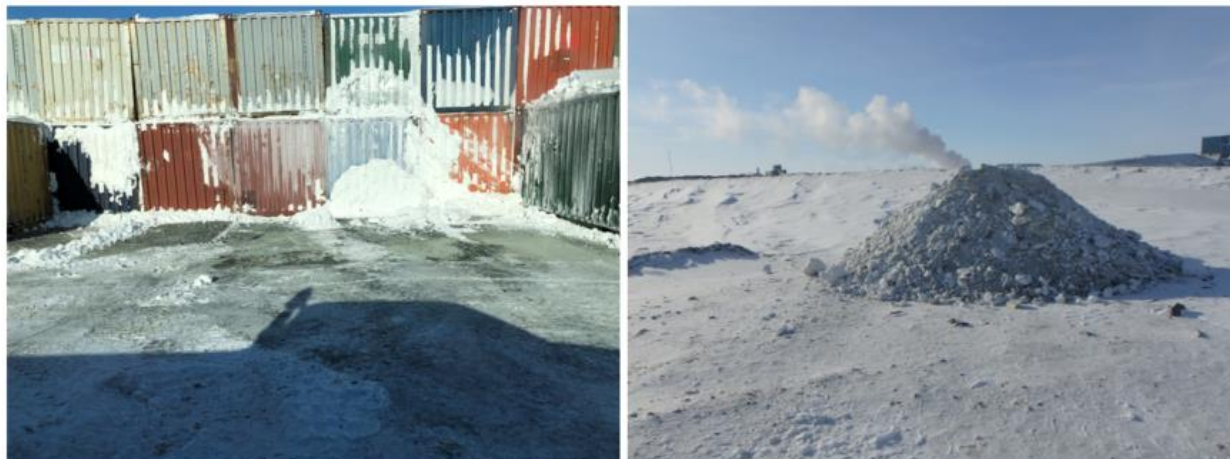
Figure 4: Initial clean-up of the area after sea-cans removed and loader began removing material (Left). Contaminated material brought to the landfarm (Right).

Used absorbent pads and Oil-Dri Quicksorb was disposed of as hazmat in Quatrex bags. Sea-cans impeding the clean-up were removed from the area. A loader was used to scrape the surface and remove 7 m³ of contaminated material from the spill site. The contaminated material was placed in the landfarm.
