Follow Up Report: #20-087

March 28th 2020, Emulsion Spill

The following information refers to spill 20-087 reported by Agnico Eagle Mines Ltd. March 28th 2020, and is being provided in accordance with:

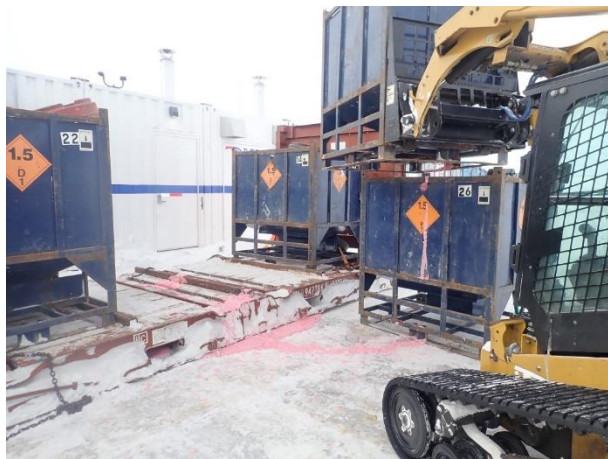
Figure 2: Forklift removing emulsion bin from flat-rack.

Emulsion plant personnel removed the damaged bin from the flat-rack using a forklift, and drained the emulsion from the damaged bin into another bin (Figure 2). The flat-rack was moved using a hyster, to provide access to the spill (Figure 3). Spilled emulsion was pumped into an emulsion bin for reprocessing and reuse (Figure 4). A bobcat was used to scrape remaining emulsion residue from the ground. This material was brought back into the emulsion plant and neutralized.

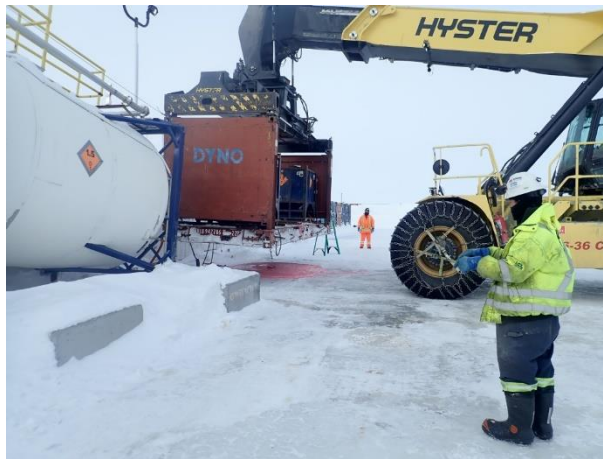
Figure 3: Hyster removing flat-rack from spill area.

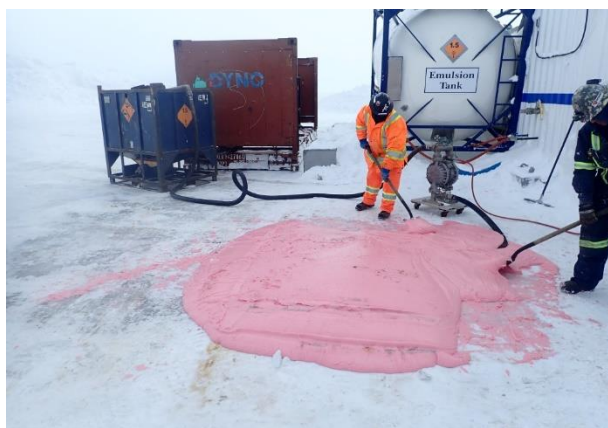
Figure 4: Spilled emulsion being pumped to emulsion bin.

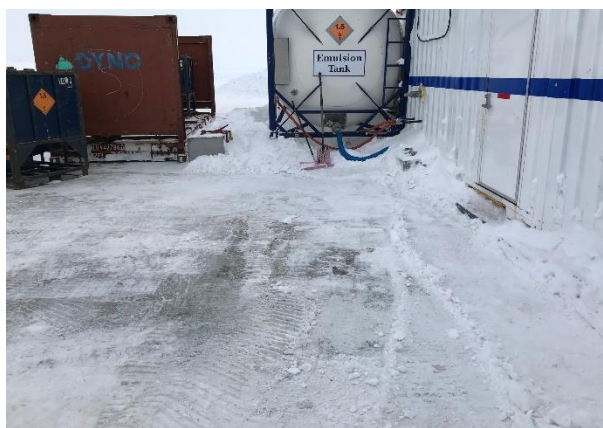
Figure 5: Spill area following clean up.

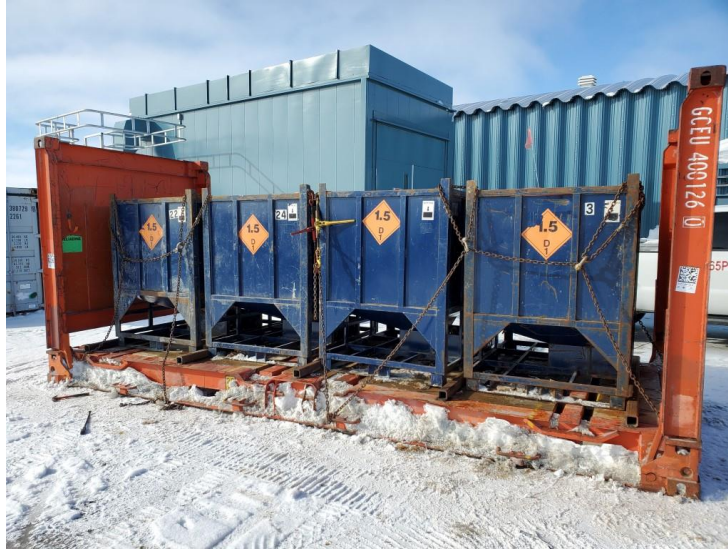
Figure 6: Steel dividers installed to improve visibility during pre-loading inspection.

The Environment Department held a follow-up meeting with the Mine Department and Dyno Nobel (Emulsion Contractor) to discuss the cause and corrective measures. Operators loading and unloading emulsion bins will now require a spotter to ensure forks are correctly positioned under emulsion bins. Flat-racks used to transport emulsion bins between the emulsion plant are now equipped with dividers, to ensure all sides of the bin can be thoroughly inspected prior to filling (Figure 6). Bins must be placed on the flat-rack with valves facing out to provide quick access in the event of a hose connection failure.
