Follow Up Report: #20-121

May 4th 2020, Emulsion Spill

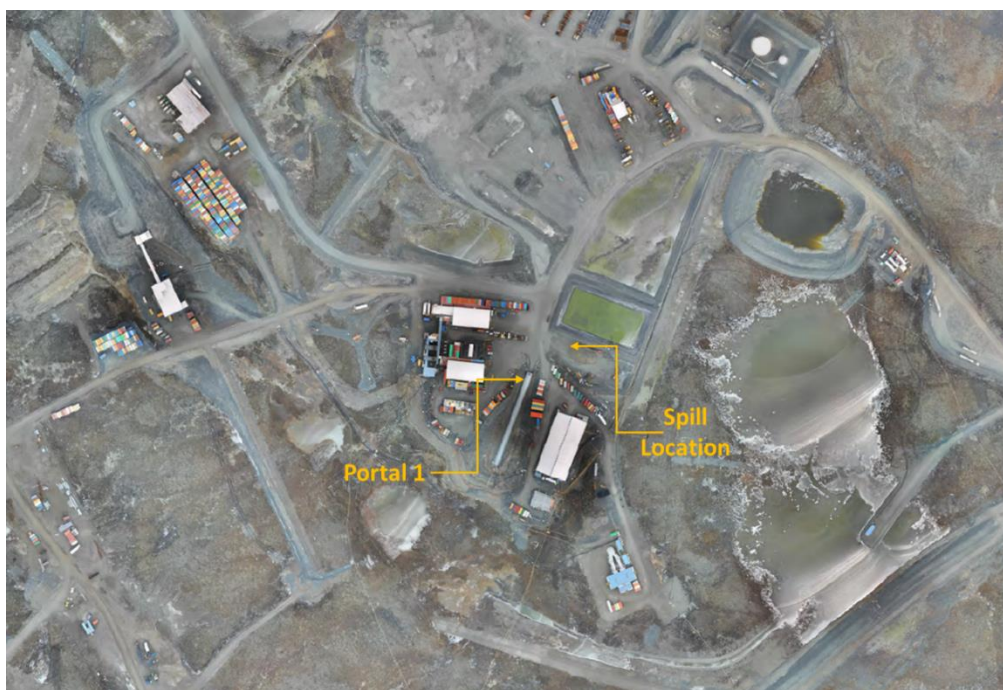
On May 4th at approximately 3:30 am, an estimated 800 L of emulsion was spilled on the gravel transfer pad just outside of Portal 1 (Figure 1). While attempting to remove the emulsion bin from the flat rack, the operator was not aware that one of their forks had been improperly placed below the bin, as opposed to being properly inserted through the fork slot. When they backed up with the full bin, it tipped off of the forks and fell onto its side, popping off the lid, and spilling the contents on the ground. The emulsion poured out over an area of about 10 m².

Figure 1: Location of 800 L emulsion spill.

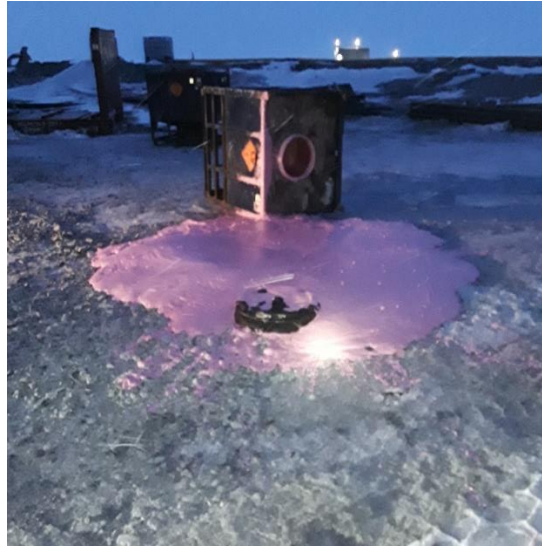
Figure 2: Initial spill scene just after 3:30 a.m.

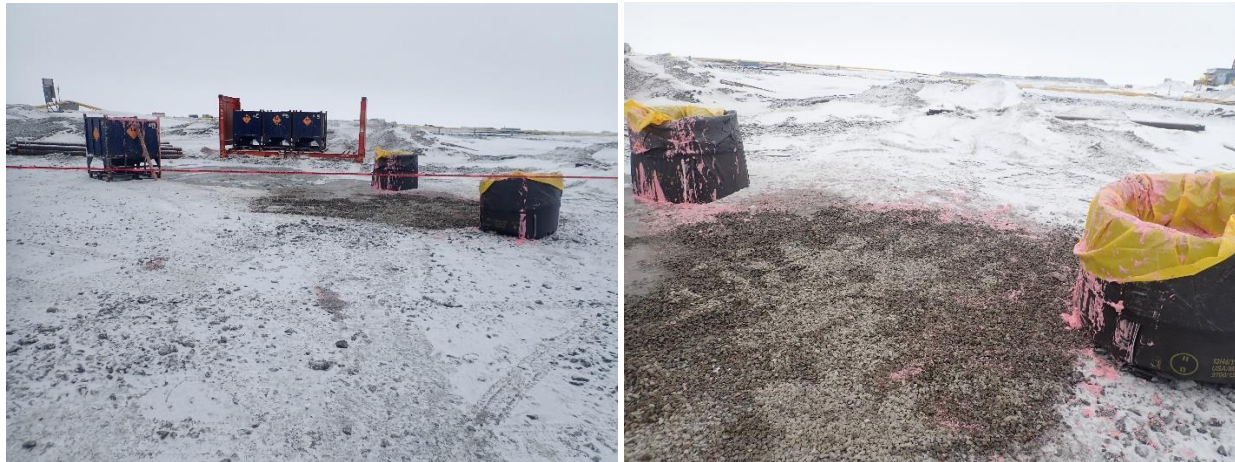
Upon arrival that morning at the site, the DYNO Nobel team had begun scooping the contaminated gravel and emulsion into quatrex bags. Normally, as much of the raw product as possible that can be recovered will be used again. Since this material was mixed with gravel, everything that was removed is now slowly being destroyed by packing the gravel-emulsion mix into blast holes where it is then detonated. It will take several weeks to properly destroy the remaining material.

Figure 3: Photos taken at 7:22 a.m. Spill recovery was underway and material was being moved into quatrex bags to be stored at the DYNO Nobel emulsion plant.

The Environment Department held additional toolbox meetings with the underground mine department, to further discuss methods for spill prevention, the importance of using a spotter, and ensuring that loads are secure before moving them. Since this specific incident had the potential to cause injury if there had been a worker next to the bin, this incident was also reported to the Health and Safety Department. Supervisor job task observations are being completed in order to improve the training for this task. In addition, a long-term solution for an improved emulsion handling and distribution system is currently being investigated.
