# Follow Up Report: #20-286

## August 12<sup>th</sup> 2020, 300 L Diesel Spill

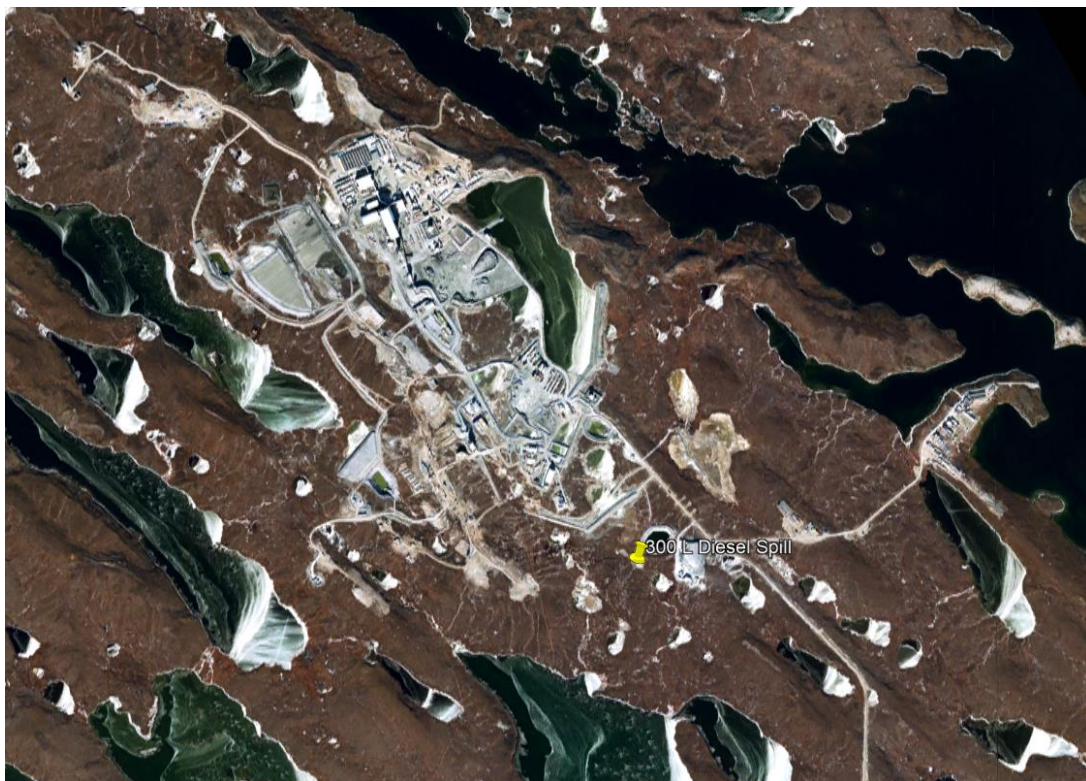
On August 12<sup>th</sup>, 2020 the Environment Department was notified of a 300 L diesel spill which occurred at 7am in Tiriganiaq II open pit. While loading waste rock into a haul truck, a rock fell from the excavator bucket, puncturing the trucks' fuel tank. The contents of the fuel tank spilled to the pit floor and did not migrate off site.

No water body was impacted by this spill. The closest water body is approximately 550 m away. The coordinates of the spill are 63° 1'18.00"N, 92°12'7.00"W (Figure 1).

**Figure 1:** Location of 300 L diesel spill in Tiriganiaq II open pit.

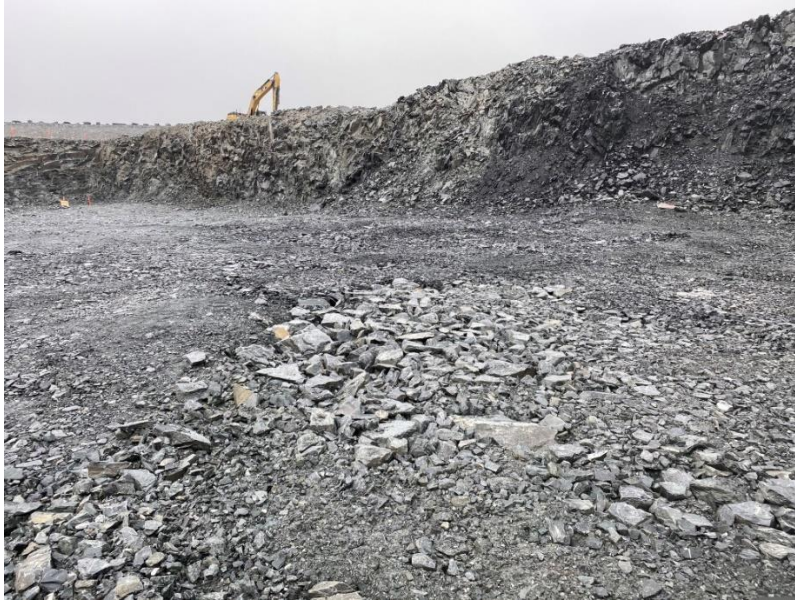
**Figure 2:** Spill location following removal of hydrocarbon contaminated material.

The previously blasted waste rock impacted by the spill was excavated and transported to the landfarm screening pad, beside Landfarm A. The material will remain in this location until hydrocarbons have volatilized, after which it will be transferred to WRSF 3.

The Environment Department completed an investigation with the Mine Department and concluded that human error and standard operating procedures were causation factors. The standard operating procedure was updated to ensure trucks are always loaded on the drivers' side, which is the opposite side to the fuel tank. Operators have been reminded to follow safe operating procedures and avoid overfilling trucks or attempting to load rocks unsuitable for the equipment.
