Follow Up Report: #20-316

September 5th 2020, 100 L Hydrocarbon Spill

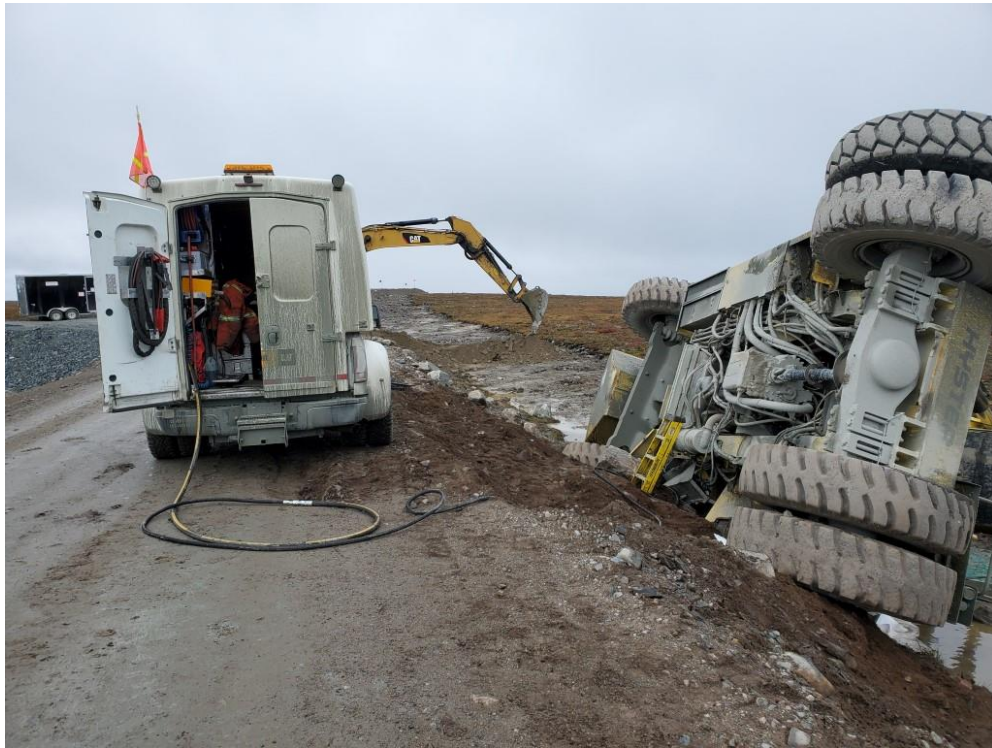
Figure 2: Upstream berm being placed while mechanic drains hydraulic, fuel and transmission systems.

The Environment Department and Emergency Response Team acted quickly to prevent the spill migrating downstream. A series of soil berms were rapidly constructed using an excavator, which blocked the steady flow of water in the channel, upstream and downstream of the source. The berms successfully prevented the spill migrating away from the overturned vehicle. Spill pads were deployed to absorb the hydrocarbons from the surface of the pooled water. The water was then removed and treated in the snow cell, using an oil/water separator. Soil within the channel with potential exposure to hydrocarbons was excavated and transported to the landfarm. Approximately 36 m³ of soil and gravel were removed. A Mini-RAE VOC detector was used during the excavation to verify contaminated material was removed.

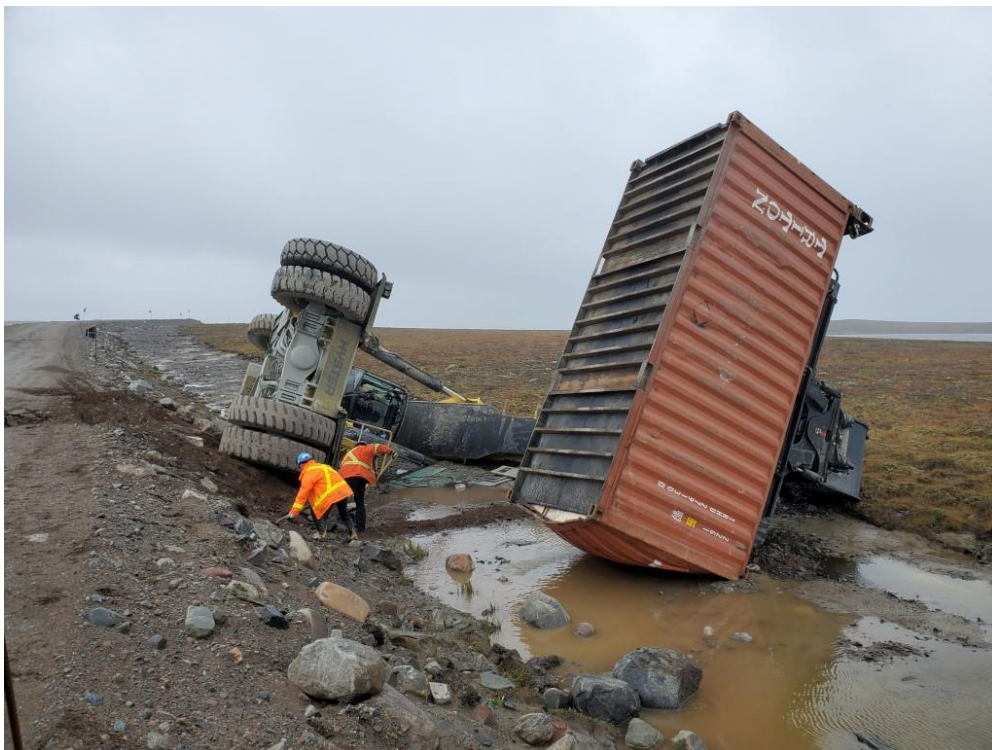
Figure 3: Downstream berm installed to contain spill at the source.

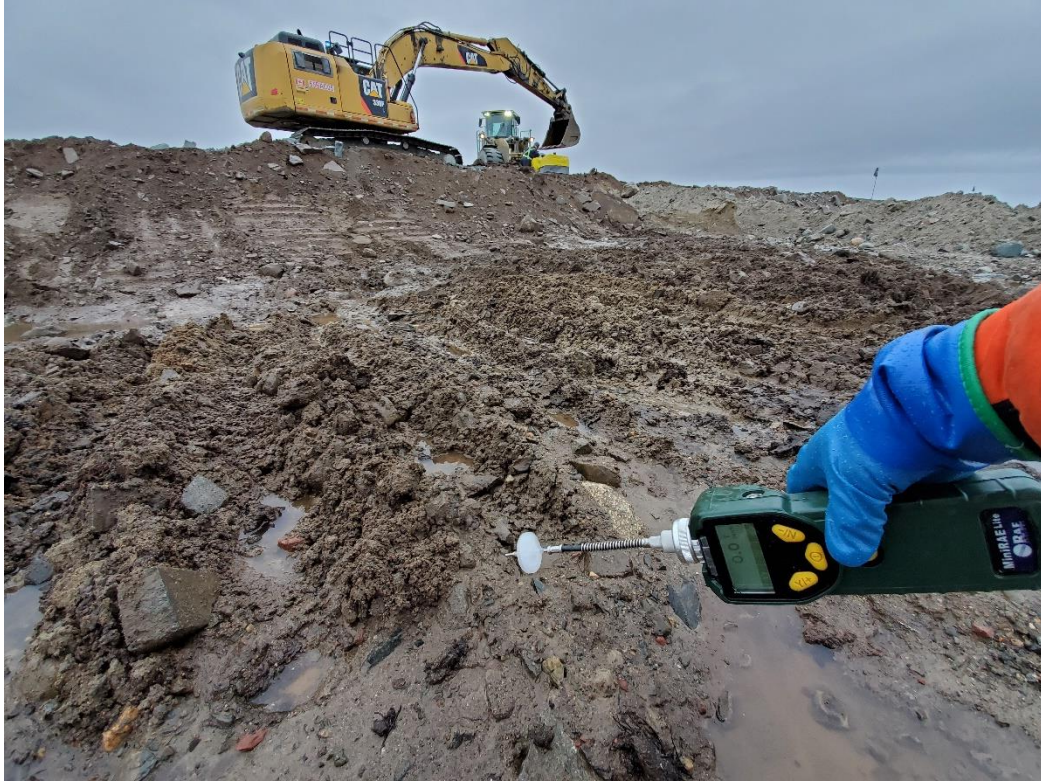
Figure 4: Mini RAE VOC detector used to ensure all affected soil was removed.

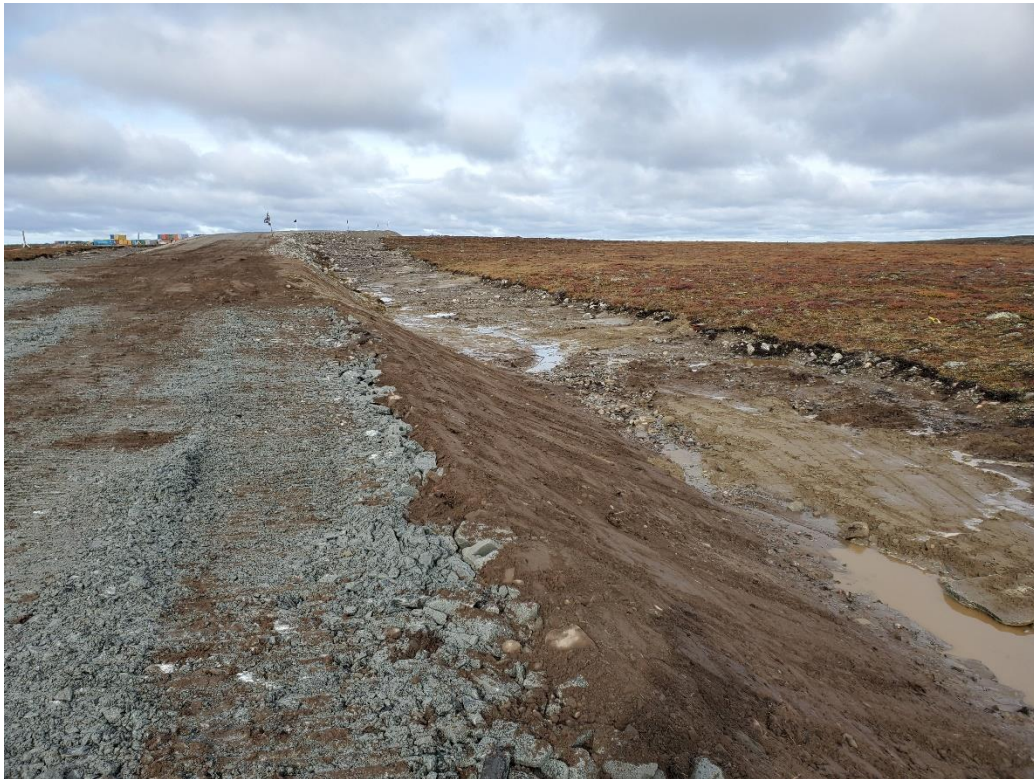
Figure 5: Road widened, and drainage channel restored.

The Energy and Infrastructure department widened the road and added a pull-out to allow vehicles to pass safely. The operator has been assigned to other duties until re-training is completed. Additional emergency spill response equipment is to be purchased to improve response time and capability, and replace items used during the spill response.
