Follow Up Report: #20-364

September 27th, 2020 – 500 L Hydrex 6240 Spill

AGNICO EAGLE
MELIADINE

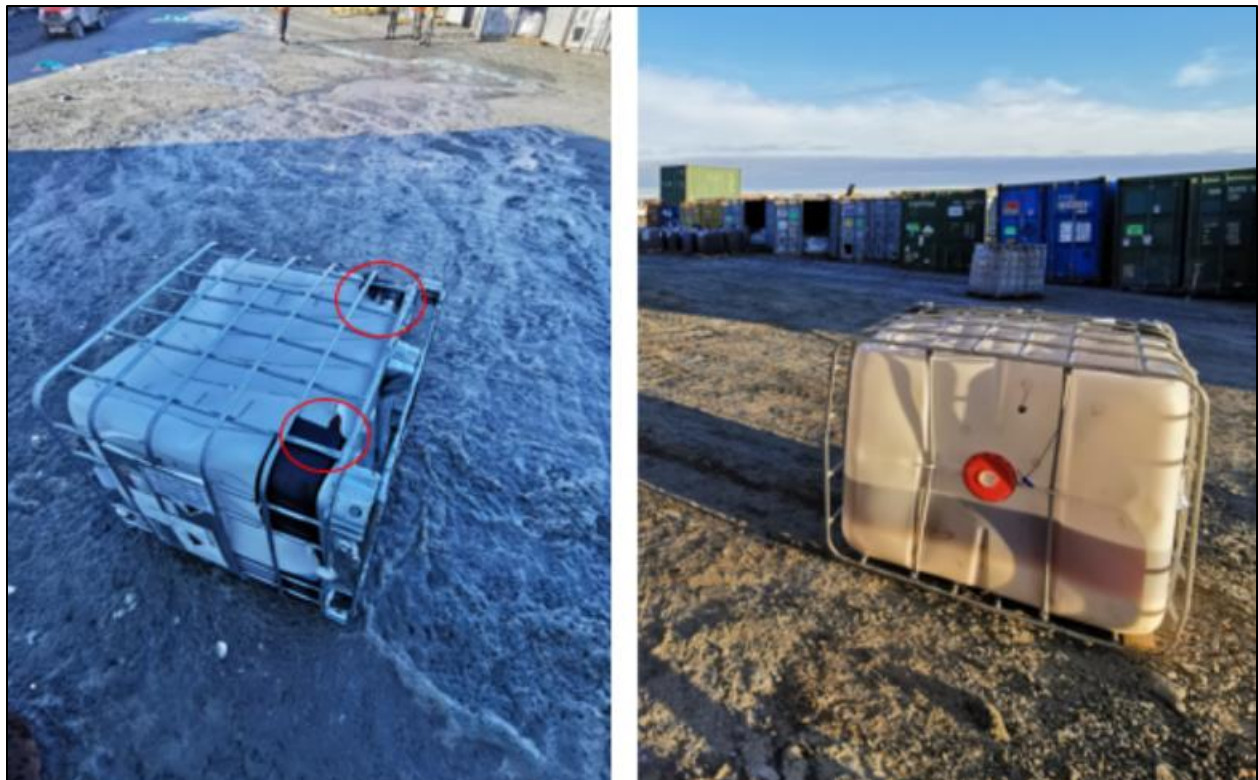
On September 27, 2020, shortly after 17:00, the Environment Department received a call requesting assistance in spill response at the SWTP. Upon arrival, the supervisor of the employee involved informed us that the equipment operating was attempting to transport a $\frac{3}{4}$ full tote of coagulant, did not use a spotter, and accidentally punctured the tote (Figure 1). The spill occurred directly outside of the SWTP loading doors (Figure 2) at the following coordinates:

Figure 1: Punctured tote with remaining liquid inside.

The root cause of the incident was the failure of the operator to follow the procedure of using a spotter to ensure the proper alignment of the forks. In the last year Meliadine has been pushing for the all departments to ensure that a spotter is used whenever forked equipment is required to transport hazardous materials (liquids, powders, etc.). Training material has been created and communicated to workers through toolbox meetings, and a site-wide reminder has been sent out following this most recent incident. Another round of toolbox meetings will be held as an additional reminder of the importance of the use of a spotter.

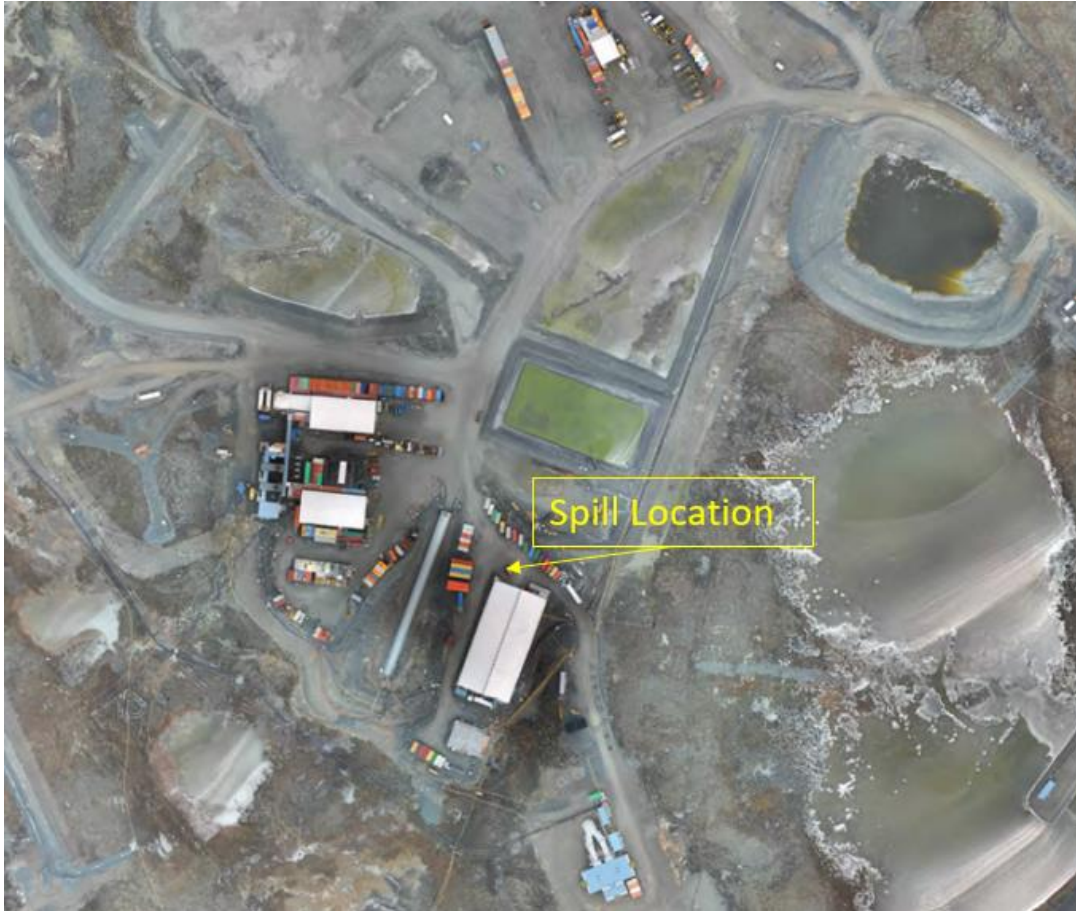
Figure 2: Location of the spill on the exterior loading ramp area of the SWTP.

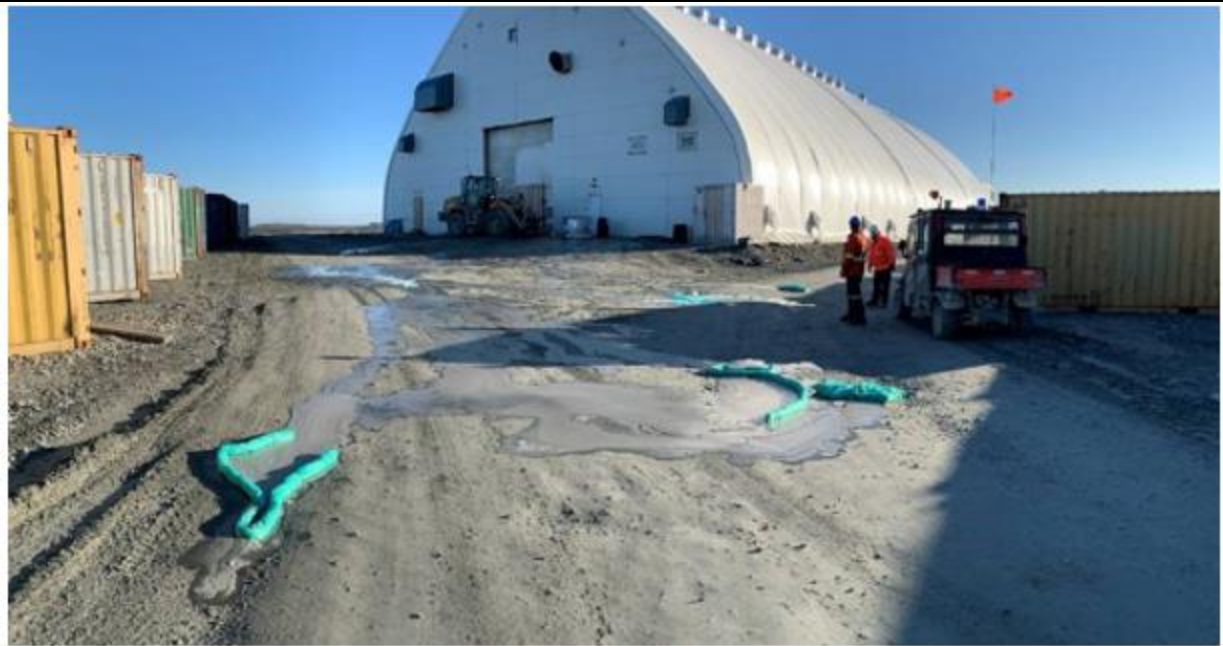
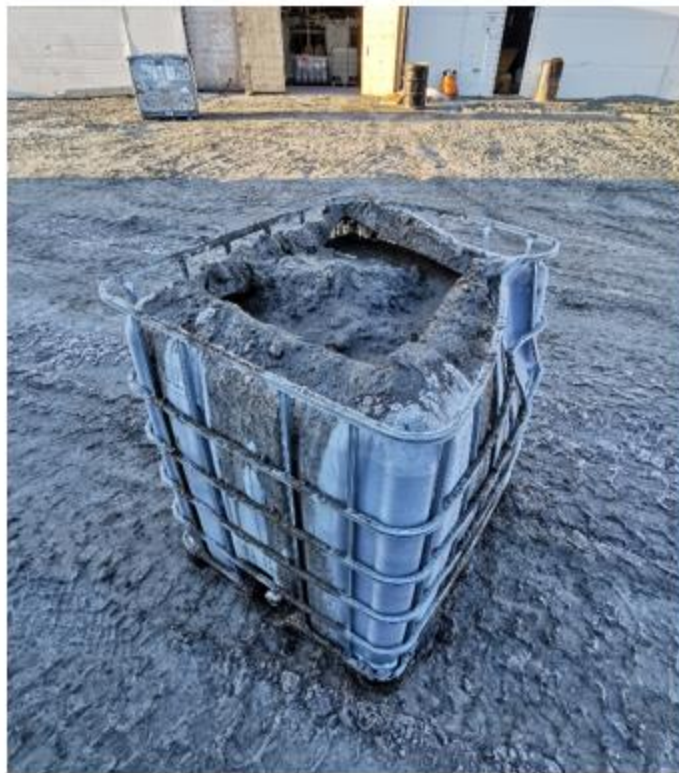
Upon puncturing the tote, the operator acted quickly by using the loader to tip the tote onto its side, preventing it from emptying completely (Figure 3). Spill pads and absorbent booms were deployed in an initial attempt to prevent the spill from spreading (Figure 4). The material itself was a sludge-like consistency and did not absorb deep into the compacted pad. However, the spill occurred on a sloped area, so the material spread out over a large surface area.

Figure 3: Initial effort to contain the spilled material from flowing away from the source.

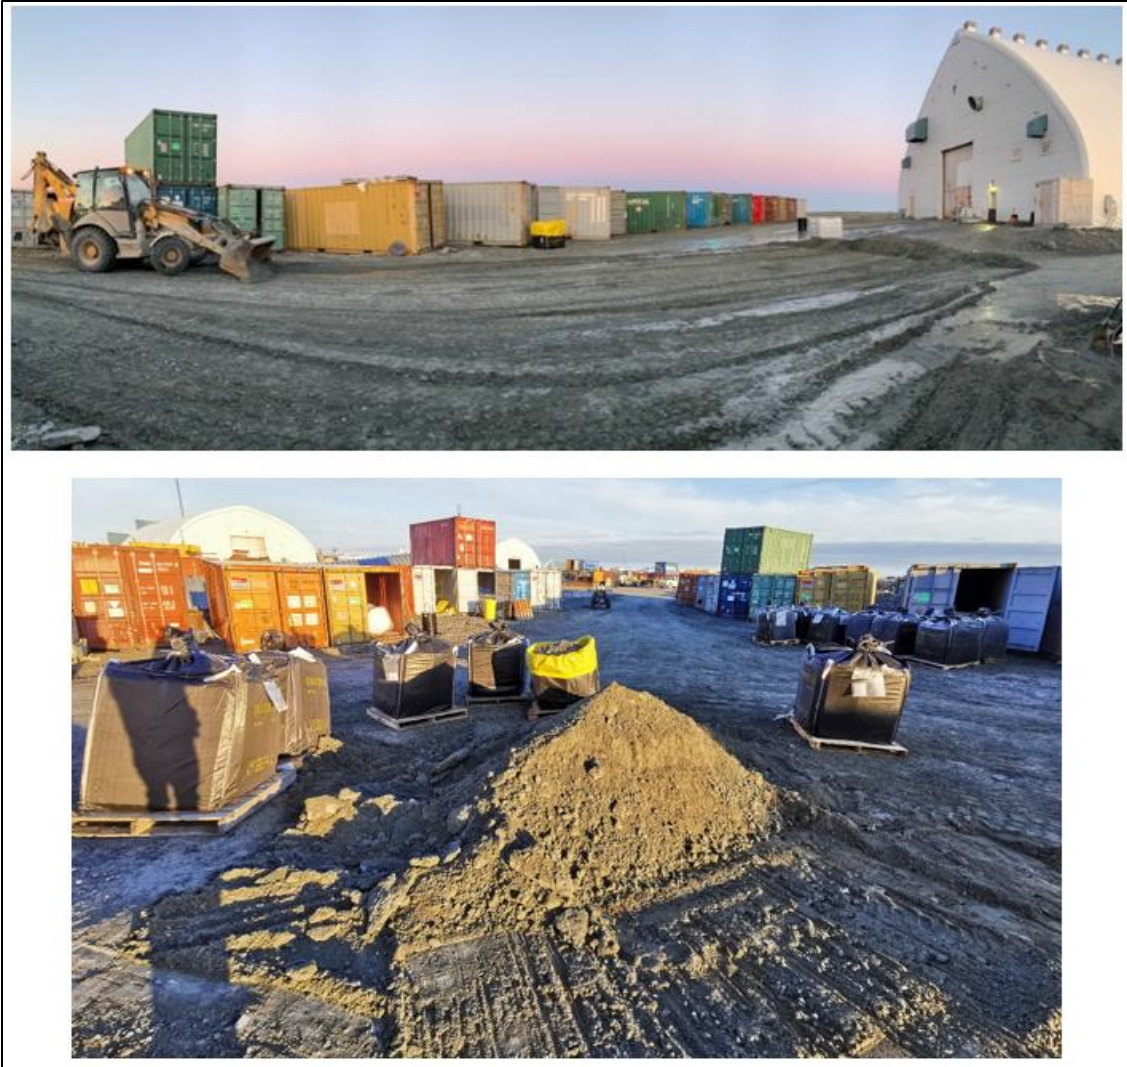
Workers manually began to shovel material into an empty tote, until a back-hoe arrived (Figure 4). The back-hoe was then used to scrape up a few inches of gravel/sand which helped to soak into the coagulant. The pile of contaminated gravel was then transferred into approximately 25 quatrex bags which will be shipped south as hazardous waste.

Figure 4: Spilled material and contaminated gravel removed.
