Follow Up Report: #20-379

October 3rd 2020, Ammonium Nitrate Spill

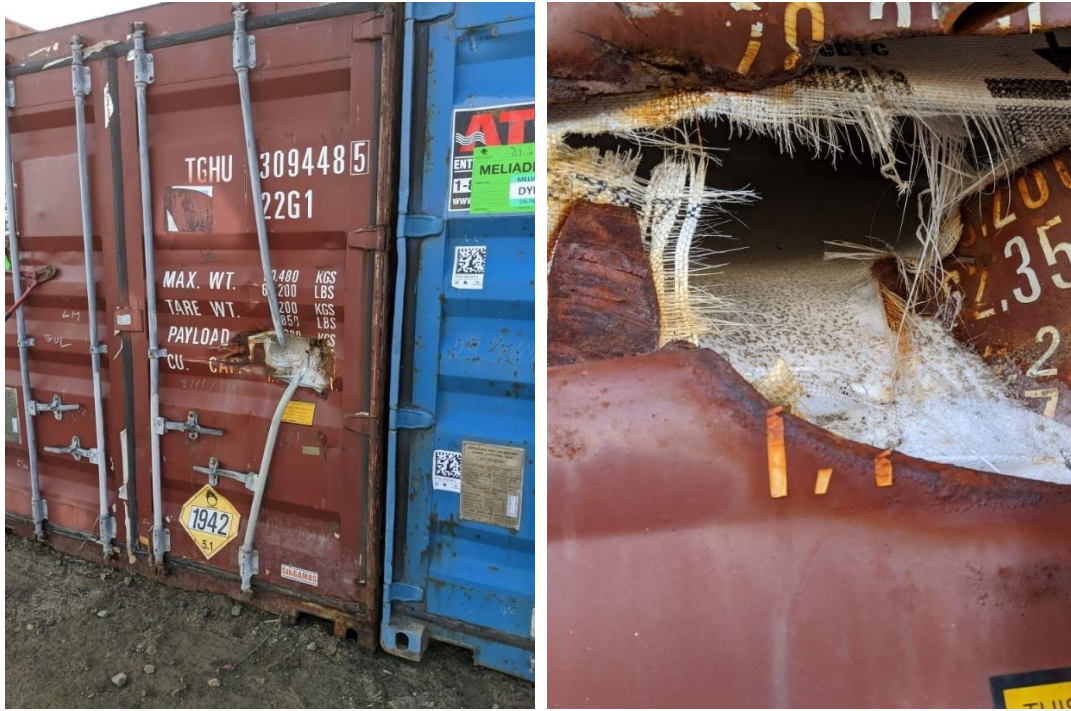
A seacan containing bags of ammonium nitrate was punctured by heavy equipment causing approximately 350 kg of product to be released to the ground. The spill was initially reported as 400 kg. However, after weighing the remaining product inside the seacan, a more accurate estimate of 350 kg was calculated. The damage was discovered October 2nd and it is thought to have occurred during snow removal earlier this year.

Figure 2: Damaged seacan containing Ammonium Nitrate.

The Environment Department held a follow-up meeting with the Energy and Infrastructure Department and Dyno Nobel (Emulsion Contractor) to discuss the cause and corrective measures. Equipment operators responsible for clearing snow will be reminded of the importance of following the snow management plan and standard operating procedures prior to resuming snow removal.

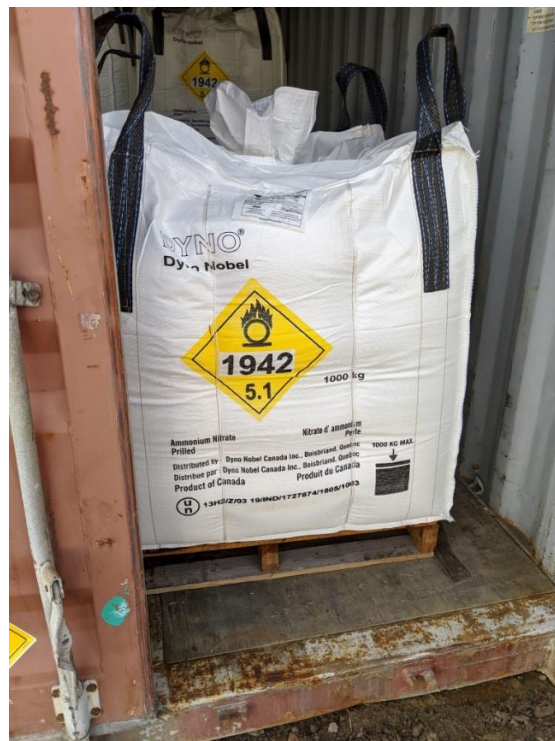
Figure 3: Damaged Ammonium Nitrate bag and spilled product removed from seacan.

Emulsion plant personnel determined that there was no risk of ignition prior to responding to the spill. The product spilled was Superprill™ Prilled Ammonium Nitrate (UN1942), which is not sensitive to mechanical impact or static discharge. Any spilled material would have likely been collected during snow removal and transported to a snow storage area. Material spilled inside the seacan was collected for use. Potentially contaminated gravel was scraped up using a bobcat and disposed of as hazmat. The damaged seacan was emptied and will no longer be used.
