Follow Up Report: #20-466

December 20, 2020 – 60 L Untreated Sewage

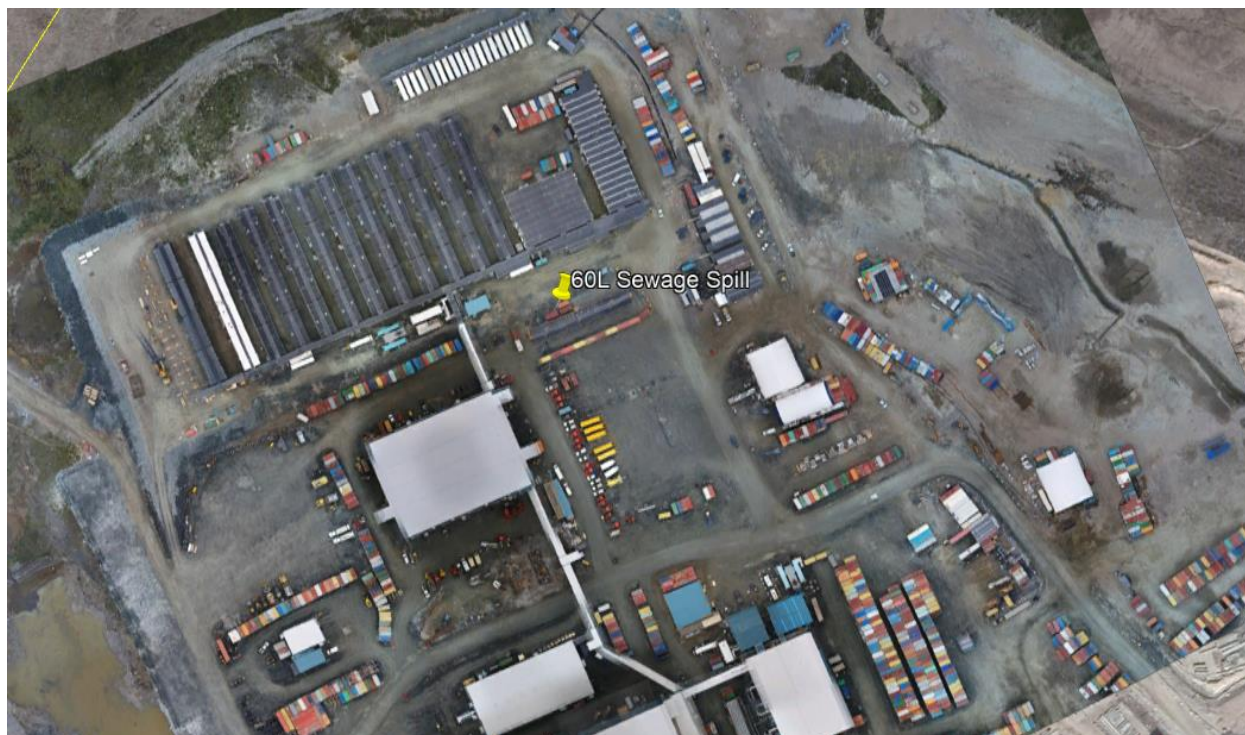
At approximately 17:00 on December 20, 2020, the Environment Department was notified of a spill of an unknown amount of raw sewage/retention tank water. The spill was later estimated to be approximately 60 L. It occurred when a Victaulic fitting failed, which was connecting two segments of piping together. The piping transports water from the retention tank of the newly installed P-Wing to the main camp lift station.

Figure 1: Location of the spill beside P-Wing.

The water pooled in a depression at the toe of the pad behind P-Wing, making the recovery of the liquid straight forward. The sucker truck was used to recover the pooled water, which was later deposited into the MSB lift station.

Workers emptying the retention tank had adjusted a segment of the pipe and the fitting was loose and slipped off the pipe. Any residual water within the pipe drained out at that section. A closer inspection revealed that this was not the correct fitting for that type of pipe, and so when the pipe was adjusted it came loose. The fitting has since been replaced with a more suitable one.
