# Follow Up Report: #21-004

## January 5, 2021 – 170 L Hydraulic Oil Spill

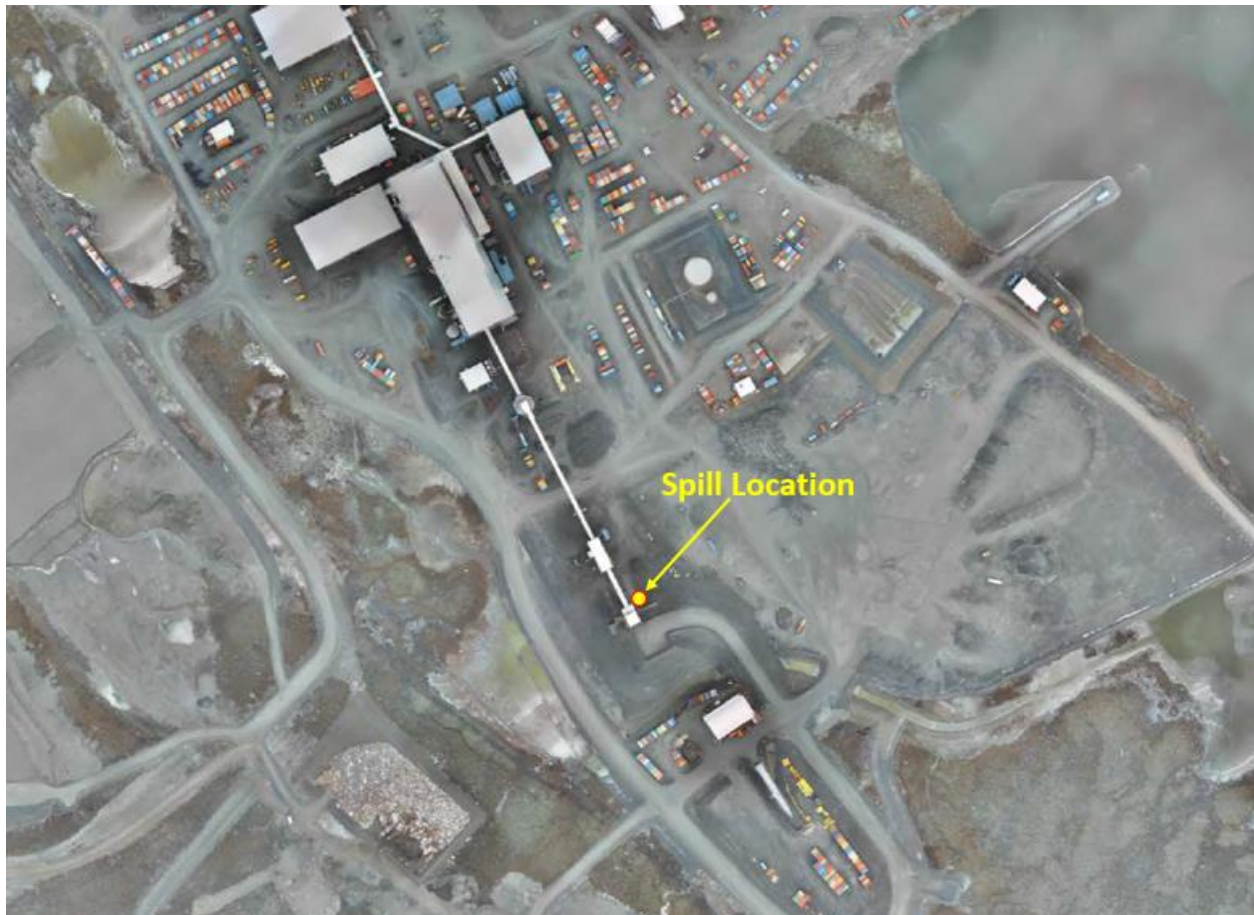
At approximately 1:30 am on January 5, 2021, a breakage in a section of a hydraulic line on the exterior of the apron feeder building led to the release of approximately 170 L of hydraulic oil. The oil ran down the eastern wall of the building onto the snow below and was confined to a small area allowing for complete recovery of the spill.

**Figure 1:** Location of the spill on East side of the apron feeder building.

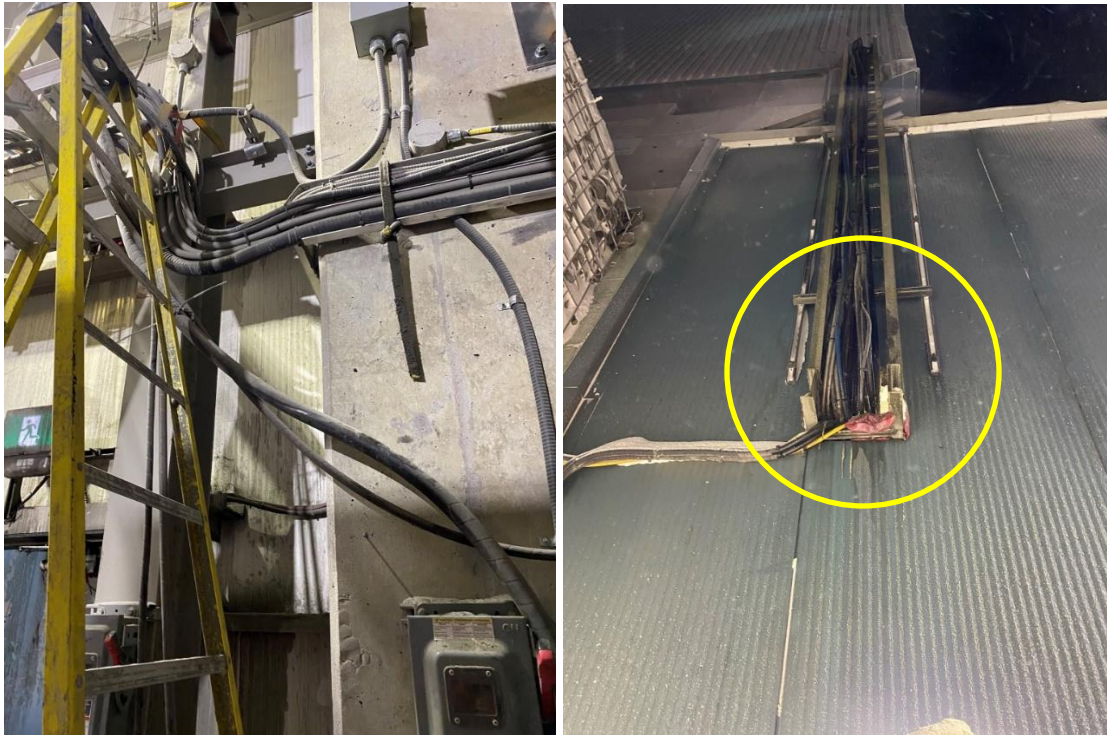
**Figure 2:** A hydraulic line breakage occurred on the exterior of the building (circled area).

The specific cause in this incident is attributed to wear and tear on the hydraulic lines, compounded by the cold temperatures the lines are exposed to. The strong vibrations caused by mechanical equipment inside the building, put additional stress on these lines and fittings. Although these lines are currently insulated and heat-traced to prevent temperature drops in the hydraulic system, a plan is in place to install a heated seacan to contain the hydraulic tanks and keep the overall system warmer. Ridged piping will also be installed over the current lines which will help with insulation and wear and tear.

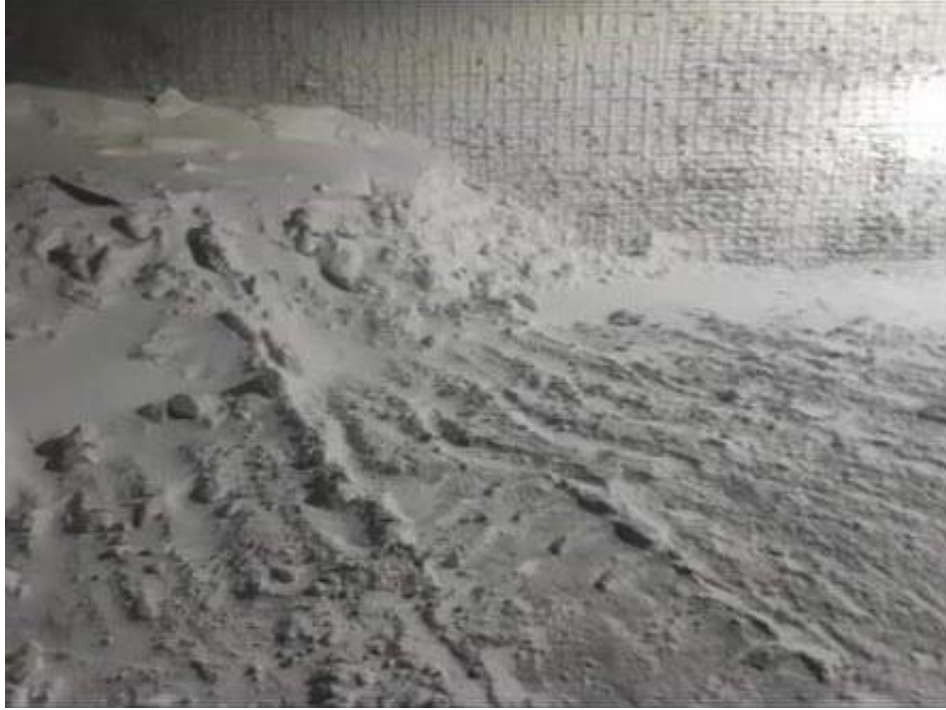
**Figure 4:** With the storage trailer moved away, the contaminated snow was able to be removed.
