# Follow Up Report: #21-016

### 165 m<sup>3</sup> Heat Recovery Water Spill

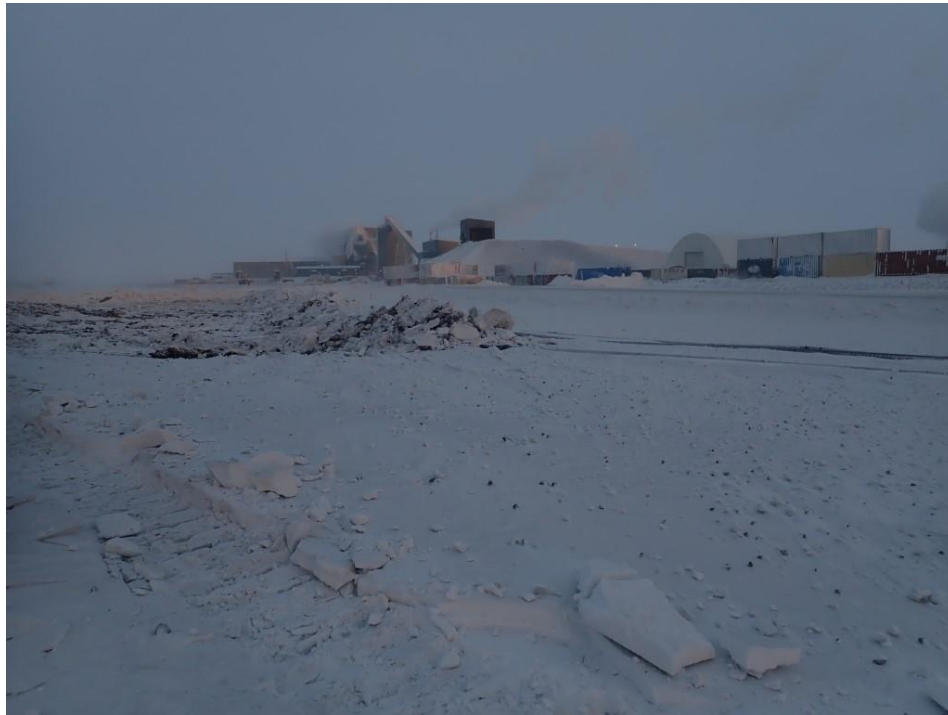
On January 18<sup>th</sup>, at approximately 1:00 pm, an estimated 165 m<sup>3</sup> of heat recovery water was spilled as water was being conveyed via a 16" heat recovery waterline. Equipment was pushing snow near the heat recovery waterline. This action caused the line to break and the water within the line was released. A portion of the water froze on surface, with the remainder migrating below surface.

**Figure 2:** Snow pushed into heat recovery waterline.

The waterline has been disabled until it can be replaced in summer. Energy and Infrastructure (E&I) department will inspect the new line during recommissioning before resuming operations.

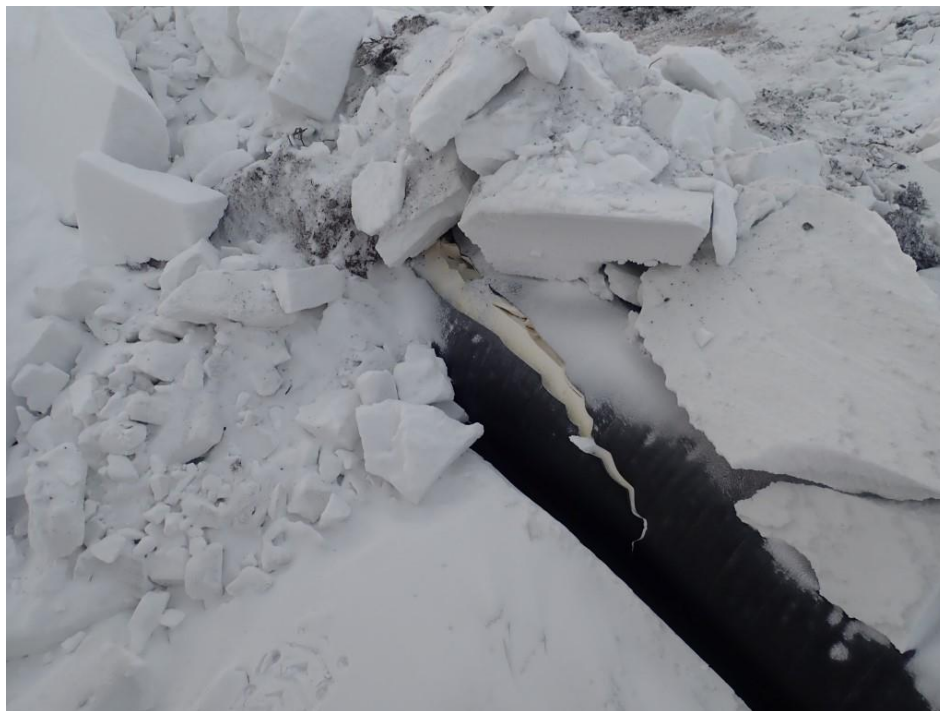
**Figure 3:** Damage to heat recovery waterline.

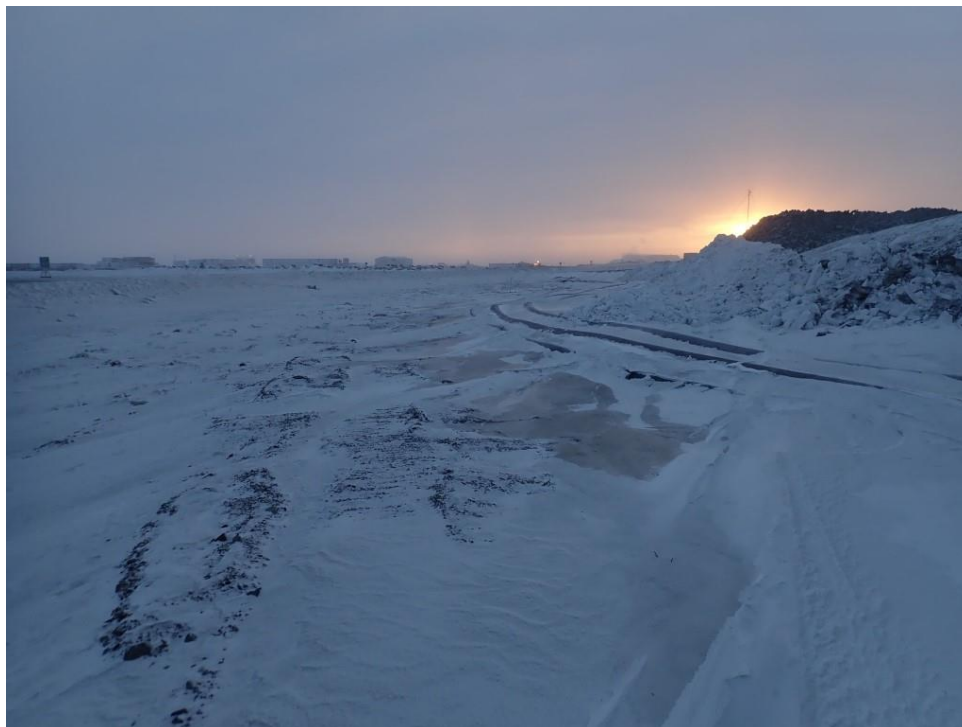
No clean-up was required as the water was completely contained in the site catchment area and will migrate to CP1 when thawed. The source of the heat recovery water is the Meliadine Lake freshwater intake, which directs the water through the water treatment plant. Water quality is monitored at this licensed compliance monitoring location, Mel-11. Given the source and containment of the water spill, the incident is not expected to have an environmental impact.

**Figure 4:** Heat recovery water flowing from east side of WRSF 1 toward CP-1.
