Follow Up Report: #21-132

April 23, 2021 – 150 L Hydraulic Oil Spill

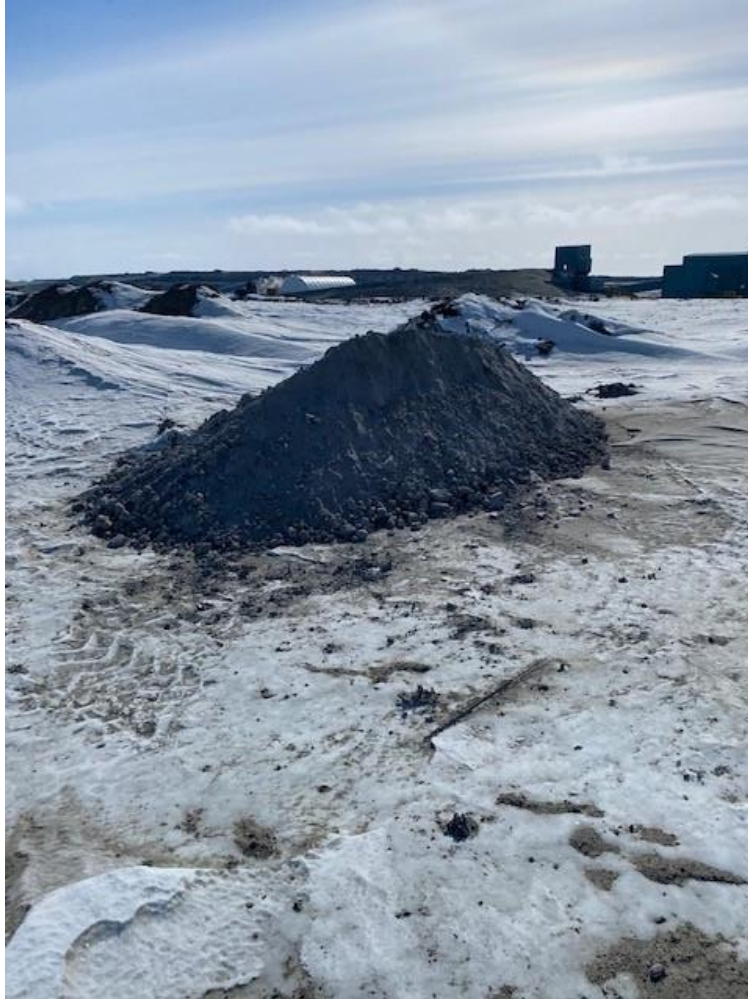
Figure 3: Contaminated material transferred to Landfarm A.
