# Follow Up Report: #21-175

## May 13, 2021 – 80 m<sup>3</sup> Sewage Water

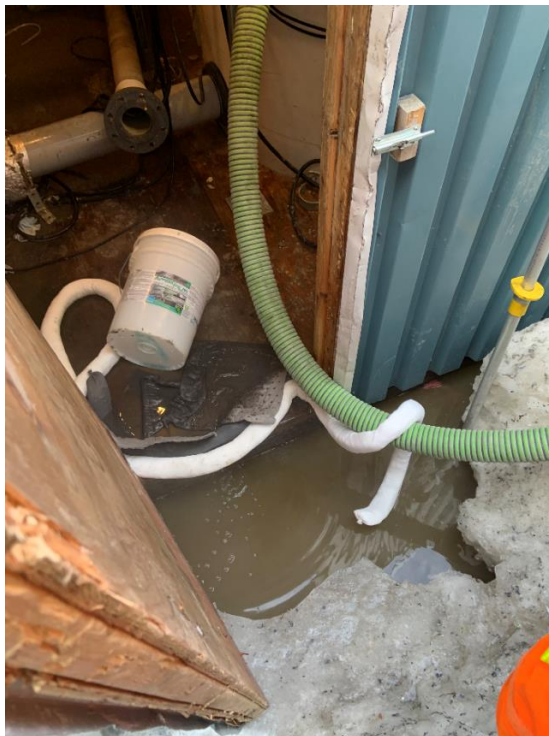
**Figure 3:** Entrance door of the lift station and water pooling directly outside.

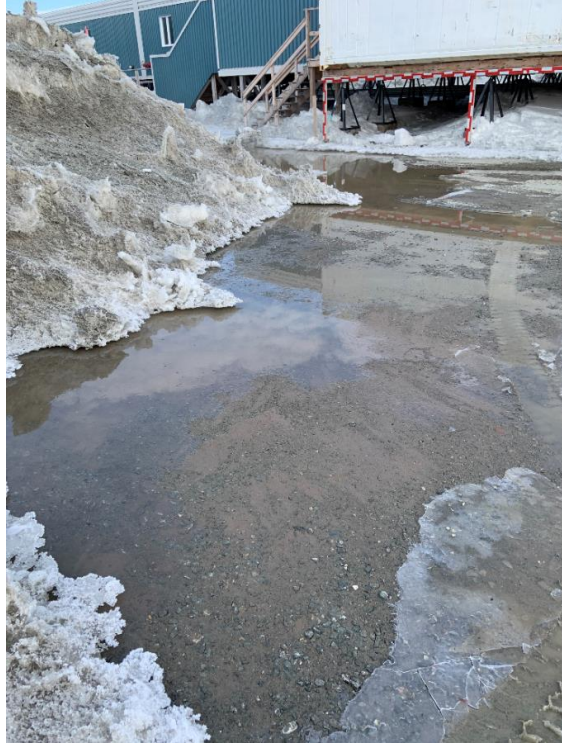
**Figure 4:** Water pooling on south side of the main camp.

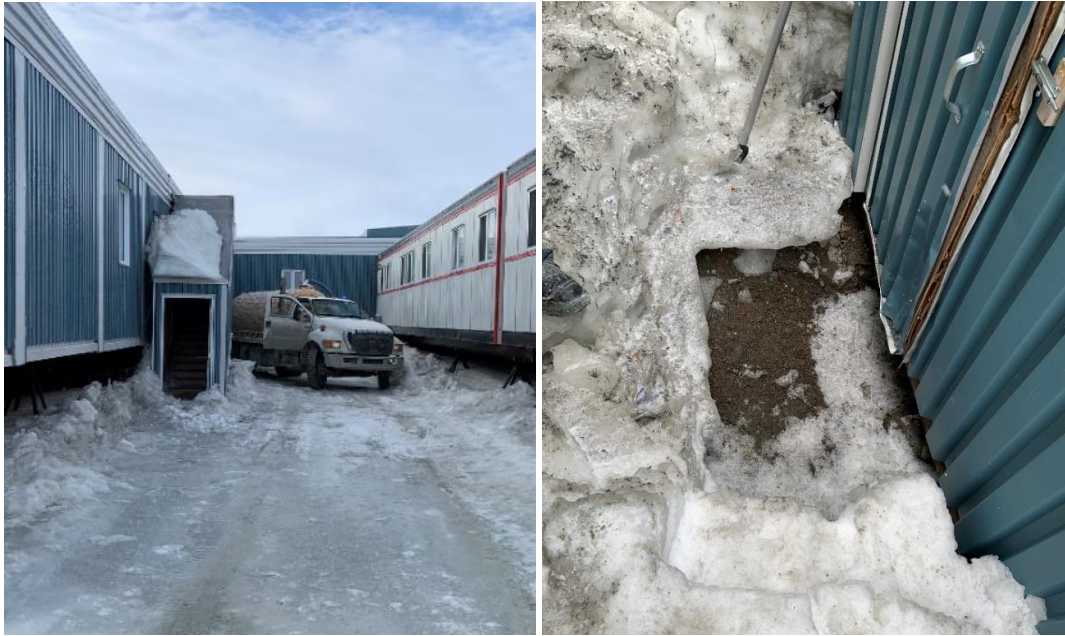
**Figure 5:** The sucker truck was utilized to empty the lift station holding tank and to collect pooling water outside of the lift station.

As soon as the issue was discovered, all water throughout the camp and the Multi Service Building (MSB) was shut off. Crews began using the sucker truck to pump water out of the lift station, as well as any product that was pooling outside the lift station. A temporary containment berm was built downstream of the flow to contain the spill and prevent further migration. Peat material was placed on top of the pooling water on the south side of the camp to absorb it and prevent further downstream flow. All pooled water that was recovered from the ground was discharged back into the water treatment system. The sand and soil used to contain the water was later removed, placed in the WRSF and encapsulated in waste rock.

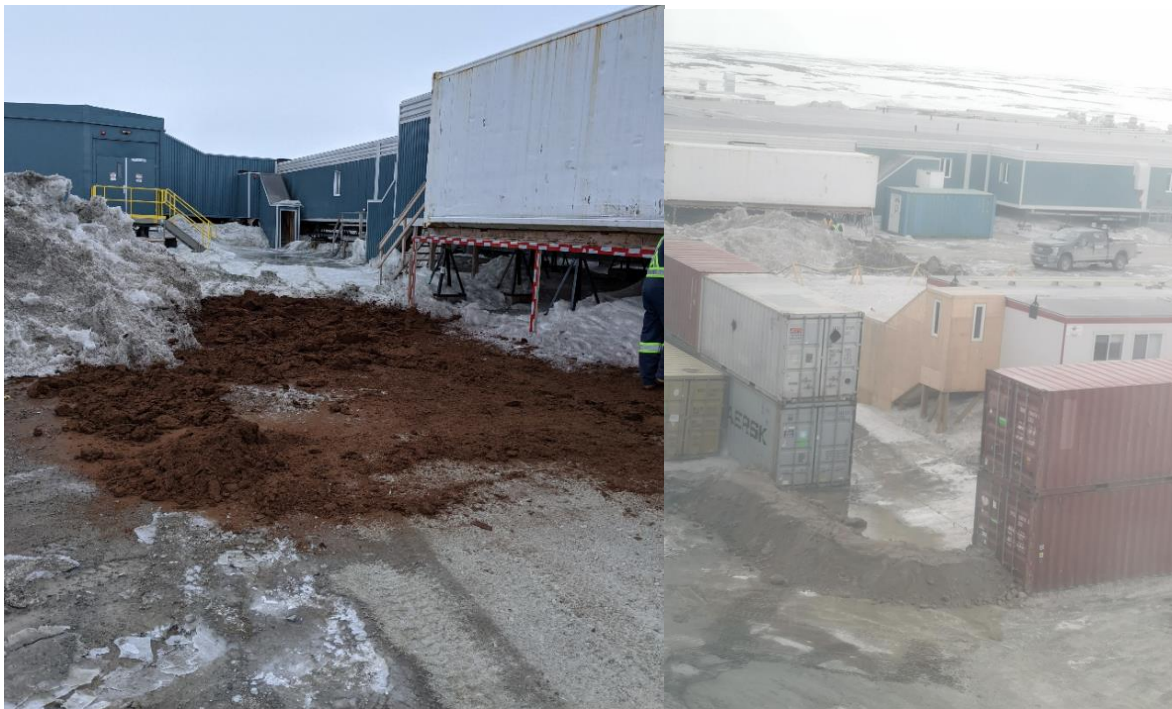
**Figure 6:** Clean peat/soil was used to absorb pooling water, and a temporary berm construction to mitigate downstream flow.
