Follow Up Report: #21-236

June 5, 2021 – 3500 L Wing 12 Drain Pipe

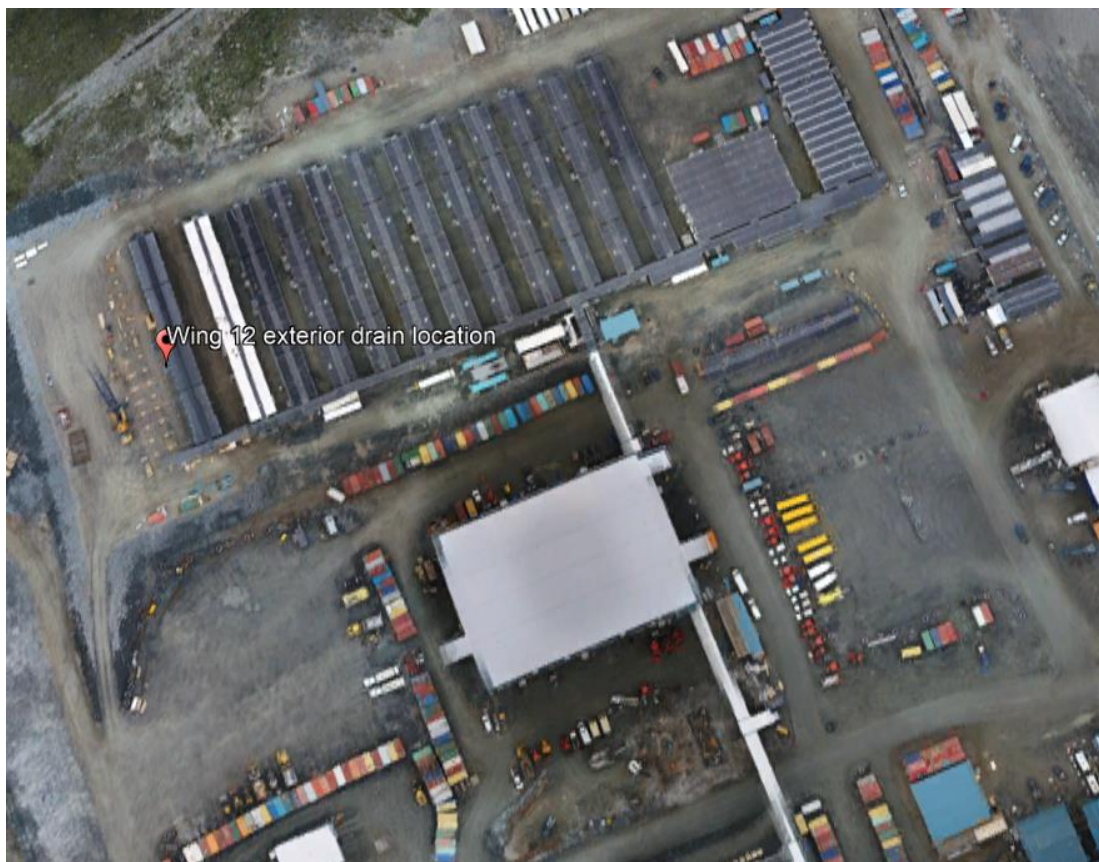
Figure 1: Location of the exterior drainage pipe where the spill occurred.

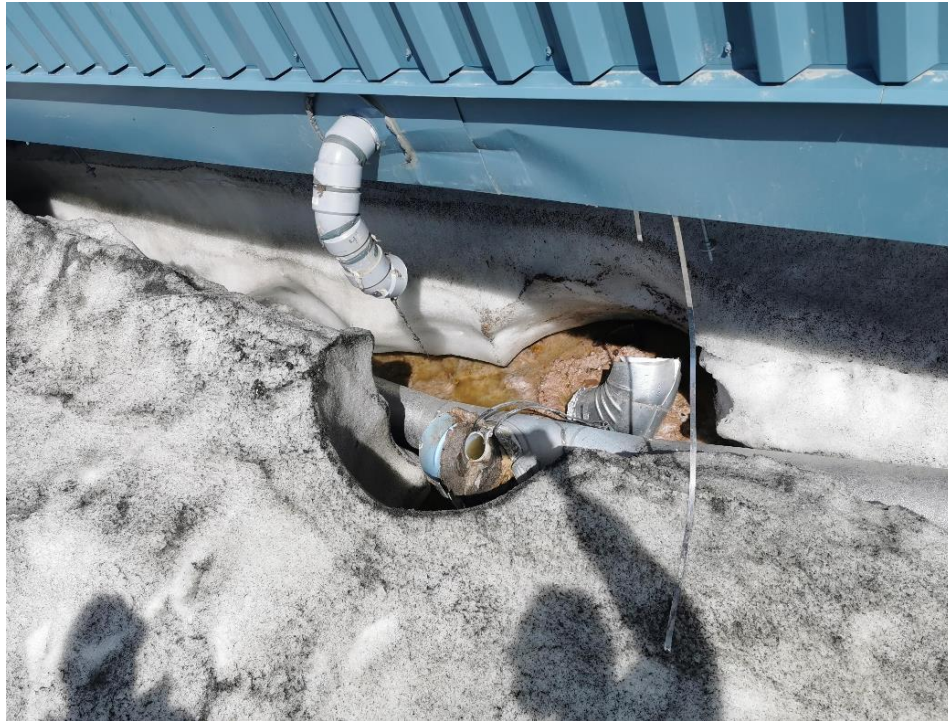
On June 5, workers conducting a regular inspection of the camp exterior found that a drainage pipe had separated from the building due to the weight of thawing snow. The pipe flows directly between the bathroom drains of the dorm wing 12, and delivers drain water to the exterior pump/lift station of the wing. Greywater and blackwater from the showers, sinks, and toilets, was released onto the gravel pad beneath the wing. An estimated 3,500L of water would have been released.

A follow-up investigation revealed that the pipe hangers on this wing were only temporary, and were never replaced when the wing was installed the previous year. The temporary hangers were unable to support the additional weight of the thawing snow, which led to the breakage.

Figure 2: Drainpipe on the exterior of Wing 12 that separated from the building due to the weight of snow.

The piping was replaced and installed with heavy-duty pipe hangers, heat trace cables and insulation. All of the hangers on the remaining wings were inspected and they were all the correct heavy-duty type. An external consultant is also being considered to conduct an in-depth audit of the greywater/blackwater drainage and pumping systems throughout the mine site. Other long-term plans are being discussed, such as acquiring smaller equipment to be used specifically for snow removal between wings.

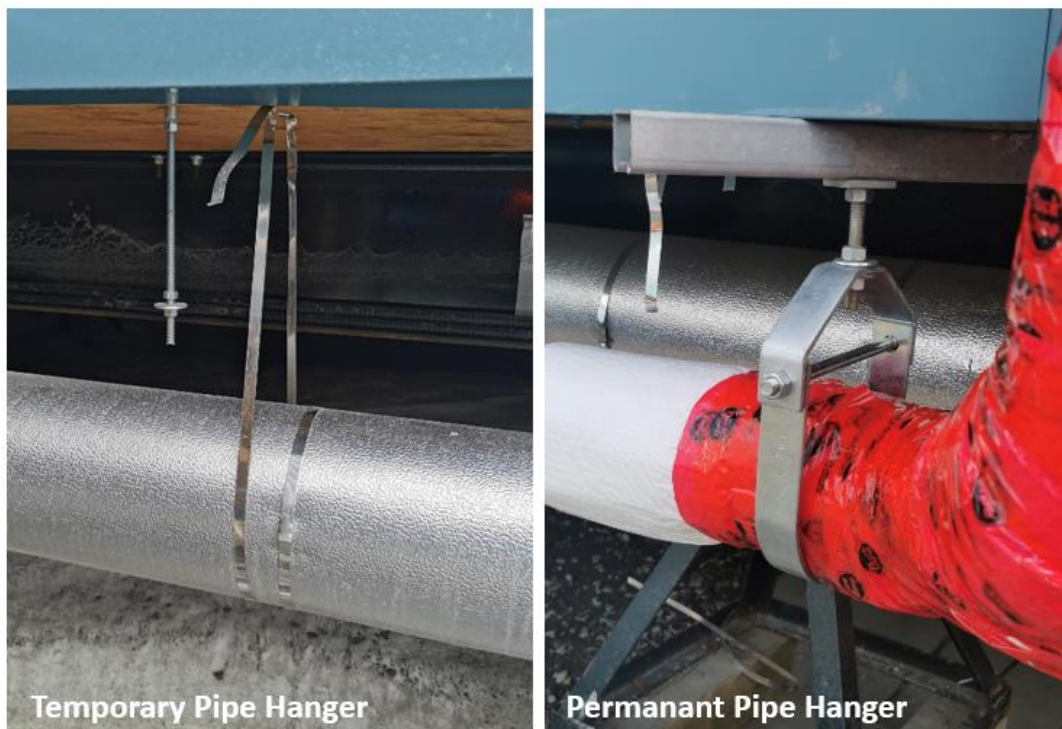
Figure 3: Example of the temporary pipe hanger that was in place prior to the spill, versus the permanent pipe hanger that is now installed.

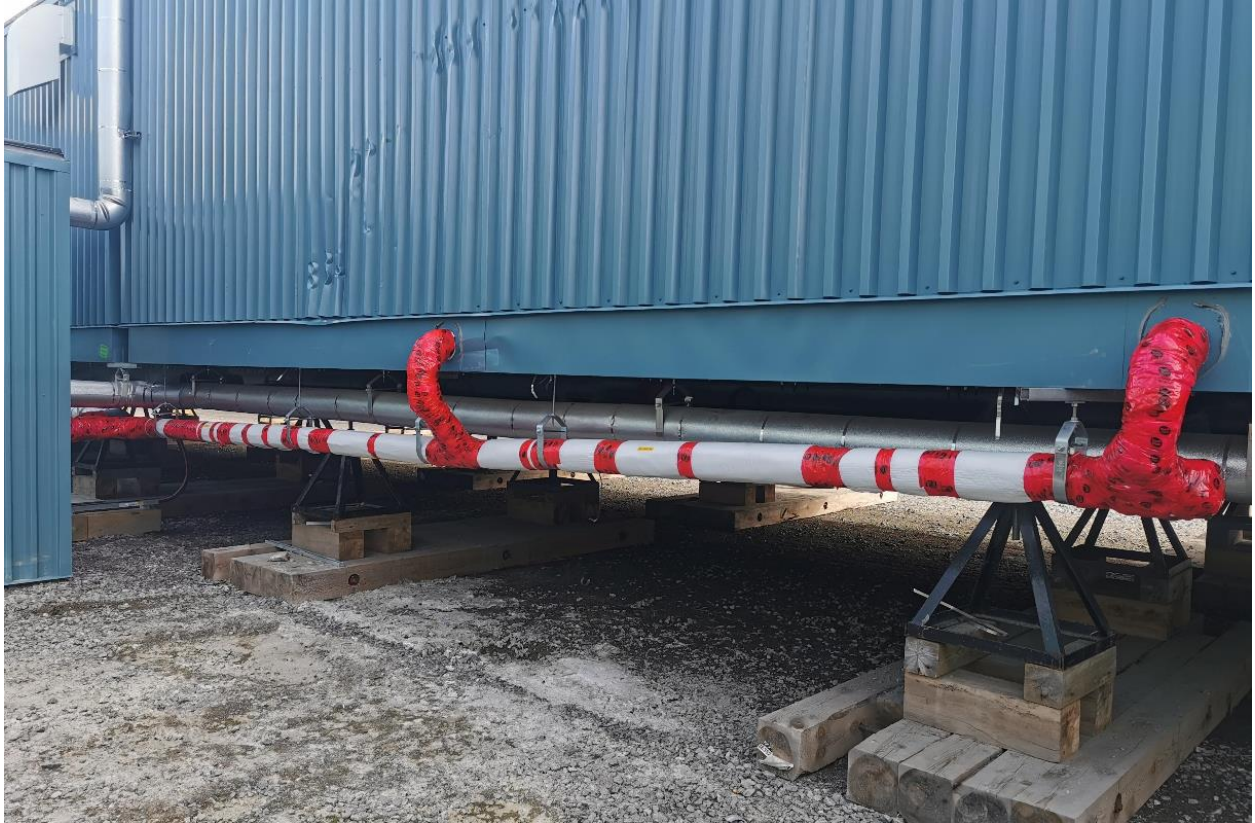
Figure 4: Clean up of the area and reinstallation of the drainpipe with heat trace and insulation.

The initial action was to close out the usage of the Wing 12 bathrooms so until the pipe could be fixed, in order to prevent any more water from being released. The sucker truck was used to recover as much standing liquid and debris from the ground as possible, which was deposited back into the lift station of the main camp to be treated through the Sewage Treatment Plant. The snow was removed from the area in order to better assess and repair the damage.
