# Follow Up Report: #21-279

## June 29, 2021- Heat Recovery Water

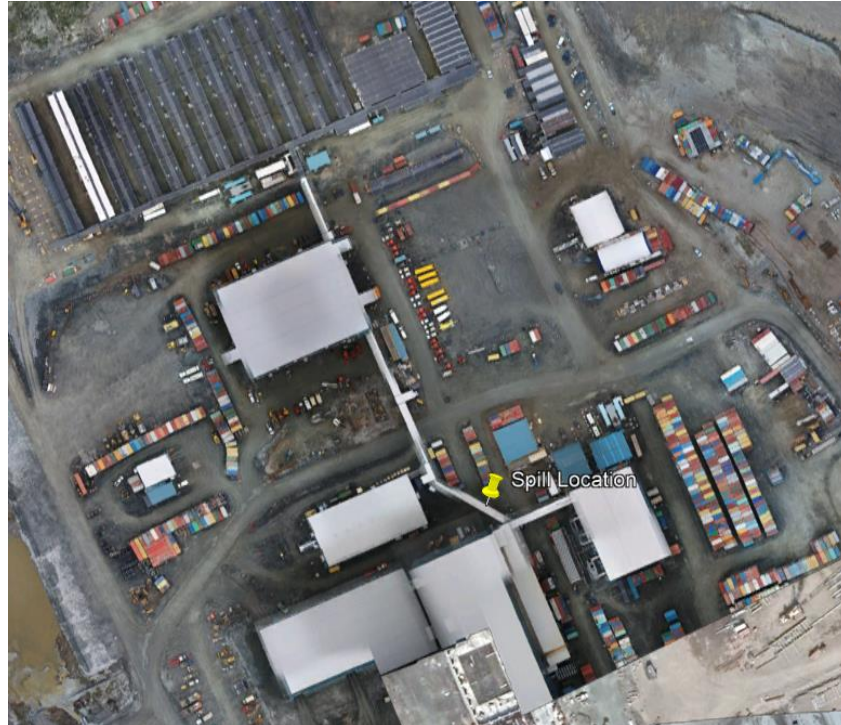
Due to failure of an expansion joint on the heat recovery system, approximately 8 m<sup>3</sup> of water containing corrosion inhibitor (Drewgard 4109) spilled in the south end of the Arctic corridor (between the Multi Service Building (MSB) and the process plant), and then leaked to the ground below on the Industrial Pad. The mix of Drewgard to water in the system was estimated to be 11 L of Drewgard to every 1000 L of water.

**Figure 1:** Location of the spill source was inside the arctic corridor, which then leaked to the ground below on the Industrial Pad.

The release occurred due to the failure of an expansion joint in the boiler recirculation system. The cause of the failed component is uncertain and is currently still under investigation. The expansion joint was replaced and the system inspected for leaks. A visual alignment was performed by an E&I millwright and E&I heat technician using a level indicator and shims on piping support beams. The failure was discussed with engineering firm BBA and an investigation report was issued, which is currently being reviewed by the E&I maintenance team.

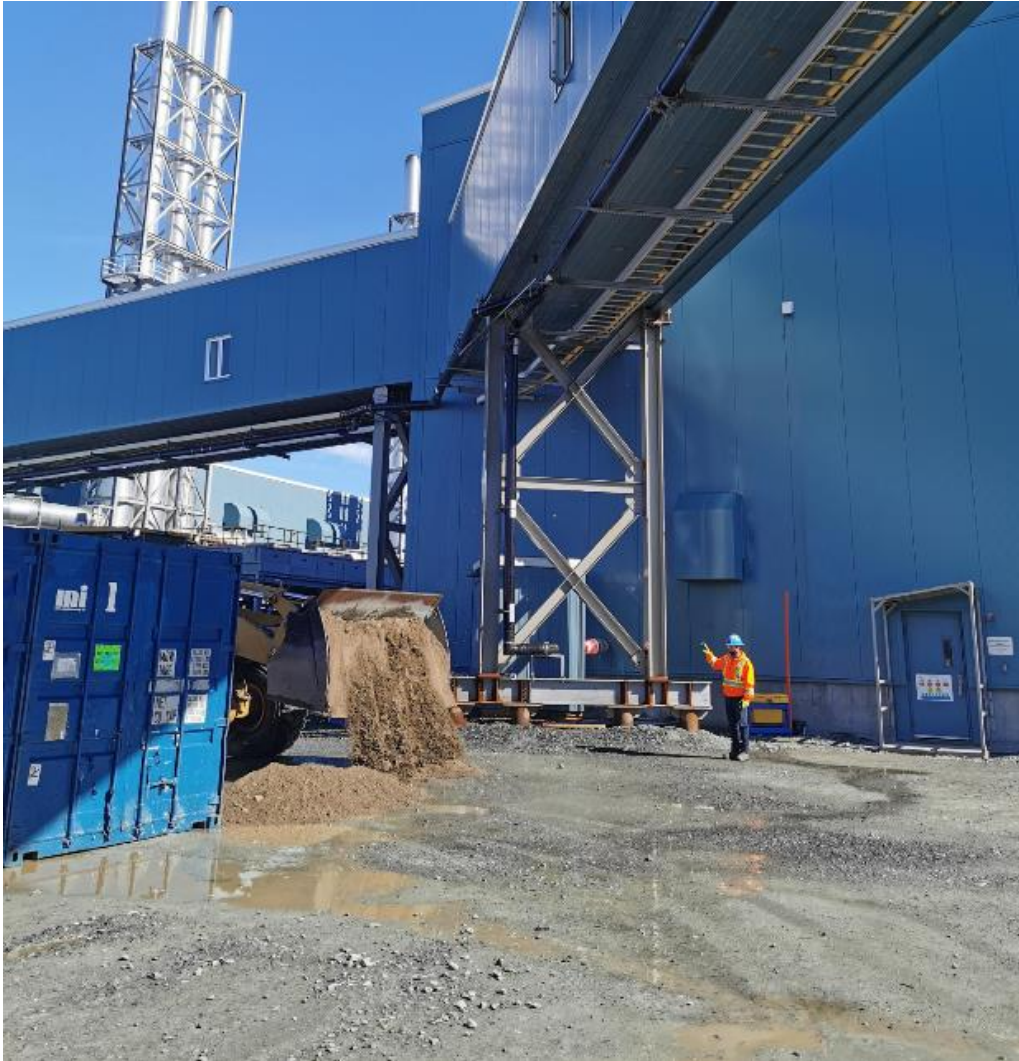
**Figure 2:** Sand berm being created at the south end of the spill location to contain the heat recovery water.

Sand berms were constructed in order to contain the spilled water in a central area and mitigate further migration until site personnel were able to shut down the system, preventing further release of heat recovery water. Contaminated material was removed with a front-end loader, placed in the Waste Rock Storage Facility 1 (WRSF1) and encapsulated in waste rock.

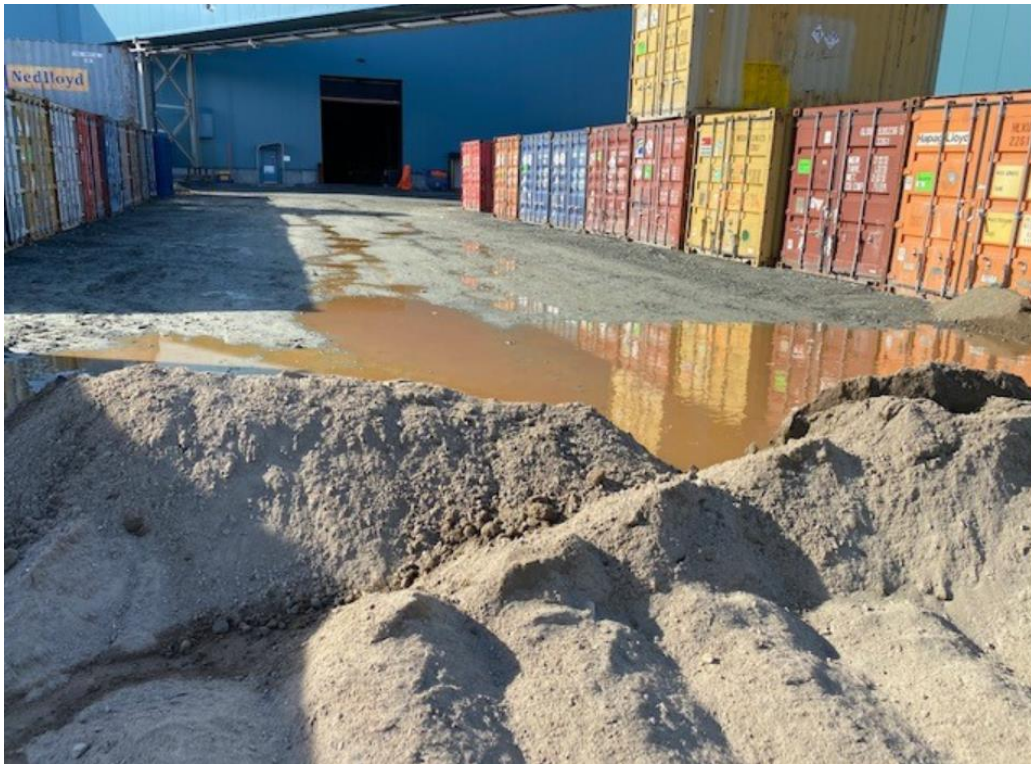
**Figure 3:** Sand berms constructed at the north end of the spill location.
