# Follow Up Report: #21-299

## July 11<sup>th</sup>, 2021 – Saline Effluent Treatment Plant (SETP) Treated Water Spill

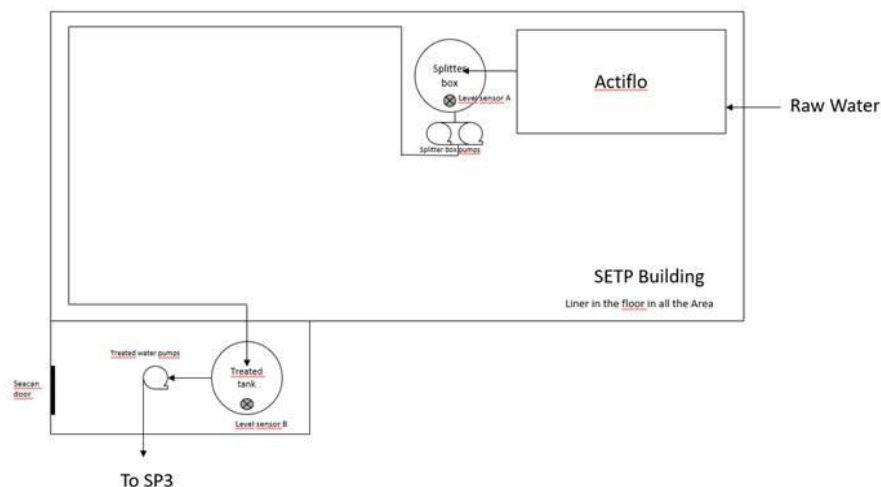
During seasonal commissioning of the SETP it was identified that the treated water pump was running full speed because level sensor "B" indicated High-High, however the tank was empty. To protect the pump, it was decided to manually shut down the pump. The sensor "B" high-high level alarm in treated water tank, caused the splitter box pump to automatically shut down. The Actiflo continued to transfer water to the splitter box as level sensor "A" was reading Low-Low level. This rapidly increase the level in the splitter box and resulted in an overflow in the SETP building.

The Actiflo was stopped however water continued to flow into the splitter box as there is a lead time between the Actiflo stop time and the time that the water stops flowing. Splitter box level sensor "A" indicated Low-Low as the splitter box continued to overflow. To avoid continuing overflowing in the building, the splitter box pumps were restarted directing flow to the treated water tank. The treated water tank level sensor "B" was now reading 1/3 full. The sensor continued to read 1/3. When inspecting the tank, it was found to be overflowing and approximately 1 cubic meter had spilled out the door while the sensor continued to read 1/3 full. The system was immediately shut down for further investigation.

**Figure 1:** SETP configuration.

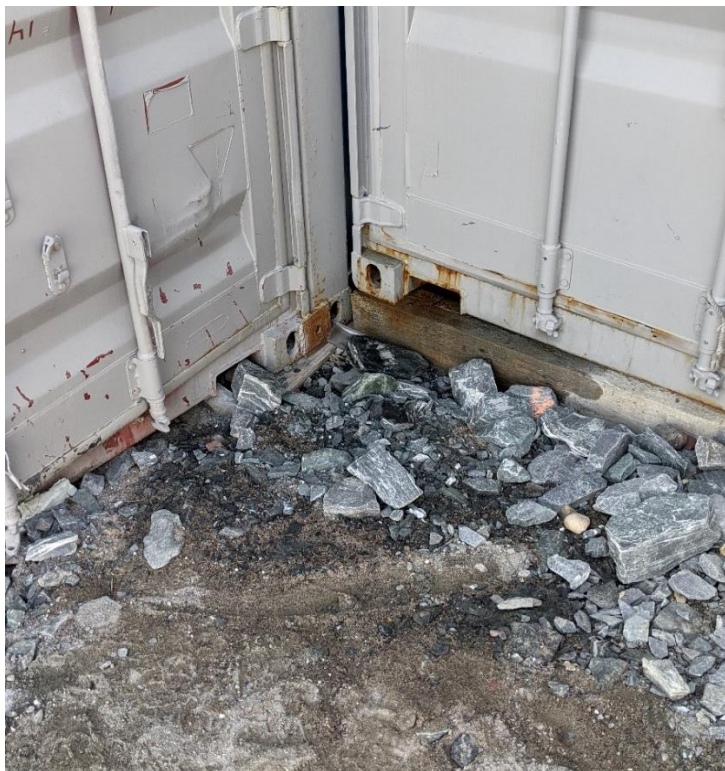
**Figure 3:** Treated water flow outside SETP.

The plant was shut down to stop the release to the ground outside the sea-can. The SETP was being commissioned with water from SP1, thus no chemicals were added. The water spilled to the ground will be captured within the site water management system and directed to CP5.

The immediate cause was a result of a faulty reading from both sensors, it is assumed that the faulty readings were a result of foam within the system causing in accurate reading on the ultrasonic sensors. Agnico Eagle Mines Ltd. instrument technicians calibrated the sensors and confirmed accurate reading. Agnico Eagle Mines Ltd. will increase the frequency of SETP tank level inspections.
