# Follow Up Report: #21-360

## August 22, 2021 – A40 TSS Release

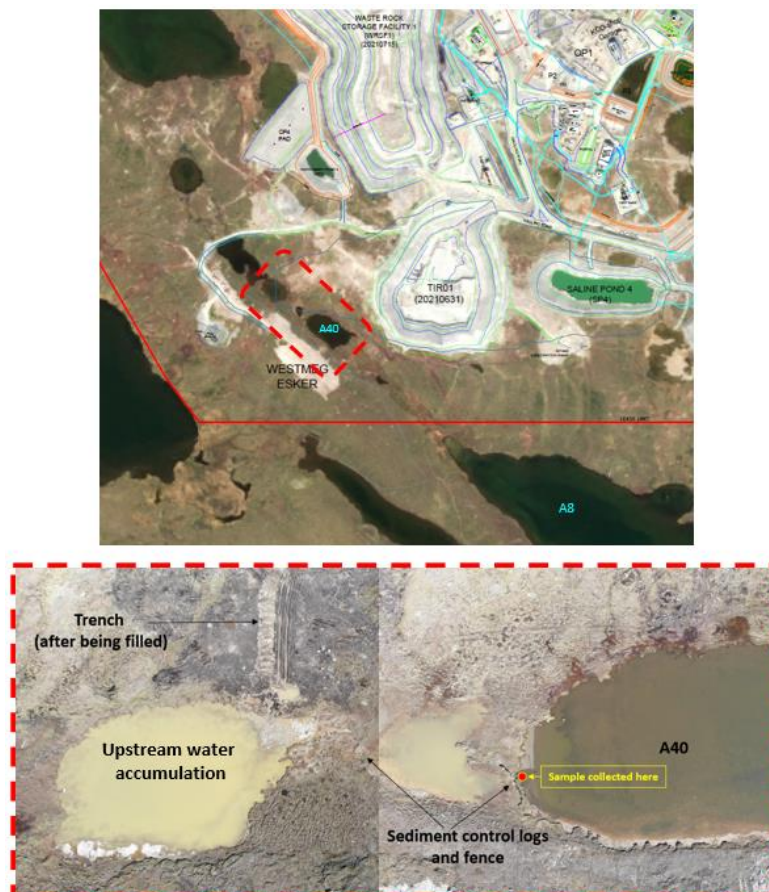
At approximately 8:00a.m. on August 22<sup>nd</sup>, the Environment Department was notified that an unapproved trench had been cut within an overburden excavation zone of the Tiri-01 open pit expansion area (Figure 1). The workers involved cut the trench in order to divert water, which had accumulated due to heavy rainfall, away from the excavation zone. Turbid water flowing in the trench was directed towards accumulated water along the access road, which lies in the footprint of the future Tiri-01 open pit (Figure 1). A plume of turbid water began flowing downstream into pond A40, before mitigation measures were able to be deployed.

**Figure 1:** Upper panel shows the location of the general area relative to other site infrastructure. Lower panel shows a drone image of the impacted water bodies, and locations of the trench (after being backfilled) and sediment controls. Field turbidity readings were taken from A40, as well as a TSS samples downstream of the sediment control fence.

Upon being notified of the situation, Environment personnel acted quickly to retrieve sediment control logs from storage and to investigate the area of concern. Upon arrival the trench was observed to have turbid water flowing through it and accumulating into an area of ponded water upstream of A40. Upon closer inspection, the Environment personnel realized that the accumulated water was very turbid and was making its way to a smaller pond (A40) approximately 90m downstream which then flowed into a larger lake (A8) approximately 700m downstream. Without delay, sediment control logs were deployed at the outlet of the accumulated water and at the inlet of A40 (Figure 1). At this time a plume of turbid water had reached the inlet of A40, and a sample was collected.

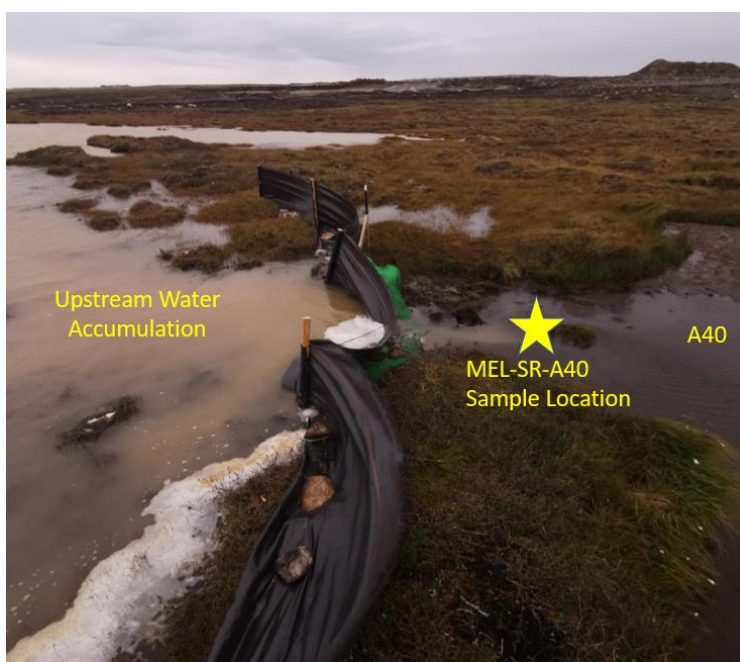
**Figure 2:** Installation of sediment control fence and logs. Sample location established immediately downstream of the sediment control fence.

A sediment control fence and additional wood chip logs were installed at that location to prevent additional sediment from entering the pond and immediately lowered the turbidity of water entering A40 (Figure 2).

The immediate corrective action was to install the sediment controls logs and fence, which took effect right away. In order to ensure similar occurrences do not happen during future heavy rain periods, the accumulated water upstream of A40 will be captured and returned onsite to be managed by existing site water management infrastructure.
