Follow Up Report: #21-400

September 15, 2021 – Dome 3 Hydraulic Oil Spill

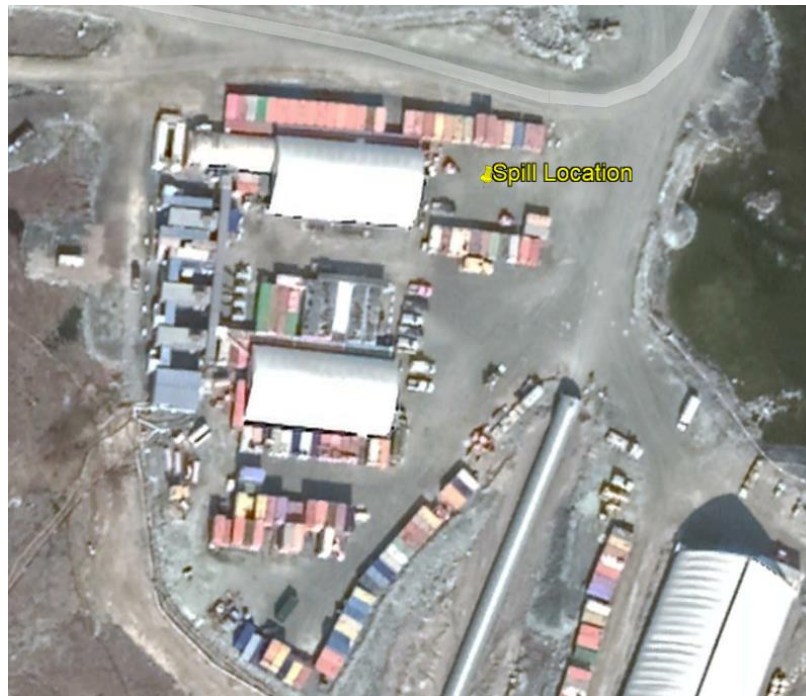
At approximately 04:30 on September 15, 2021, a broken hydraulic oil fill connection on a Fuel/Lubrication truck led to the release of approximately 300 L of hydraulic oil. The oil was contained within the dome 3 parking area covering an area of approximately 90 square metres.

Figure 1: Location of the spill on East side of Dome 3.

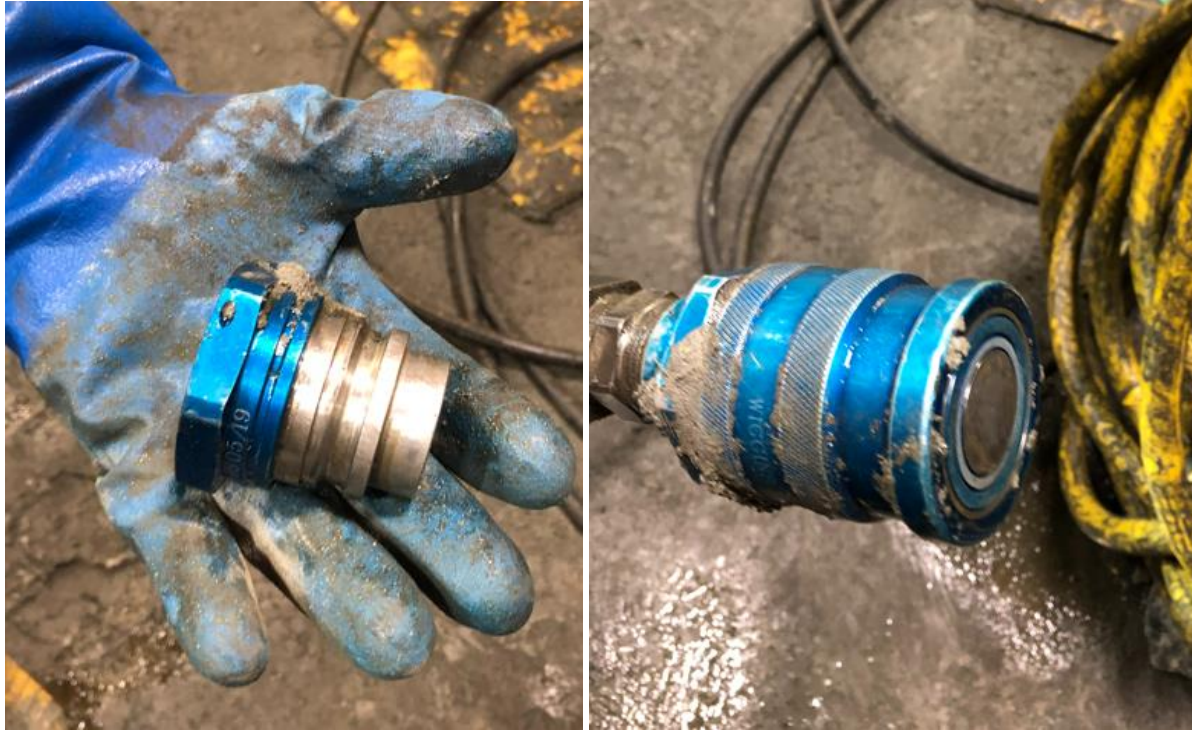
The fuel/lubrication truck operator removed the Fuel/Lubrication truck from Dome 3 while the Hydraulic oil fill line was still connected to the truck. This resulted in the connection on the truck breaking off and releasing the oil. Procedures for operating mobile equipment require the operator to complete a vehicle inspection prior to operating the equipment. This inspection includes a vehicle walk around which did not happen on this occasion.

Figure 2: Broken hydraulic line connection from Fuel/Lubrication truck.

The specific cause in this incident is attributed to human error and not following procedures. A review of the requirements was carried out with the individual to ensure proper understanding of the procedure and associated inspection checklist.

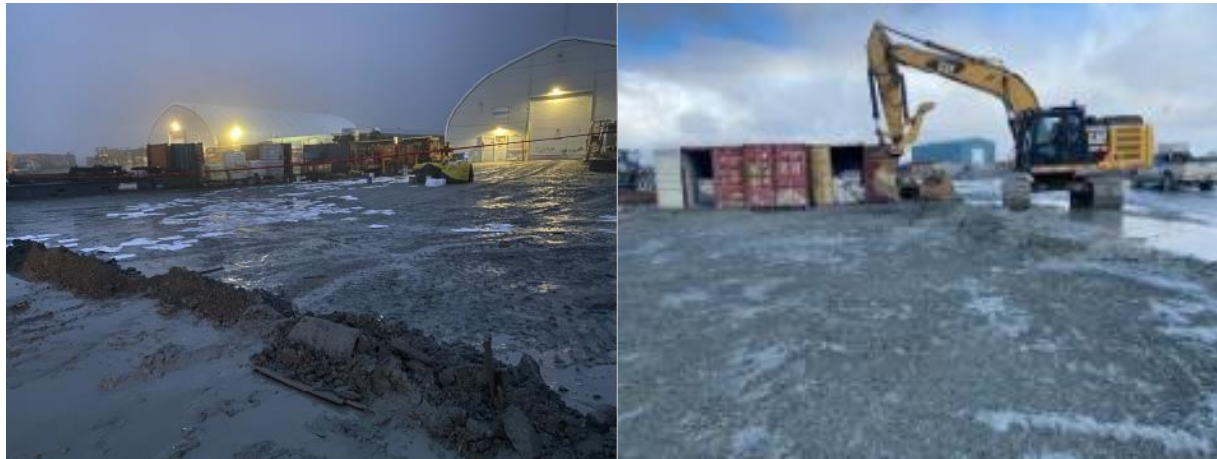
Figure 3: Containment berm and excavator clean up.

Spill pads were immediately placed on the affected area and a berm was constructed to contain the oil. The Underground Mine Supervisor and Environment Department organized a clean-up of the area. The area was cleaned up using an excavator and haul truck. All contaminated material was disposed of in the Landfarm.
