Follow Up Report: #21-440

October 14, 2021 – 200 L Hydraulic Oil Spill

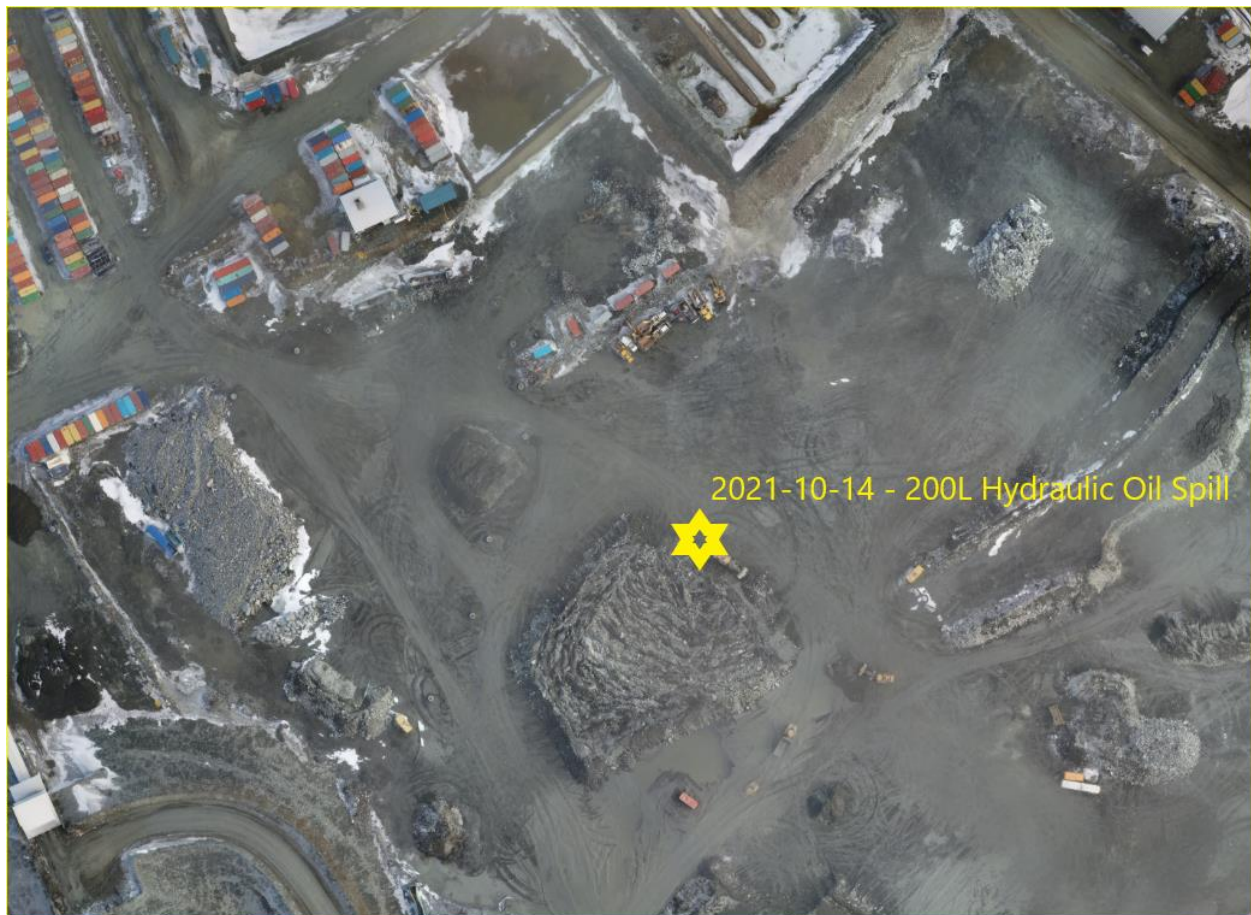
Figure 1: Location of the spill on ore pad

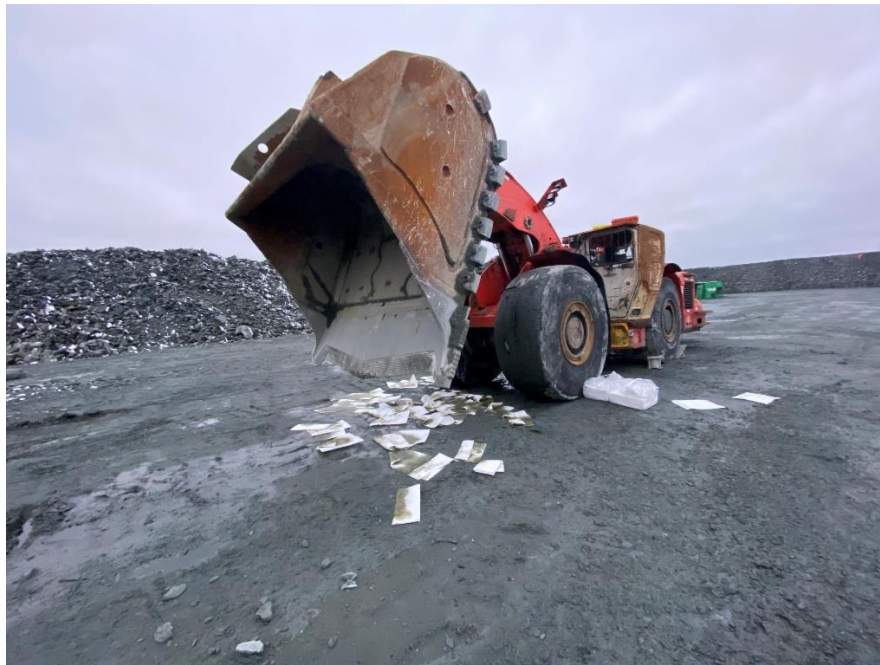
Figure 2: Hydraulic line failure during operation

The root cause of the incident was a result of an unsecured pressurized hydraulic hose rubbing on a bent bracket. Maintenance replaced and properly secured the hydraulic hose and repaired the bent bracket to prevent further rubbing on the new hose.
