Follow Up Report: #21-461

November 2, 2021 – 300 L Untreated Sewage

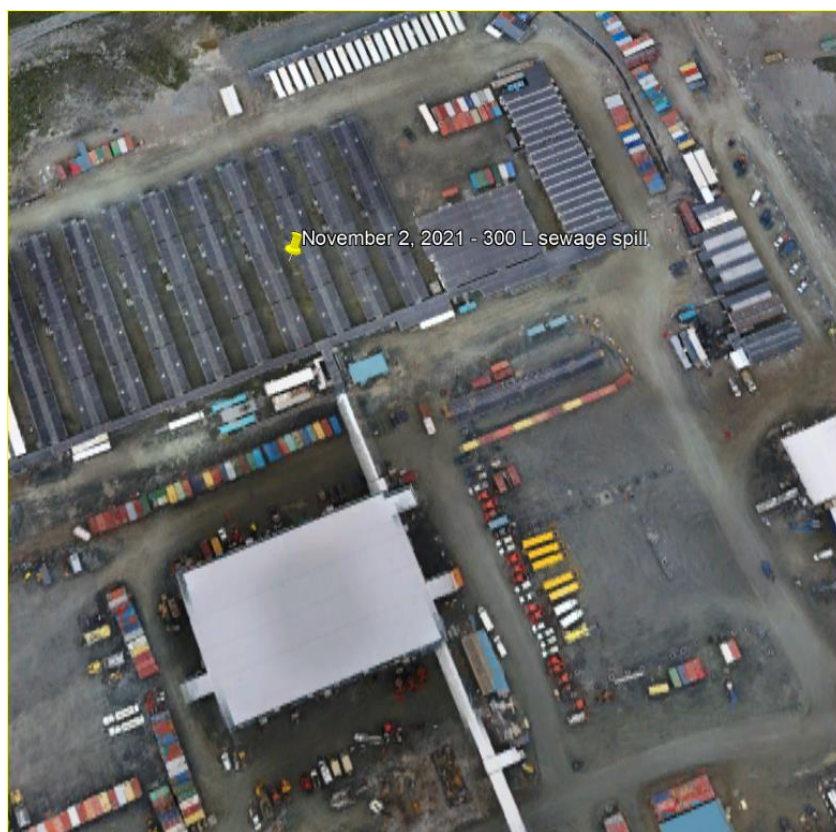
At approximately 7:15 on November 2, 2021, the Environment department was notified of a spill of approximately 300 L of raw sewage. The spill occurred when a fitting pulled away from the pressurized piping. The piping transports sewage from the wing 3 lift station to the main camp sewage treatment facility.

Figure 1: Location of the spill between wings 3 and 4.

The fitting (Fernco) installed on the downstream side of the lift station pump was not the correct fitting for a pressurized service. This resulted in the fitting pulling away from the piping causing the release. The fitting has since been replaced with the proper fitting for the service and an inspection of each lift station (wings 1-14) will be conducted to ensure all other fittings are replaced with the appropriate fittings for pressurized service.
