Follow Up Report: #21-471

November 16th, 2021 – Tailing's Cement Paste Spill

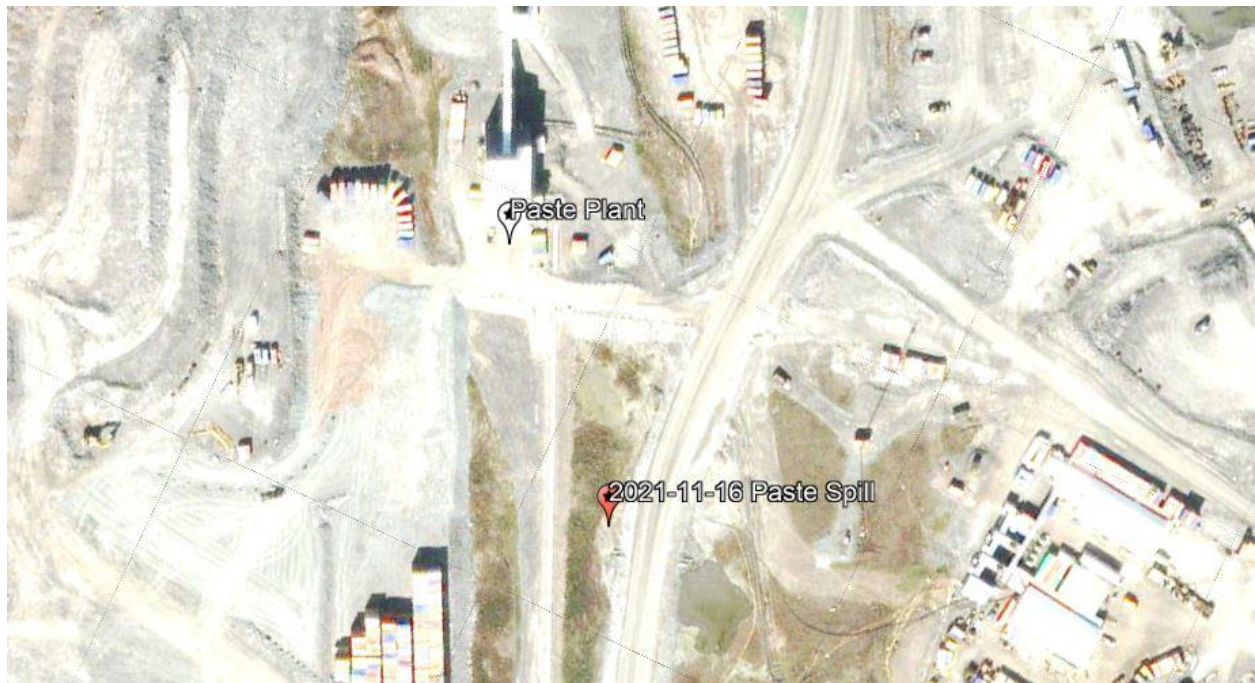
No natural water bodies were impacted with the closest being approximately 640 m northwest (B8). The spill occurred at 63° 1'34"N, 92°12'56"W, beside TIRI01 hauling road.

Figure 1: Location of cement paste spill by TIRI01 hauling road

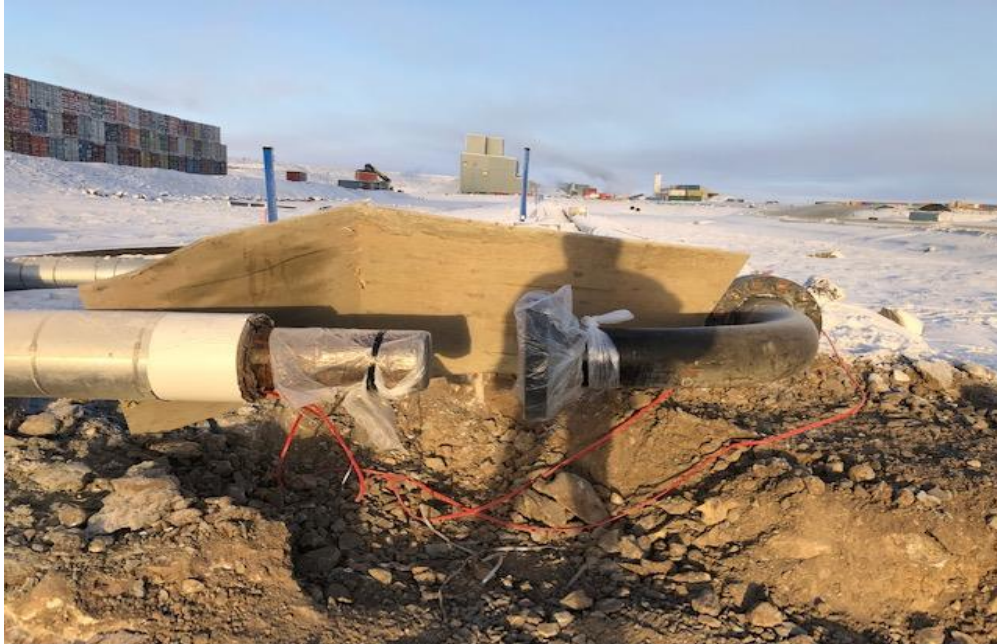
Figure 3: Disconnected line and remediated area

The paste plant line was immediately shut down and the environmental department was called to assess the spill. An excavator was brought to the area to move cement paste into a rock truck. All material collected was brought to the tailing's storage facility for proper disposal.
