# Follow Up Report: #21-474

## November 23, 2021- Heat Recovery Water

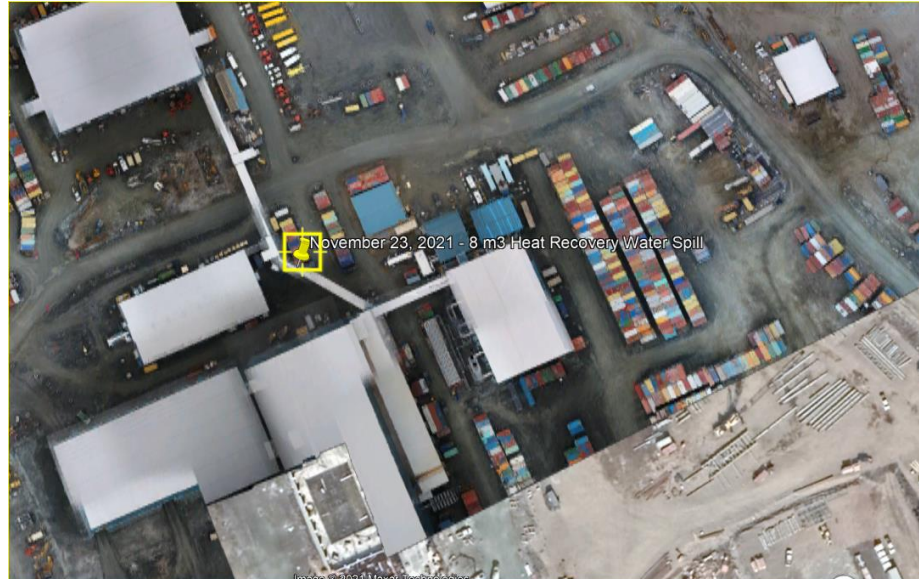
Due to failure of an expansion joint on the heat recovery system, approximately 8 m<sup>3</sup> of water containing corrosion inhibitor (Drewgard 4109) spilled in the south end of the Arctic corridor (between the Multi Service Building (MSB) and the process plant), and then leaked to the ground below on the Industrial Pad. The mix of Drewgard to water in the system was estimated to be 11 L of Drewgard to every 1000 L of water.

**Figure 1:** Location of the spill source was inside the elevated pedestrian corridor, which then leaked to the ground below on the Industrial Pad.

The release occurred due to the failure of an expansion joint in the boiler recirculation system. A review of the original design indicated the correct components were used during construction. Therefore, the cause of the failed component is uncertain and is currently being investigated by an external consultant. The expansion joint was replaced, and the system inspected for further leak leaks. A visual alignment was performed by the Energy & Infrastructure Department millwright and heat technician using a level indicator and the remaining expansion joints were inspected for wear. Agnico Eagle Mines Limited will replace the expansion joints as per the recommendation from the external consultant.

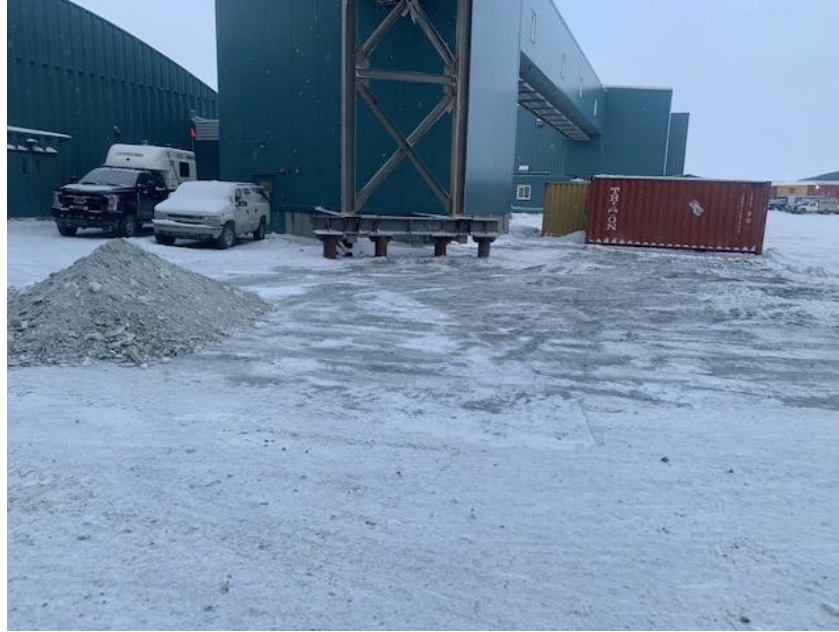
**Figure 2:** Final clean up.

was contained to the immediate area. Storage containers were removed from the area and a loader was used to clean up the frozen material. Waste material will be stored in totes for final disposal in the spring.
