Follow Up Report: #21-481 November 30th, 2021 – Sewage Treatment Plant (STP) Treated Water Spill

The following information relates to spill 21-481 reported by Agnico Eagle Mines Ltd. December 1st, 2021, and is being provided in accordance with:

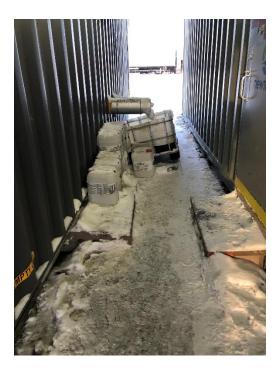
During normal operations, a suction effect from a tee in the piping system triggered a false alarm and activated an interlock that stopped both discharge pumps on the treated water tank. The high limit of the tank also failed resulting in a continuous flow of water to the tank and an eventually overflow. This resulted in a spill of 200 liters of treated water to the ground.

Figure 3: Frozen treated water outside STP.

The plant was shut down to stop the release to the ground outside the tank. The treated water released is normally directed to contact pond 1 (CP1). The majority of the spill migrated underneath the STP and is unable to be collected at this time. In the Spring the spilled Treated water will be captured and directed to CP1 the intended final location.

The immediate cause was a result of a faulty interlock. The interlock was removed from the discharge pump to prevent the overflow of the treated water tank. As well the treated water overflow line will be rerouted so that it is recirculated back into the system.
