Follow Up Report: #21-492

December 7, 2021 – Pump shack fire- 800L fire suppressant water

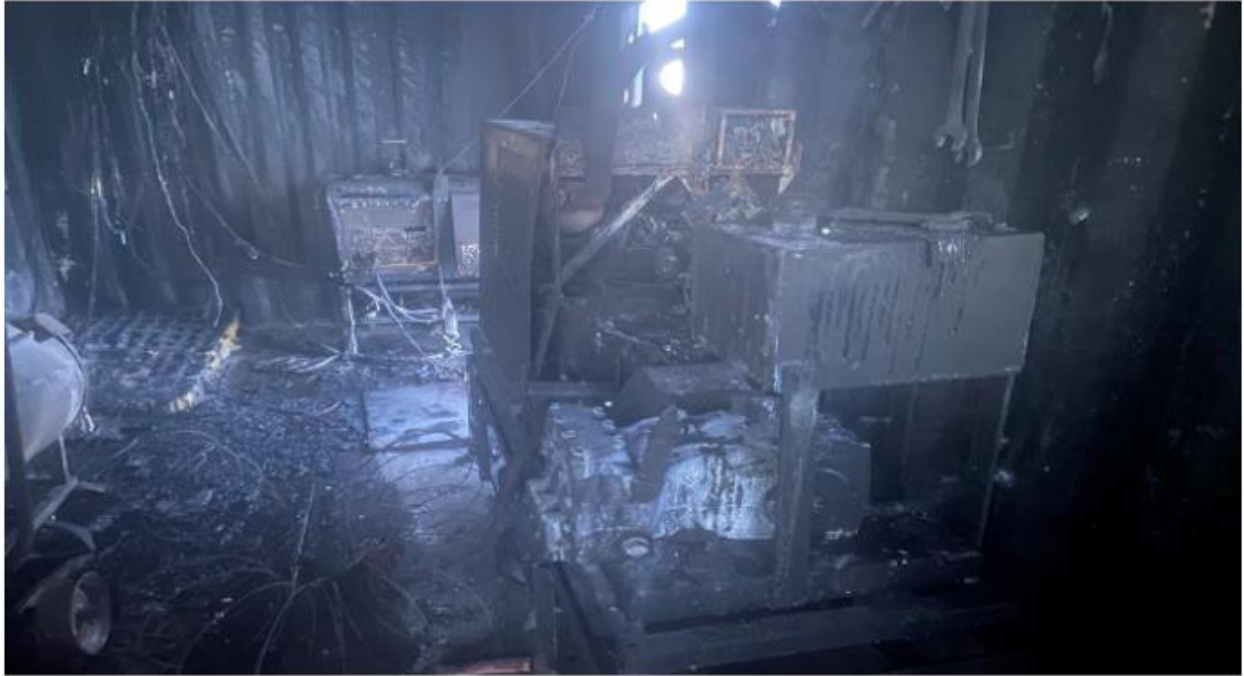
At approximately 15:00 on December 7th, drillers working at a surface diamond drill noticed flames inside the drill's freshwater pump shack, located 45 meters from Meliadine Lake. The driller contacted his supervisor and upon arrival to the pump shack, attempted to extinguish the fire using fire extinguishers. The Emergency Response Team (ERT) arrived at the scene and used the pumper truck to suppress the fire with water. Due to the nature of the shack, the interior contains oil or grease covered surfaces. The act of suppressing the fire with water led to the release of charred material onto the ground and some of which was contained within the shack (Figure 2).

Figure 2: Photos of the pump shack after the fire was suppressed and the shack was towed back to the shop.

The root cause of this incident relates back to the cause of the fire, and the need to suppress it with water. The incident has been investigated separately by the Health and Safety team and it was determined that a fan of the frost fighter stopped and caused it to overheat melting the plastic fuel tank underneath enhancing the fires growth.

Maintenance schedule for the frost fighter inside the pumps shack is related to the number hours in use, scheduled maintenance inspection will be increased to decrease the chance of equipment failure.

Moreover, the ERT will evaluate possible other fire suppression methods than water to reduce the environmental impacts.

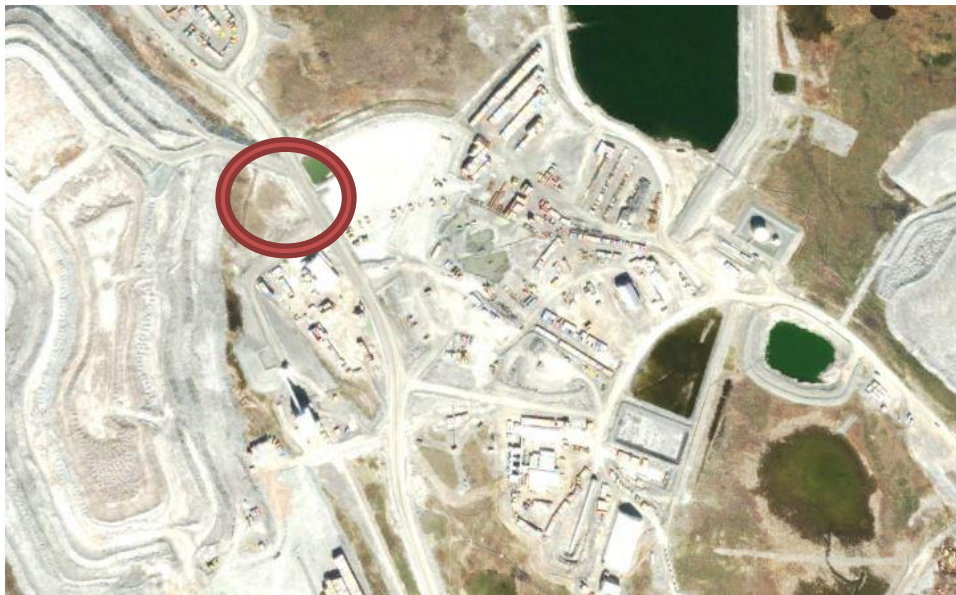
On December 9th the Orbit Garant drilling team was able to plow all the contaminated snow and ice into a large pile and brought this material to the Snow Cell (Figure 3) on our mine site where it will be stored until the summer and then treated through the oil-water separator.

Figure 3: Contaminated material was placed at the contaminated snow cell
