Follow Up Report: #2022067

March 6th, 2022 – Thickener Process Water Spill

The following information relates to spill 2022067 reported by Agnico Eagle Mines Ltd. On March 6th, 2022, and is being provided in accordance with:

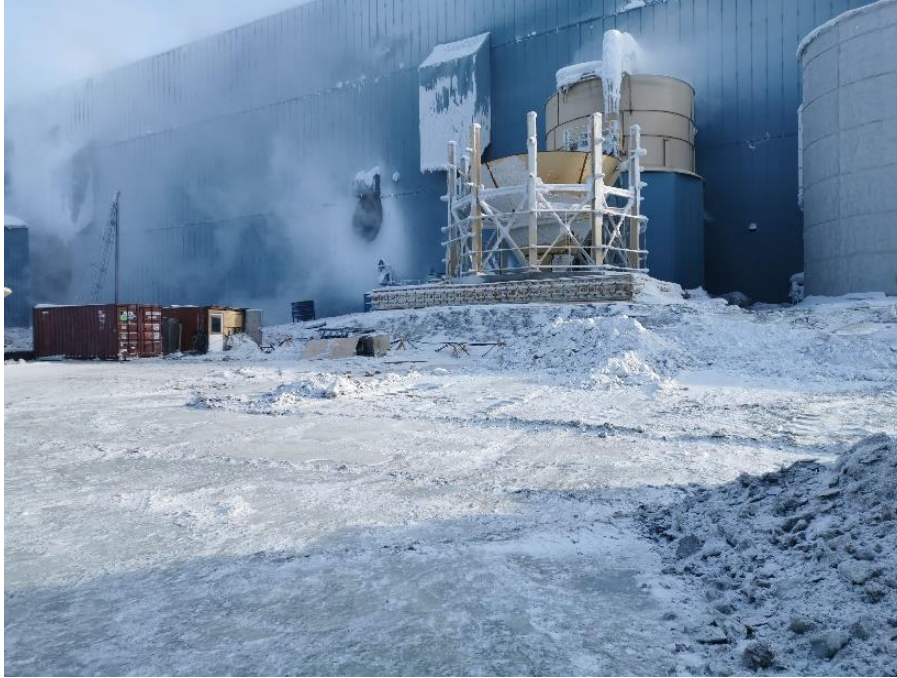
Figure 2: Thickener process water spill clean up

The investigation into the cause of the release identified ice build at the overflow discharge pipe. The ice buildup resulted in a blockage of the discharge causing the thickener tank to overflow.

A temporary berm was built to contain the spill and minimize the impacted area. An excavator, loader and haul truck were used to clean up the spilled material. All material collected was placed in the process plant sump where it will be returned to the process plant system.

- Visually inspecting the top of the grinding thickener/clarifier feedbox every 2 hours and clearing snow if safe (ongoing).
- Ensuring there is adequate water flow from the clarifier feedbox to the grinding thickener by removing some baffle on the clarifier feedbox (completed).
- Preventatively cleaning the grinding thickener overflow launder to regain a full capacity.
- Installing air vent system on the grinding thickener overflow pipe to the process water tank.
- Pouring a concrete secondary containment.
- Installing an additional thickener tank which will split the flow going into the grinding thickener.
