Follow Up Report: #2022076

March 10th, 2022 – Thickener Process Water Spill

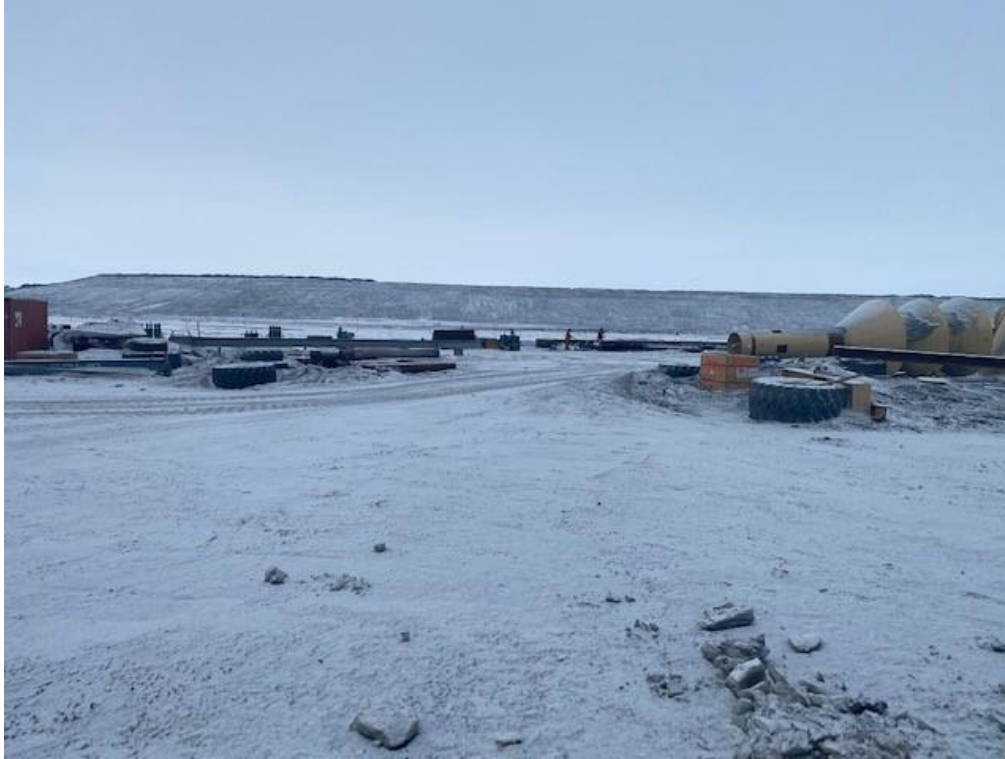
Figure 2: Thickener process water spill clean up

The topography of the area and the freezing conditions caused the thickener process water to pool and freeze on the west side of process road. A loader and haul truck were used to clean up the material. All material collected was placed in the process plants sump where it will be returned to the process plant system.
