Follow Up Report: #2022075

March 11th, 2022 – Thickener Process Water Spill

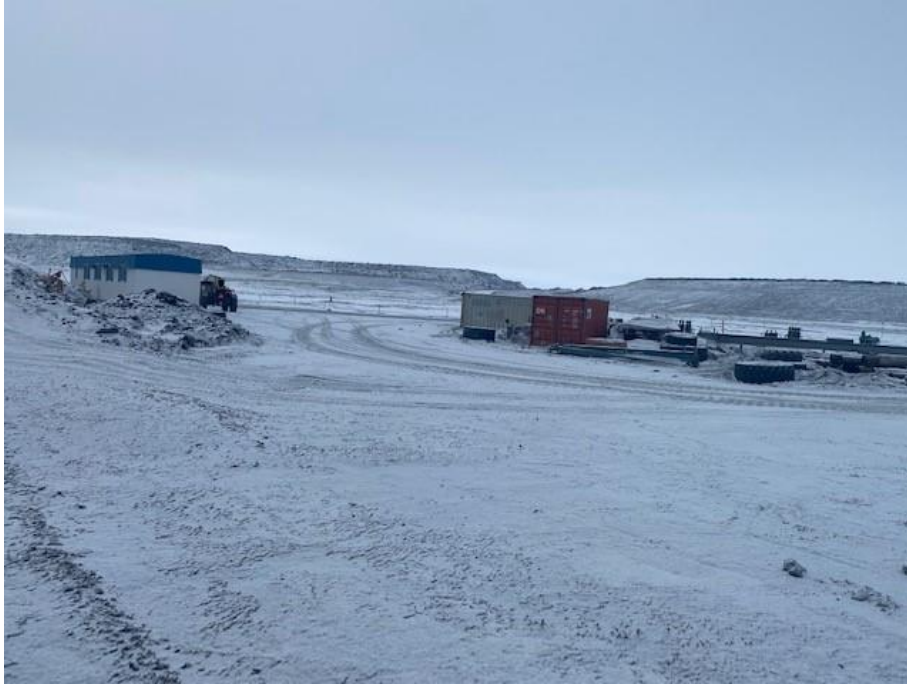
Figure 2: Thickener process water spill clean up area

The topography of the area and the freezing conditions caused the thickener process water to pool and freeze on the west side of process road. A loader and haul truck were used to clean up the material. All material collected was placed in the process plants sump where it will be returned to the process plant system. Additionally, the overhead walkway on the top of the thickener tank was cleared of ice.

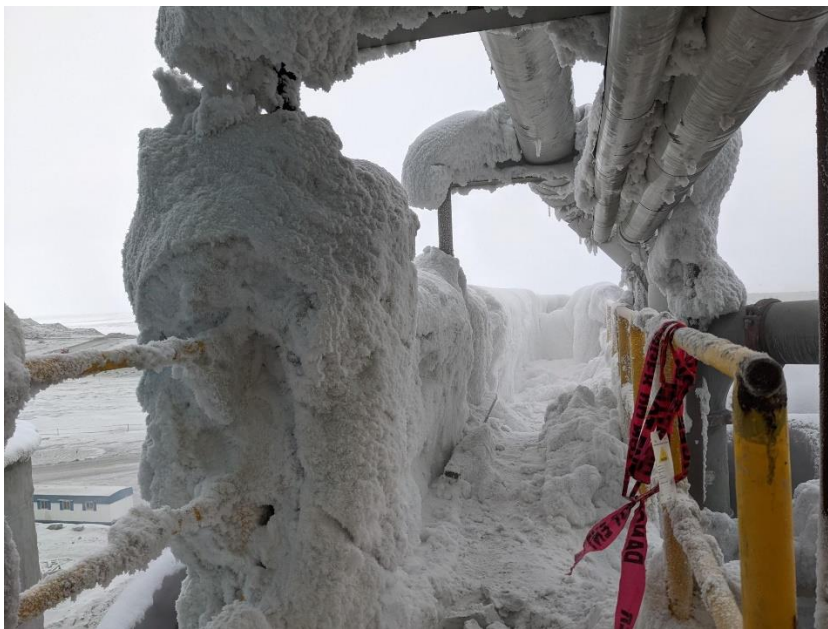
Figure 3: Pre-clean up of the overhead ice on the thickener tank (caused by humidity)

The investigation into the cause of the release identified ice build at the overflow discharge pipe. The ice buildup resulted in a blockage of the discharge causing the thickener tank to overflow. The following corrective measures are being implemented:

- Visually inspecting the top of the grinding thickener/clarifier feedbox every 2 hours and clearing snow if safe (See figure 3 and 4).
- Ensuring there is adequate water flow from the clarifier feedbox to the grinding thickener by removing some baffle on the clarifier feedbox (completed).
- Preventatively cleaning the grinding thickener overflow launder to regain a full capacity.
- Installing air vent system on the grinding thickener overflow pipe to the process water tank.
- Pouring a concrete secondary containment.
- Installing an additional thickener tank which will split the flow going into the grinding thickener.
