Follow Up Report: #2022171

May 8th, 2022 Saline Water Spill

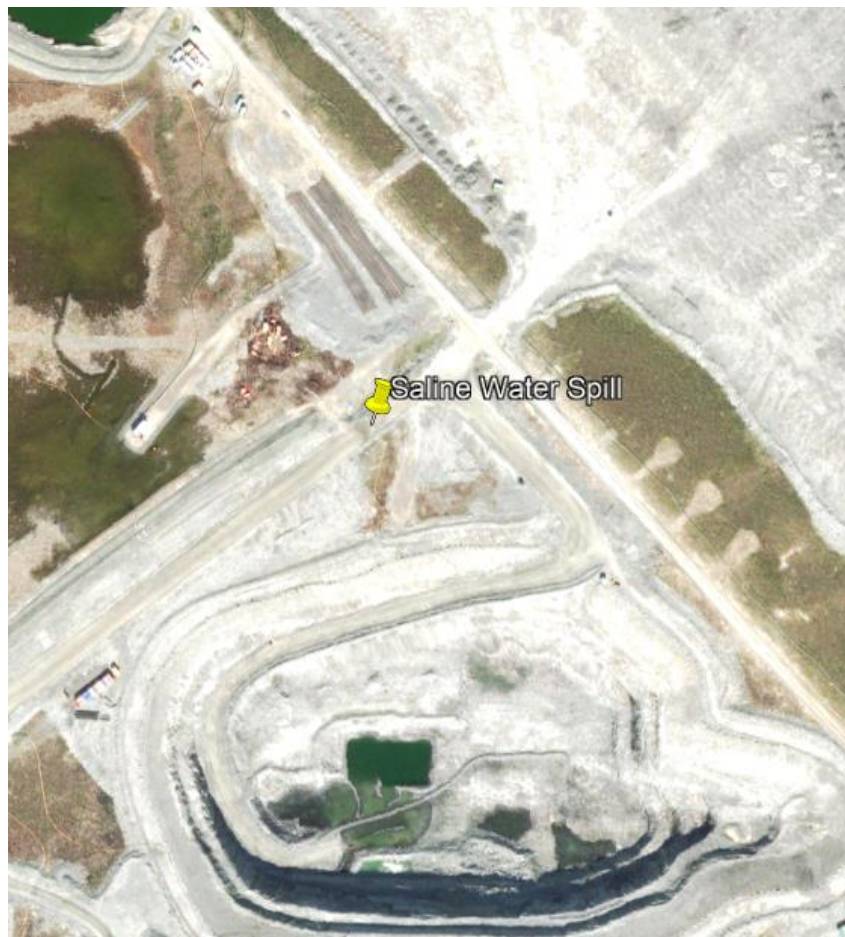
No water bodies were impacted by this spill. The closest natural water body, lake A38, is approximately 500 m from the spill location. The coordinates of the spill are 63° 1'30.56"N, 92°12'4.54"W.

Figure 1: Location of saline water spill on the haul road north of Tiriganiaq pit 2.
