Follow Up Report: #2022172

May 8th, 2022 – MEL-SR16

Surface Water Runoff

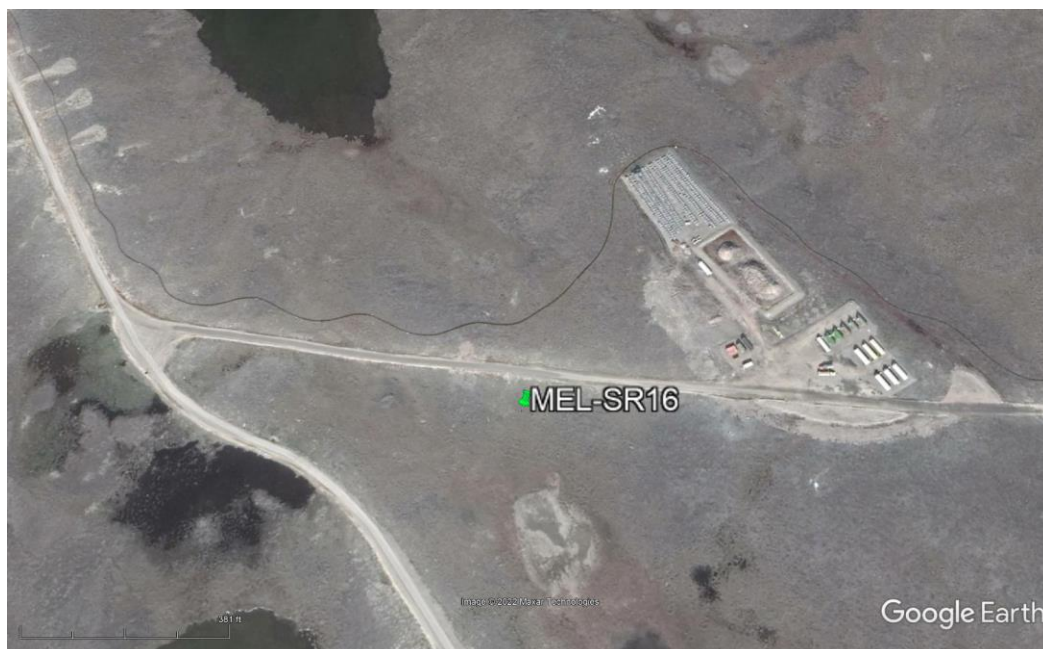
Figure 1: Sample location MEL-SR16

The coordinate of MEL-SR16 is "63 01'22.3" 92 11'21.5". The closest water body (J5) is approximately 180m southeast.

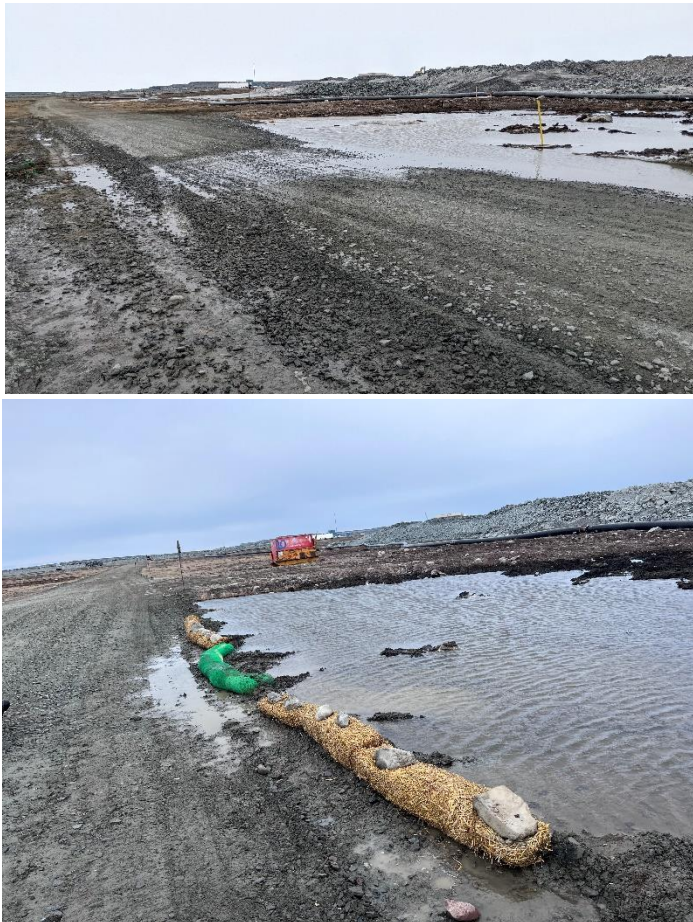
Sampling station MEL-SR16 is located downstream the Exploration Camp Road. The flow path of surface water runoff is from the north side of the road, running south over the road. Runoff across the road and the associated entrainment of sediment is the expected cause of the TSS exceedance.

- The water flowing at MEL-SR16 appeared turbid
- The flow was of low volume

Figure 2-3: During the event and after the event

- Turbidity measurements were taken to confirm visual observations
- A MEL-SR sample was taken as per the 2AM-MEL1631 Water Licence
- Straw logs and wood chip logs were installed on both sides of the road to filter out entrained sediment and to minimize flow velocity to encourage decantation of sediment from the flowing water
- The potential exceedance of Part D Item 18 of the 2AM-MEL1631 Amended Licence was reported as due diligence within 24 hours of the observation

To mitigate the risk of a reoccurrence, all surface runoff in the area is being closely monitored during routine inspections and following heavy rainfall events to ensure that appropriate sediment controls (e.g., straw logs, wood chip logs) are in place to minimize TSS transport.

Furthermore, water from the upstream area ponded area on site (Figure 2) is being collected via water truck as feasible and moved to the Containment Pond 2 (CP2) or Containment Pond 5 (CP5). The purpose of this activity is to minimize the likelihood of water running across the road during heavy rainfall events.
