## Follow Up Report: #2022180 May 11<sup>th</sup>, 2022 – 15 L Sewage

The following information refers to incident #2022180 reported by Agnico Eagle Mines Limited May 12<sup>th</sup>, 2022, and is being provided in accordance with:

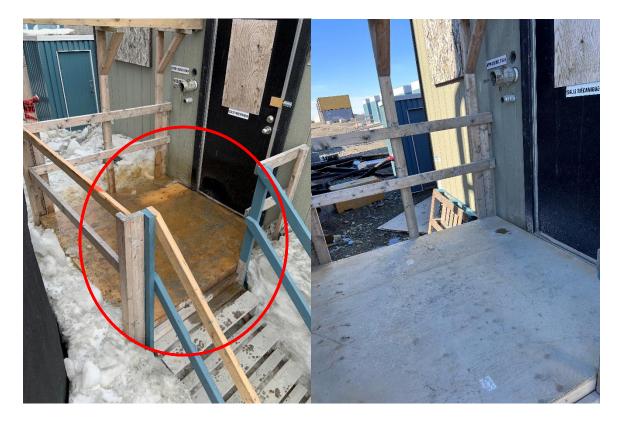
The spill was contained to the lift station building and the local area. The STP operator immediately installed a bucket underneath the location of the spill to contain the material. All of the material was removed with the vacuum truck and discharged back in the lift station.

Figure 2: C wing lift station spill and cleanup

The release was a result of human error as the STP operator did not empty the C wing lift station resulting in an overflow.

This lift station was added to the check list as a reminder. After further investigating into this incident, the discharge valve was observed to be open, which caused the overflow to spill outside of the lift station. The valve is now closed when the lift station is not discharging. In the event the lift station overflows in the future, all of the sewage will be contained within the building.
