Follow Up Report: #2022221

May 29th, 2022, Ammonium Nitrate Spill

The following information refers to spill 2022221 reported by Agnico Eagle Mines Limited May 29th, 2022, and is being provided in accordance with:

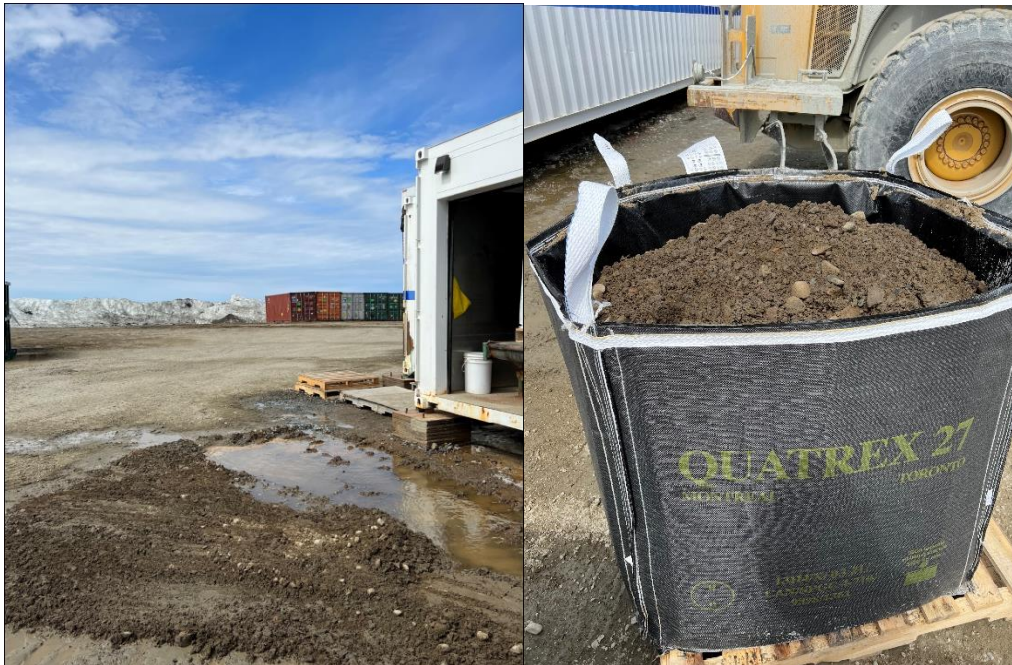
Figures 3-4: Spill area final cleanup and contaminated material packeted and ready to be disposed

The recuperated Ammonium Nitrate material will be used at the open pit inside bore holes as part of the blast pattern during future events as initially intended.
