Follow Up Report: #2022267

June 13th, 2022 – 25 L Sewage Spill

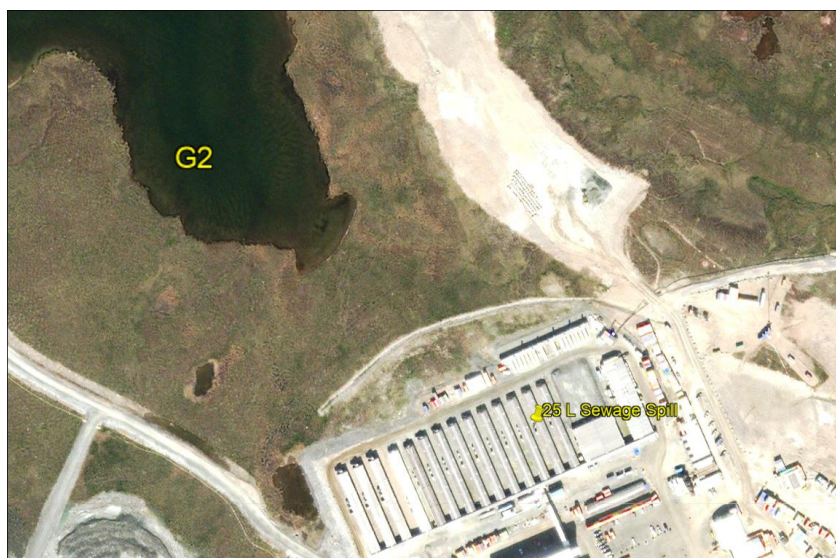
At approximately 7:00 am on June 13th, 2022, an estimated 25 liters of untreated sewage was spilled to the gravel pad from the Wing 2 lift station when two lift station pumps failed to engage.

The coordinates of this spill are 63° 2' 24.54"N, 92° 13' 42.60"W. No water bodies were impacted by this spill. The closest water body (G2) is approximately 230 meters north.

Figure 1: Location of sewage spill.

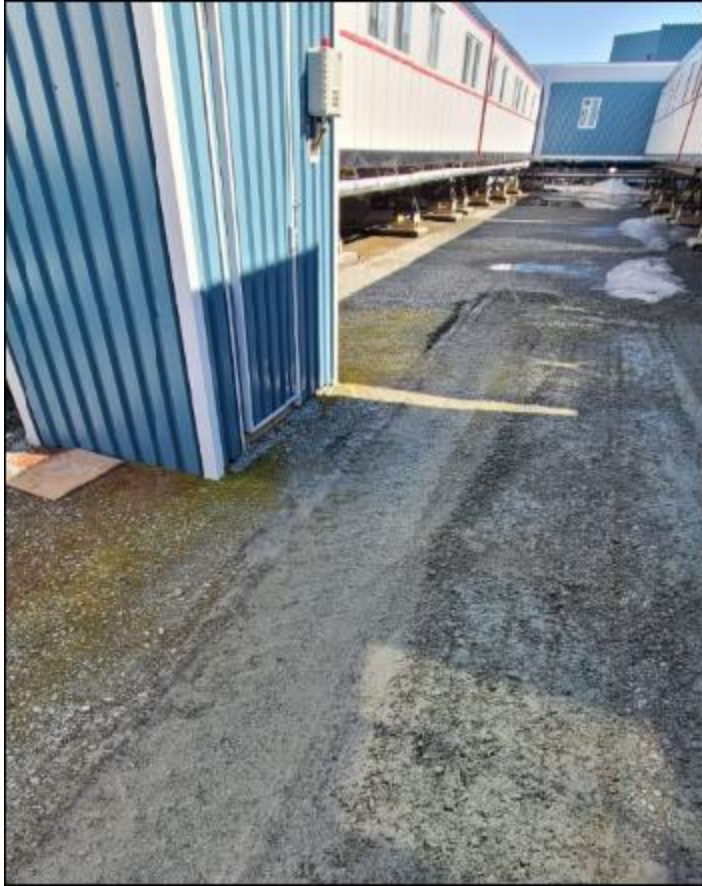
Figure 2: Location of sewage spill post-cleanup.

A piece of material that was flushed down a toilet jammed the pump causing the overflow. The backup pump in this lift station did not engage as per design. It is suspected that the backup pump was also jammed, and upon stopping and starting the pump the material was dislodged. Both pumps were tested and confirmed to be functional before being put back into service.

Upon discovery of the spill, a vacuum truck was called to empty the lift station and recover the liquid sewage outside the lift station. The recovered liquid was pumped into the MSB lift station for processing at the sewage treatment plant. The sewage contaminated gravel was scrapped up by a loader and placed in WRSF 1 for final disposal.

A formal site wide communication was distributed to all Meliadine employees and contractors (see Appendix A) conveying the importance of not flushing incorrect materials down toilets. Each lift station is equipped with a local audio/visual alarm; however, AEM is actively investigating options for these alarms to be communicated remotely. AEM is also investigating replacement pumps equipped for grinding solid products for each lift station. AEM has also engaged an external specialist to conduct an audit of the sewage works and provide a report of recommendations.
