August 24th, 2022

Re.: Follow-up Report: Spill #2022357– Release of 2m³ of Emulsion at the Meliadine Gold Project

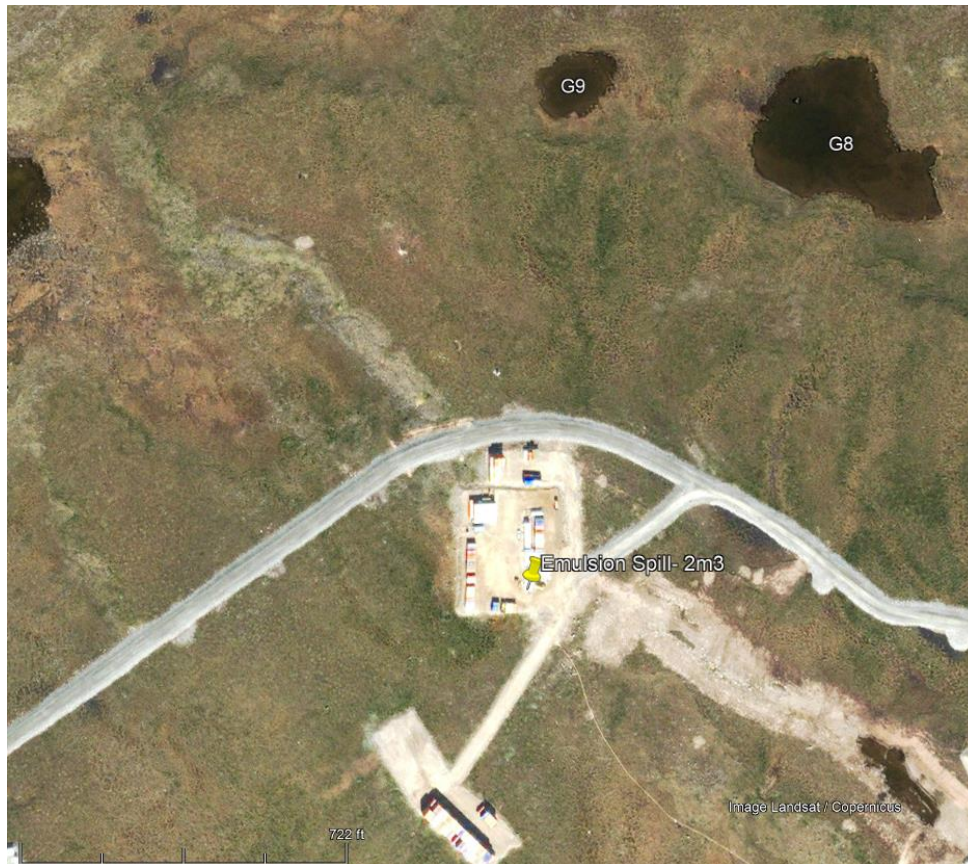
On July 28th, 2022, at approximately 11:30 am, an estimated 2m³ of emulsion was spilled on surface at the emulsion plant. An overflow from tank RU7000 (T3) occurred during underground emulsion production. No water bodies were impacted by this spill. The closest water body (G8) is approximately 315 meters north as seen in Figure 1.

Figure 1: Location of emulsion spill and proximity to water bodies.

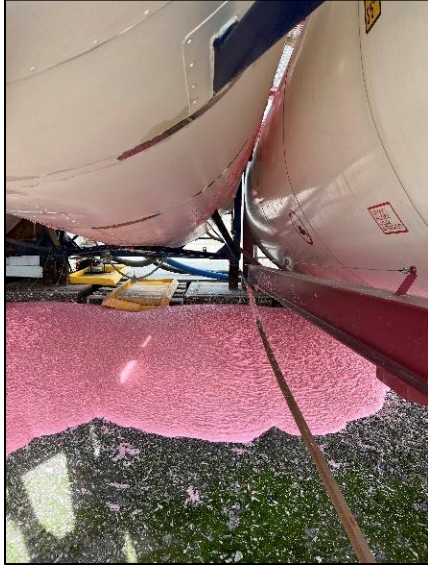
Prior to manufacturing the batch of emulsion, the tank inventory sheet was verified to ensure there would be enough room to produce the required amount of emulsion. However, it was later discovered that an

error was made on the available underground emulsion tank inventory which led to the emulsion production tank overflowing.

- The process in place to verify tank inventory prior to the production of emulsion needs to be strengthened.

Photo 1: Emulsion spill at tank RU7000

- The tank inventory sheet is now updated by the person filling bins/producing emulsion;
- A field for weights/quantities on the back of the work cards has been added as a reminder;
- All operators indicate what bins have been loaded and emulsion produced on the back of their work cards
- High level sensor has been installed on August 23rd
- The site supervisor now verifies tank inventory daily and compares it to billing information;
- Each time tanks are emptied a visual confirmation is made and noted on the inventory sheet;
- Visual confirmation of the tank level is made prior to large production blends (>10,000kg).

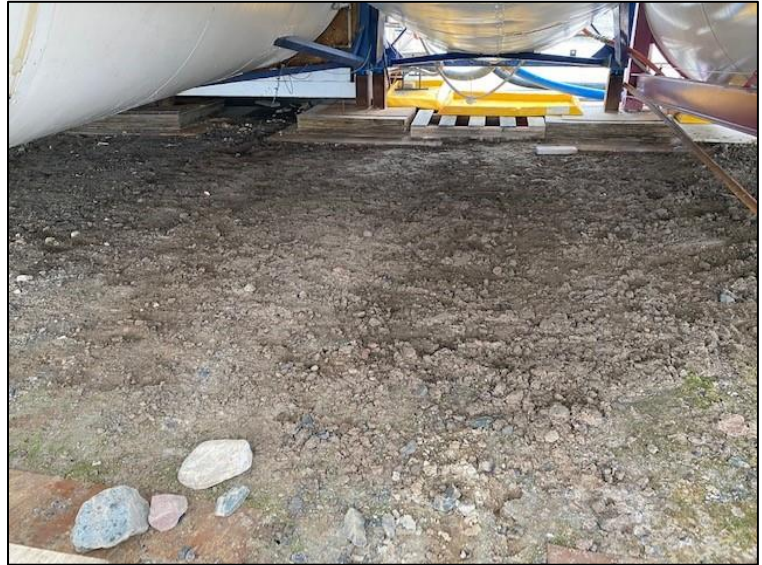
Photo 2: Spill remediation beneath tank RU7000

Spilled emulsion was pumped into a tote for reuse. Residual emulsion not suitable for reuse was hand excavated and will be placed into open pit boreholes for final disposal as per the Explosives Management Plan.
