August 30th, 2022

Re.: Follow-up Report: Spill #2022395– Release of 400 L of Untreated Sewage at the Meliadine Gold Project

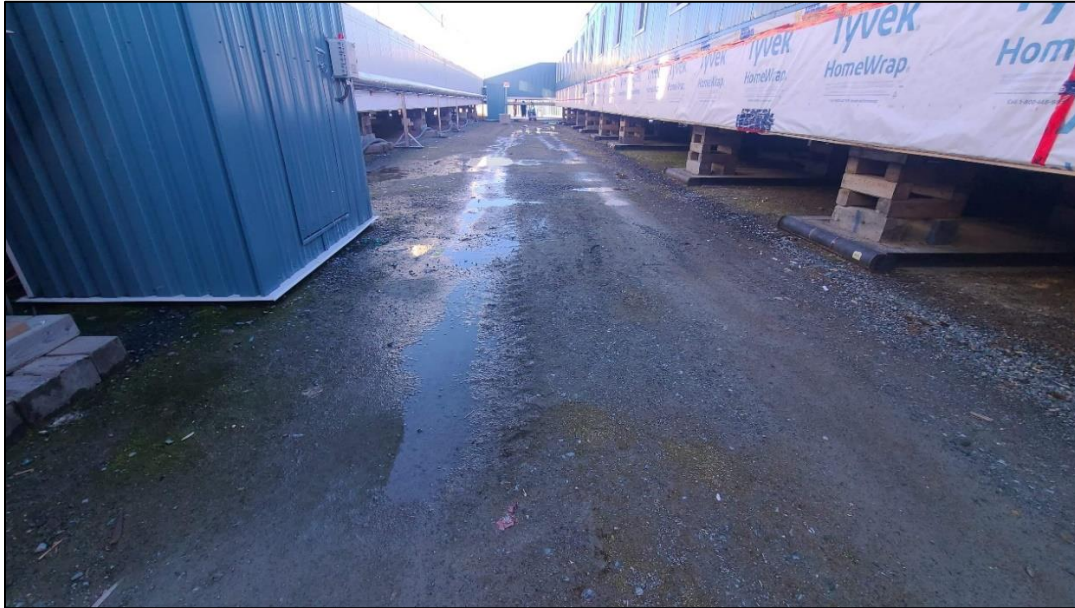
On August 2nd, 2022, at approximately 7:00 pm, an estimated 400 L of untreated sewage was spilled on the industrial pad due to an overflow of the Wing 10 lift station. No water bodies were impacted by this spill. The closest water body (G2) is approximately 200 meters north, as seen in Figure 1.

- A plumber closed a valve to perform an inspection of the Wing 10 lift station and failed to open the valve upon completion.

Photo 1: Wing 10 lift station untreated sewage spill.

Upon discovery of the spill, a vacuum truck was dispatched to empty the lift station and recover the liquid sewage outside the lift station. An estimated 30 L of free liquid was obtained with the vacuum truck and 1 m³ of surface material was brought to Landfarm A as per section 3.4.4 in the Landfarm Management Plan.

- The importance of a workplace inspection prior to and after completing work was discussed with all teams during the Weekly Safety Meeting.
- A maintenance procedure is currently being created to outline proper practices for maintenance on a lift station.

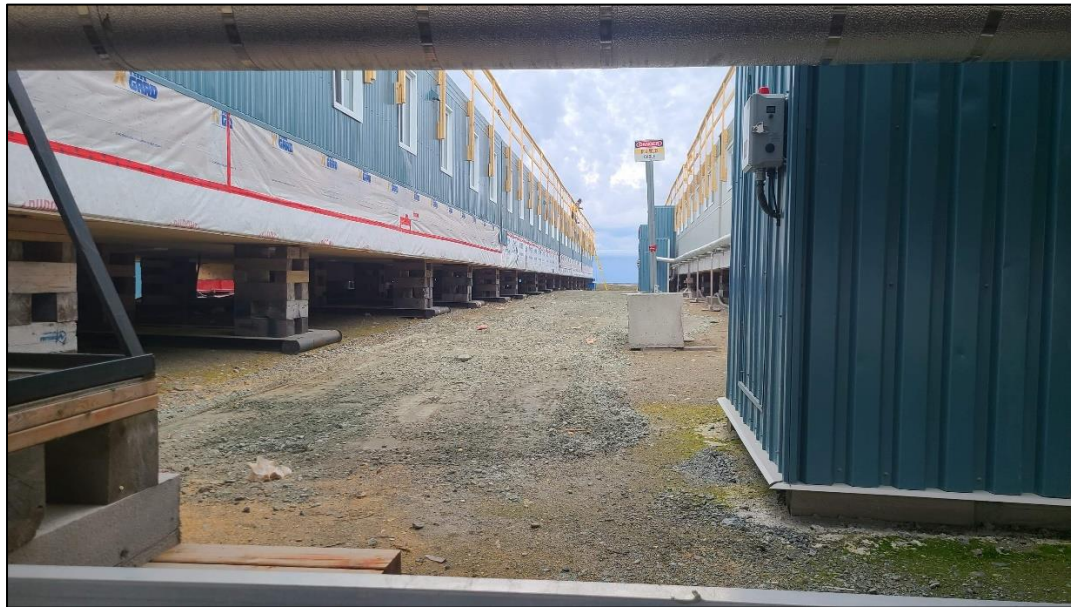
Photo 2: Spill remediation area.
