September 1st, 2022

Re.: Follow-up Report: Spill #2022425– Release of 20 L of Untreated Sewage at the Meliadine Gold Project

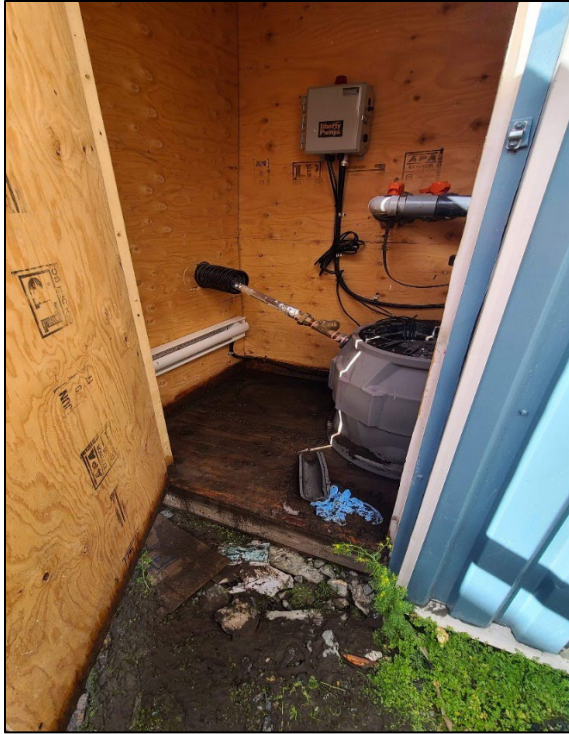
On August 2nd, 2022, at approximately 6:00 pm, an estimated 20 L of untreated sewage was spilled on the industrial pad due to an overflow of the Wing C lift station. No water bodies were impacted by this spill. The closest water body (G2) is approximately 360 meters northwest, as seen in Figure 1.

- The high-level sensor (float) in the lift station was stuck in the low-level position and did not activate the pump or the alarm in the lift station. A contributing factor to this malfunction was the material within the lift station was too thick.

Photo 1: Wing-C lift station spill

- The waste streams sent to the lift station were evaluated. The lift station received waste from the Wing C accommodations as well as the Sewage Treatment Plant's (STP) sludge dewatering system. Waste collected from the sludge handling system is now directed to the fine screen tank of the STP to reduce the likelihood of the high-level sensor becoming stuck.

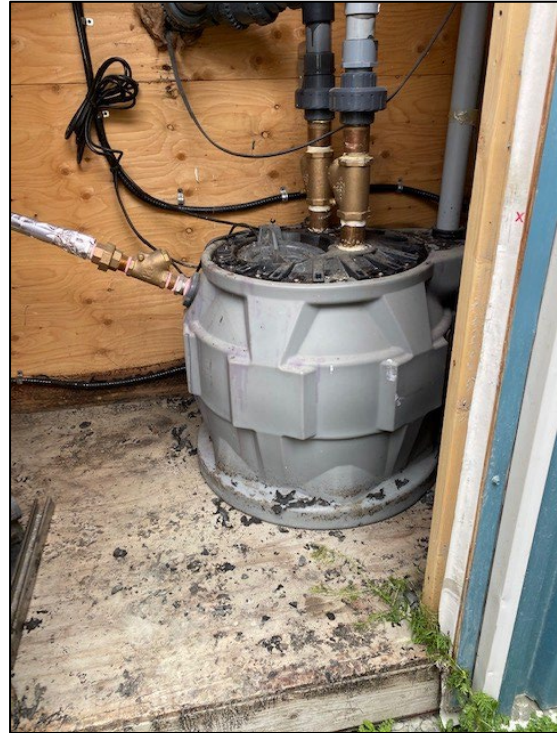
Photo 2: Wing C lift station spill remediation

Upon discovery of the spill, a vacuum truck was dispatched to empty the lift station and recover the untreated sewage outside the lift station. Free liquid was pumped back into the main camp lift station. Absorbent pads were deployed to collect the remaining liquid and packaged for offsite disposal at a licensed disposal facility. The impacted surface was hand excavated and an estimated 15 kg of material was brought to Landfarm A as per section 3.4.4 in the Landfarm Management Plan.
