September 14<sup>th</sup> , 2022

## **Re.: Follow-up Report: Spill #2022417– Release of 6 KG of Ammonium Nitrate at the Meliadine Gold Project**

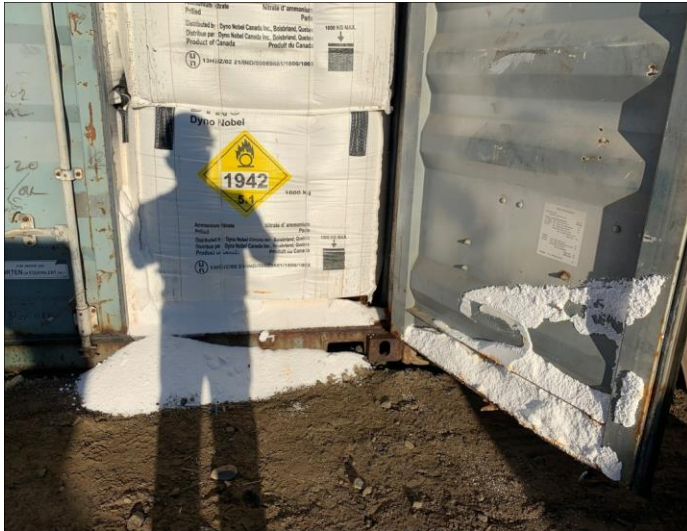
On August 15<sup>th</sup>, 2022, at approximately 7:30 am, an estimated 6 KG of ammonium nitrate was spilled on the Dyno industrial pad while opening a sealed seacan. No water bodies were impacted by this spill. The closest water body (G8) is approximately 330 meters northeast as seen in Figure 1.

- Damaged packaging and improper repair of the packaging (the ammonium nitrate bag was punctured and sealed with duct tape) prior to shipment resulted in the spill of ammonium nitrate from the sealed seacan.

**Photo 1:** Ammonium nitrate spill

- Agnico Eagle has followed up with the supplier to ensure that any punctured bags are properly repaired prior to shipping.
- Agnico Eagle will investigate the use of a metal skirt at the doors where these types of chemicals are unloaded to prevent spills from material damaged prior or during transport.

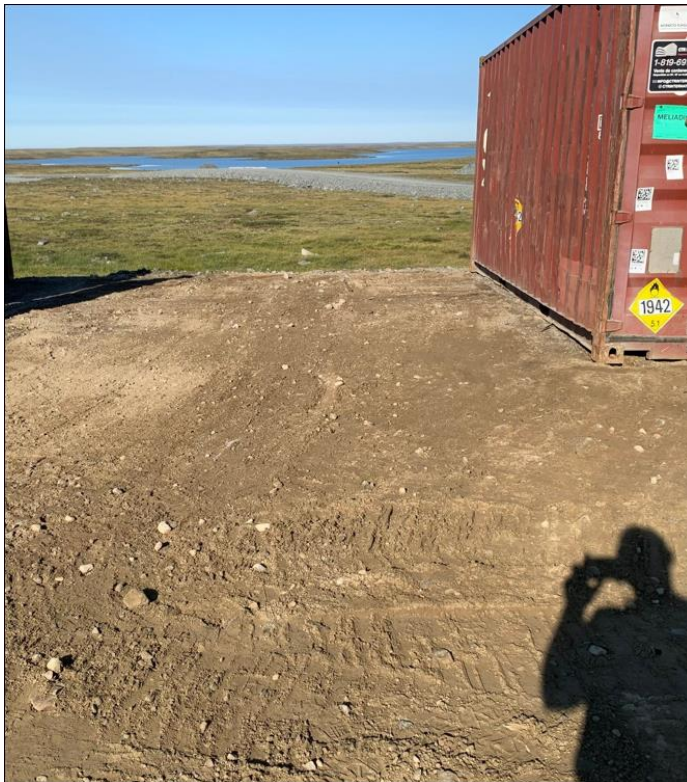
**Photo 2:** Ammonium nitrate spill remediation

Upon discovery of the spill, Dyno operators used shovels and a loader to remediate the impacted area. The seacan was moved to ensure proper remediation could be achieved. The material that was removed was placed in boreholes in the open pit and used as blasting material.
