September 15<sup>th</sup>, 2022

## **Re.: Follow-up Report: Spill #2022425 – Release of 20 L of partially treated bionest Effluent at the Meliadine Gold Project**

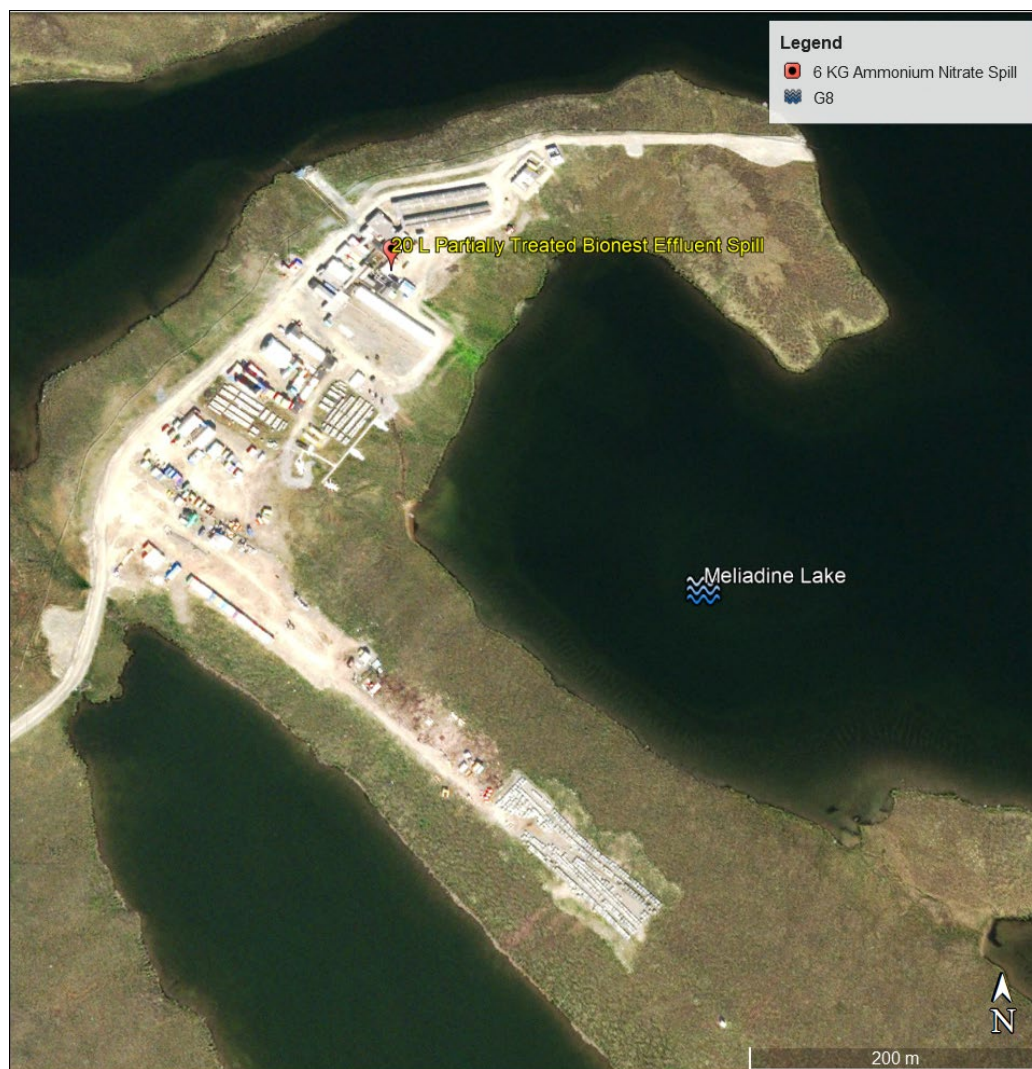
On August 16<sup>th</sup>, 2022, effluent inside the bionest vessel was found to be leaking through the bolt holes of the seacan the vessel is housed in. No water bodies were impacted by this spill. The closest water body (Meliadine Lake) is approximately 100 meters south as seen in Figure 1.

**Figure 1:** Location of partially treated bionest effluent spill and proximity to water bodies.

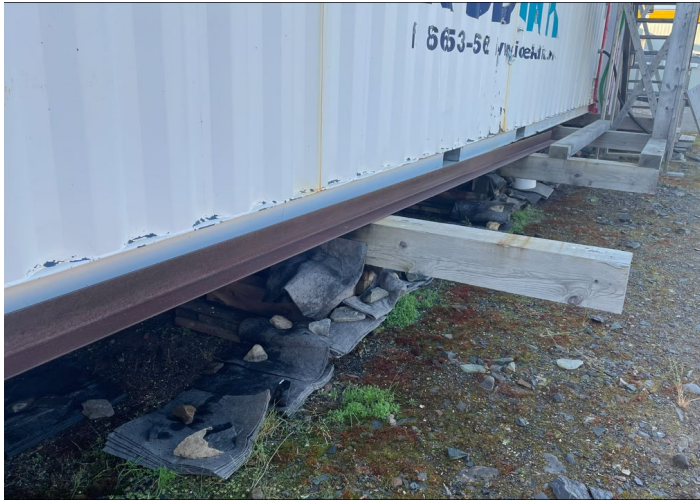
- Improper shut down and winterization of the Exploration sewage treatment plant.

**Photo 1:** Bionest partially treated Effluent spill

Upon discovery of the spill, sorbent pads and spill trays were placed under the bionest seacan to collect partially treated effluent and a vacuum truck was used to ensure the spill trays did not overflow. A frost fighter was used to thaw the remaining partially treated effluent and a vacuum truck removed the liquid as it thawed. The recovered material was processed through the Meliadine sewage treatment plant.

- The bionest secans have been proper drained and are now ready for removal from the Exploration camp as part of the Exploration camp clean up.

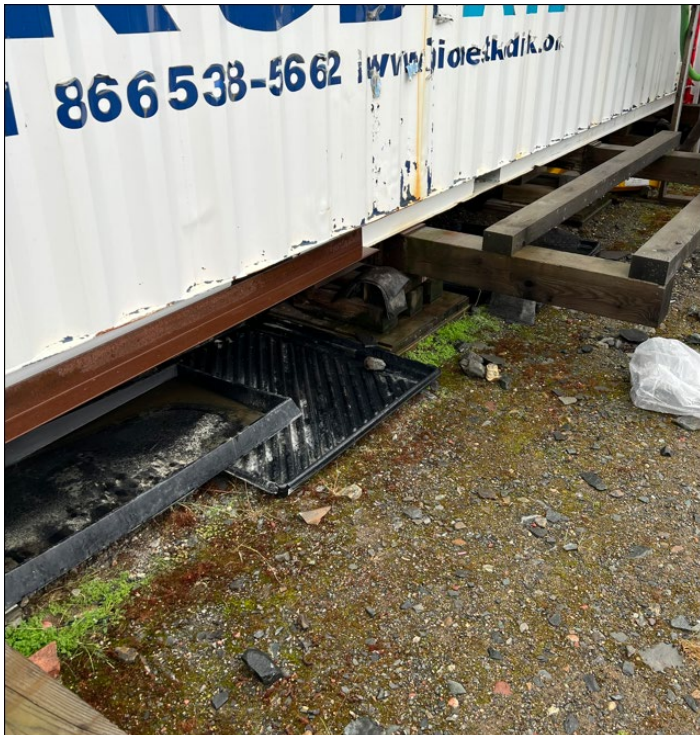
**Photo 2:** Bionest partially treated Effluent spill collection
