Re.: Follow-up Report Spill #2022465 – Release of 25 L of Untreated Sewage at the Meliadine Gold Project

Description of Incident

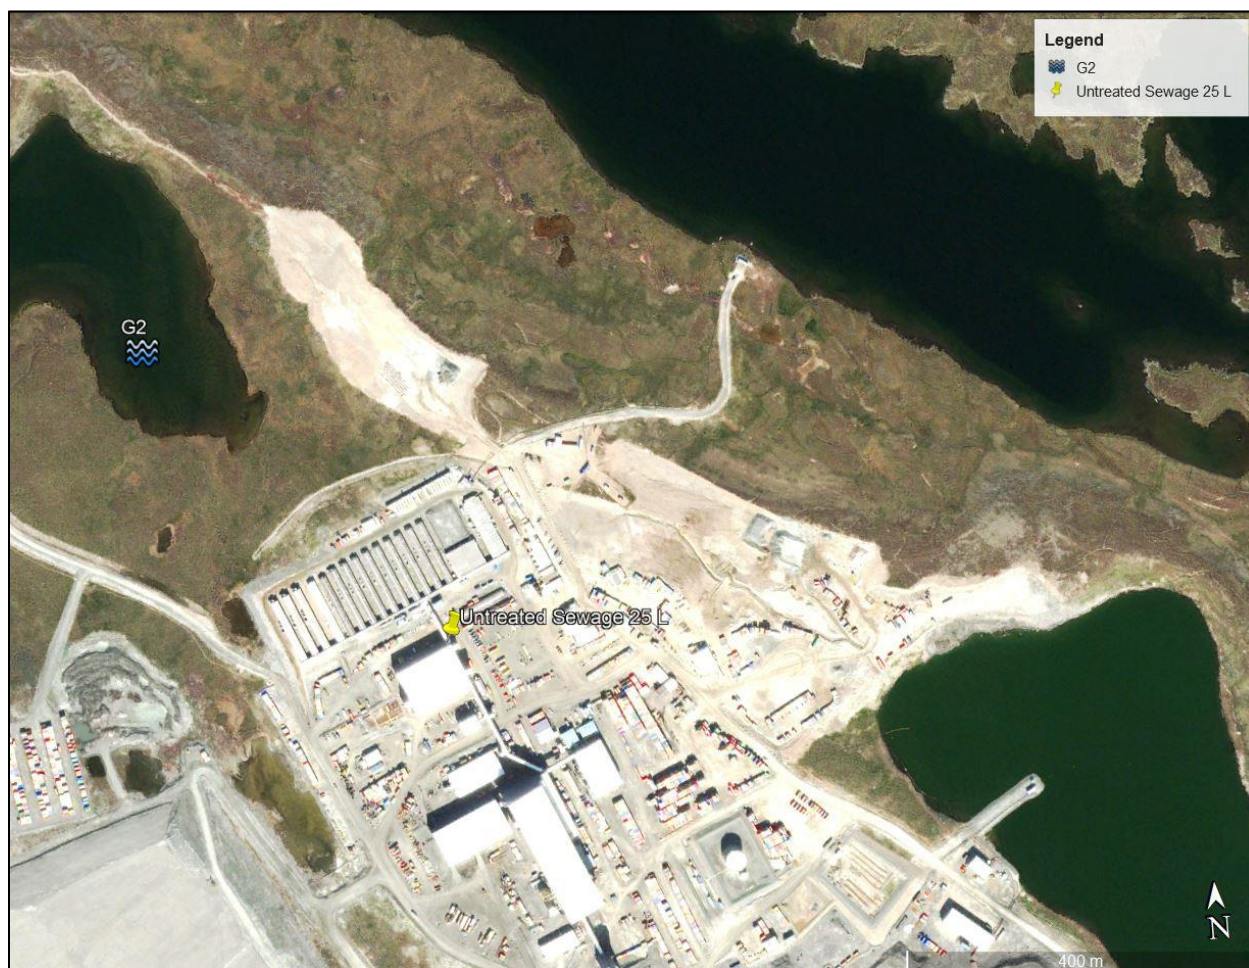
On September 13th, 2022, at approximately 8:45 am, an estimated 25 L of untreated sewage was spilled on the industrial pad due to a sewage transfer line not being fully drained when securing it for storage on the vacuum truck. No water bodies were impacted by this spill. The closest water body (G2) is approximately 325 meters northwest, as seen in Figure 1.

Figure 1: Location of sewage spill and proximity to water bodies.

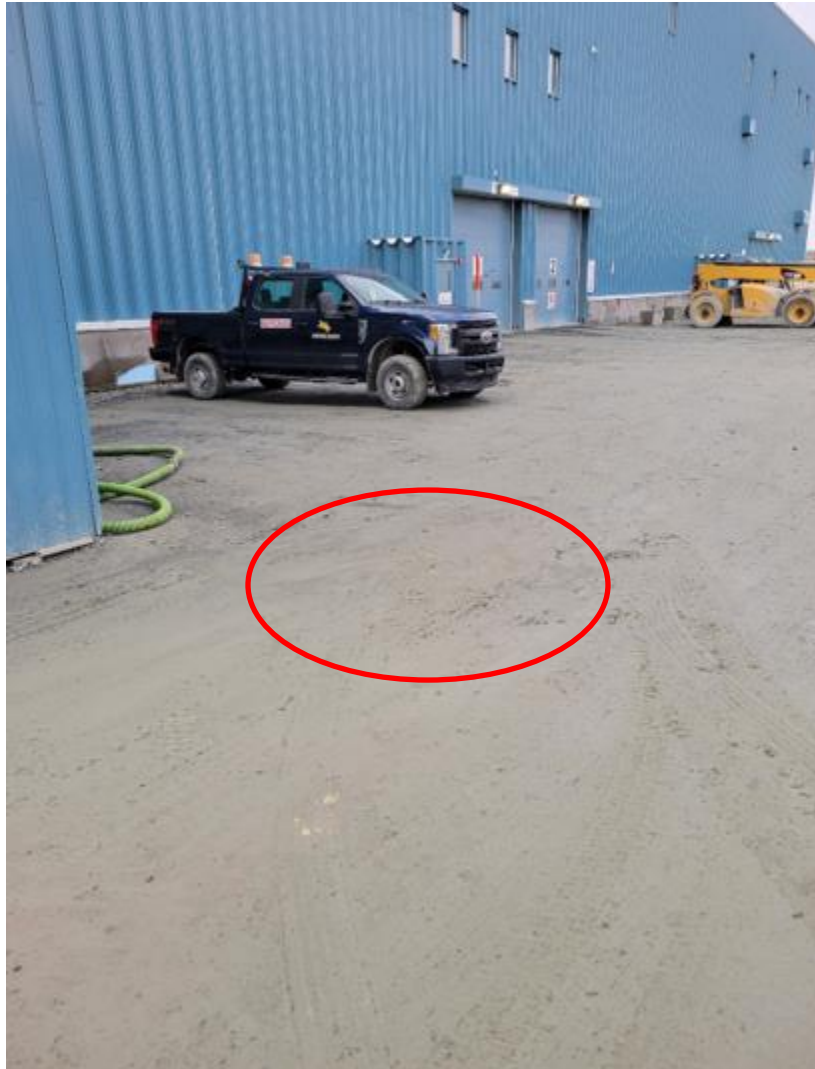
Photo 1: MSB lift station spill location (post-clean up)

The immediate response from the employee was to stop and clean up spilled material. The employee then contacted his supervisor to report the incident. The impacted surface was hand excavated and an estimated 30 kg of material was brought to Landfarm A as per the Landfarm Management Plan.

- Supervisor met with employees to discuss the incident, reviewed the importance of attention to detail and the procedure when manipulating sewage transfer lines.
