Re.: Follow-up Report Spill #2022470 – Release of 5 L of Untreated Sewage at the Meliadine Gold Project

Description of Incident

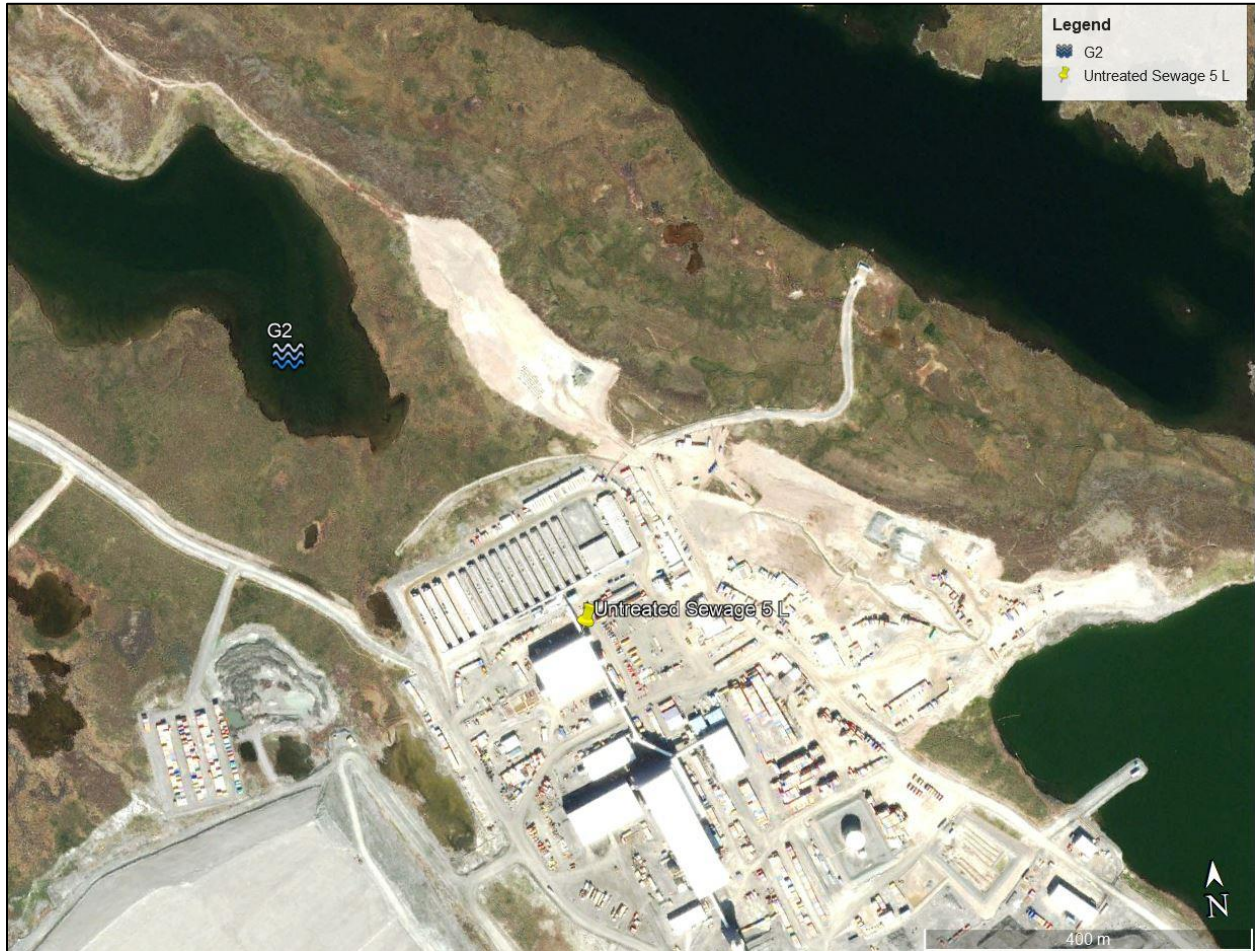
On September 14th, 2022, at approximately 2:45 pm, an estimated 5 L of untreated sewage was spilled on the industrial pad due a cracked end cap. No water bodies were impacted by this spill. The closest water body (G2) is approximately 325 meters northwest, as seen in Figure 1.

Figure 1: Location of sewage spill and proximity to water bodies.

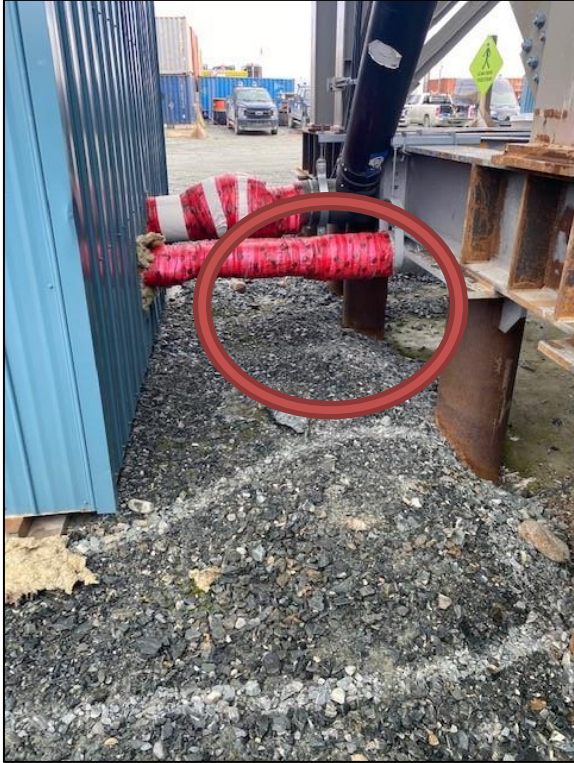
- a hairline fracture was identified on the cleanout cap

Photo 1: Sewage spill location

When the plumber noticed a leak coming from the cleanout cap he immediately stopped the MSB lift station. Once the lift station was stopped a new cap was installed. The impacted surface area was hand excavated and an estimated 5 kg of material was brought to Landfarm A as per Landfarm Management Plan.

- the cracked cleanout cap was replaced and installed by a plumber
- a visual inspection was completed after the installation
