October 13, 2022

## **Re.: Follow-up Report Spill #2022480 – Release of 205 L of Hydrochloric Acid at the Meliadine Gold Project**

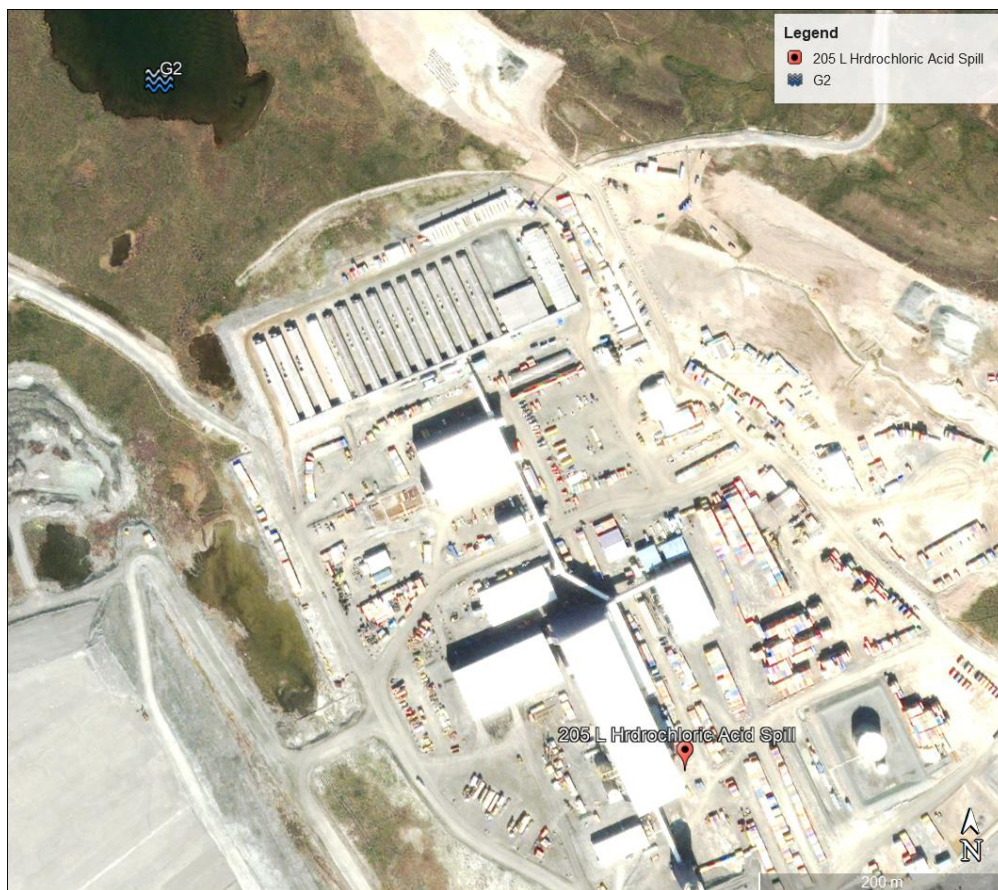
No water bodies were impacted by this spill. The closest water body (G2) is approximately 650 meters north, as seen in Figure 1.

**Figure 1:** Location of HCl spill and proximity to water bodies.

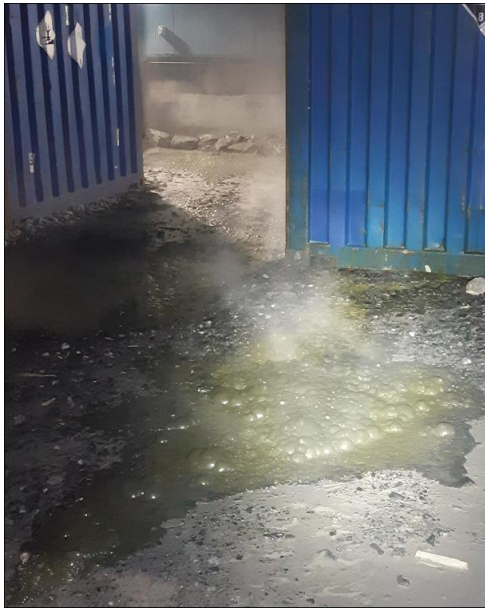
On September 30<sup>th</sup>, 2022, at approximately 1:30 am, an estimated 205 L of HCl was spilled on to the industrial pad outside of the process plant. During a transfer of a pallet of four HCl barrels from a seacan to the process plant a 205 L HCl barrel was punctured with the fork of the equipment being used to transfer the pallet. The spill occurred within the seacan and a spotter was being used, however the tight confines of the seacan would not safely allow the spotter to enter the seacan while pallets were being removed.

When the leak was discovered, the pallet was immediately set down and the area was evacuated for Health and Safety considerations. HCl then leaked out from the seacan door to the industrial pad.

**Photo 1:** HCl spill initial release

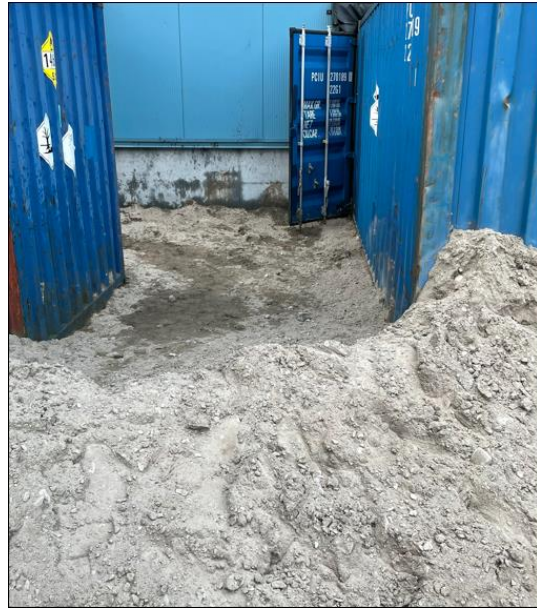
**Photo 2:** HCl spill remediation

The immediate response from the employee transferring the pallet of HCl barrels was to stop the transfer and contact the Emergency Response Team (ERT) to contain the spill. The employee then contacted his supervisor to report the incident. The spill area was evacuated and isolated by the ERT. Sand was used to contain and absorb the liquid HCl. Once the spilled material was contained and the area was determined

to be hazard free, the area of contamination was delineated and an excavator and shovels were used to remove the contaminated material to a depth of approximately eight inches. The impacted material was directed to the reclaim feeder for reprocessing through the process plant.

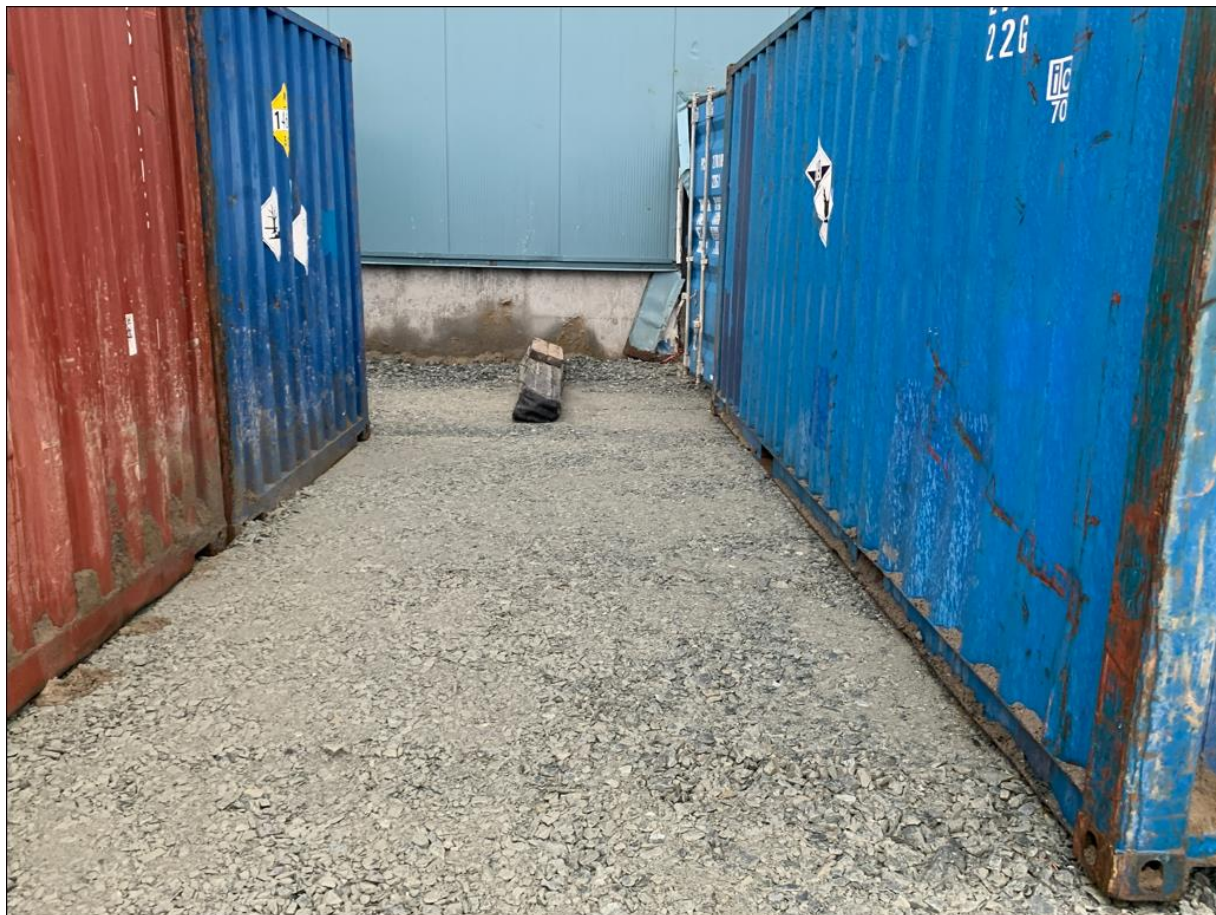
**Photo 3:** HCl spill final remediation

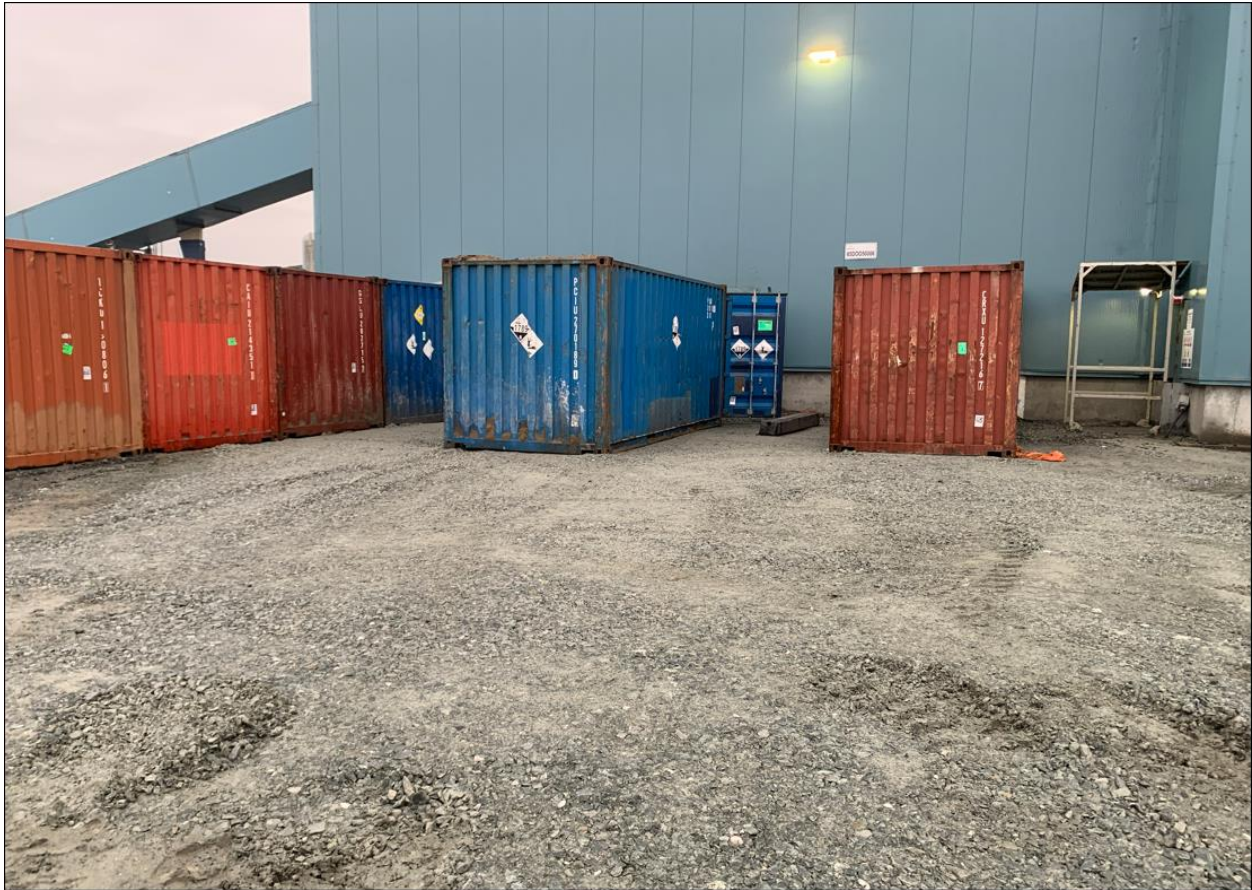
**Photo 4:** HCl spill final remediation
