Re.: Follow-up Report Spill #2022498 – Release of 250 L of hydraulic oil at the Meliadine Gold Project

On October 15th, 2022, at approximately 12:00 am, an estimated 250 L of hydraulic oil was spilled on to Ore Pad 1 (OP1). During normal operations, haul truck 14 was offloading ore onto OP1 when the hydraulic pump pressure hose failed.

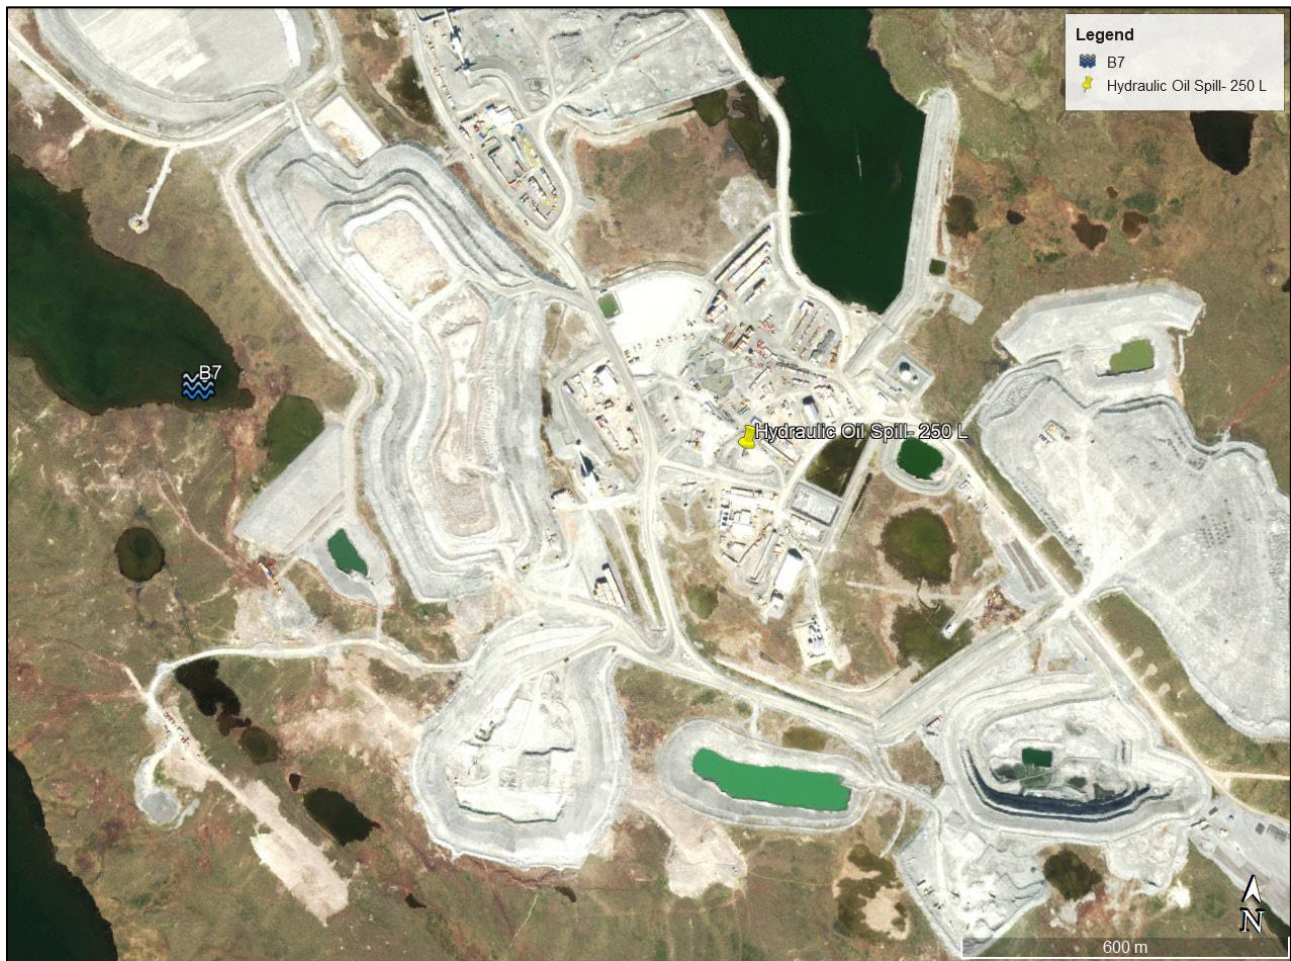
No water bodies were impacted by this spill. The closest water body (B7) is approximately 900 meters west, as seen in Figure 1.

Figure 1: Location of the hydraulic spill and proximity to water bodies.

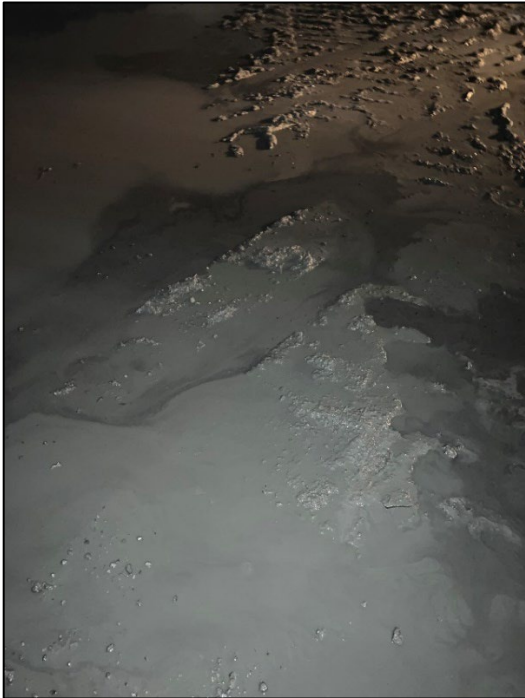
- the hydraulic hose showed signs of wear;
- the crimp on the hydraulic hose was overtightened.

Photo 1: Hydraulic oil spill area

- A more detailed inspection of the crimp on the hydraulic hose fittings installation to prevent overtightening

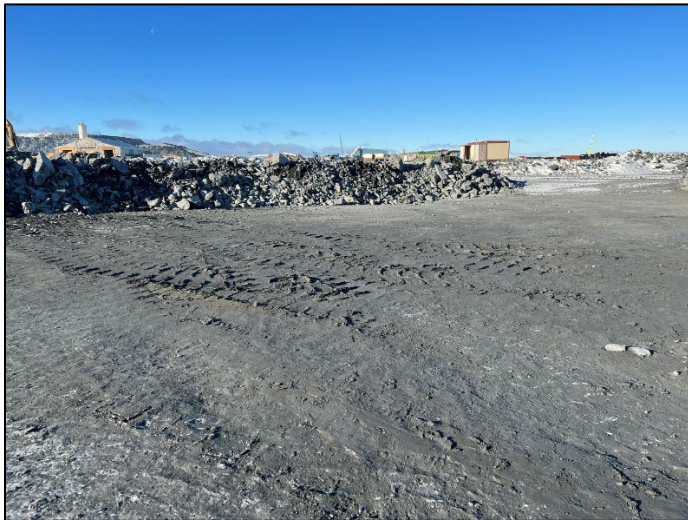
Photo 2: Hydraulic oil spill remediation area

The immediate response from the employee was to shut down the equipment. The employee then contacted their supervisor to report the incident. Spill absorbent pads were deployed to recover pooling surface oil and to contain the spill. The contaminated material was then excavated and directed to the primary crusher for processing through the process plant.
