November 8th, 2022

Re.: Follow-up Report Spill #2022503 – Release of 30 L of Sewage at the Meliadine Gold Project

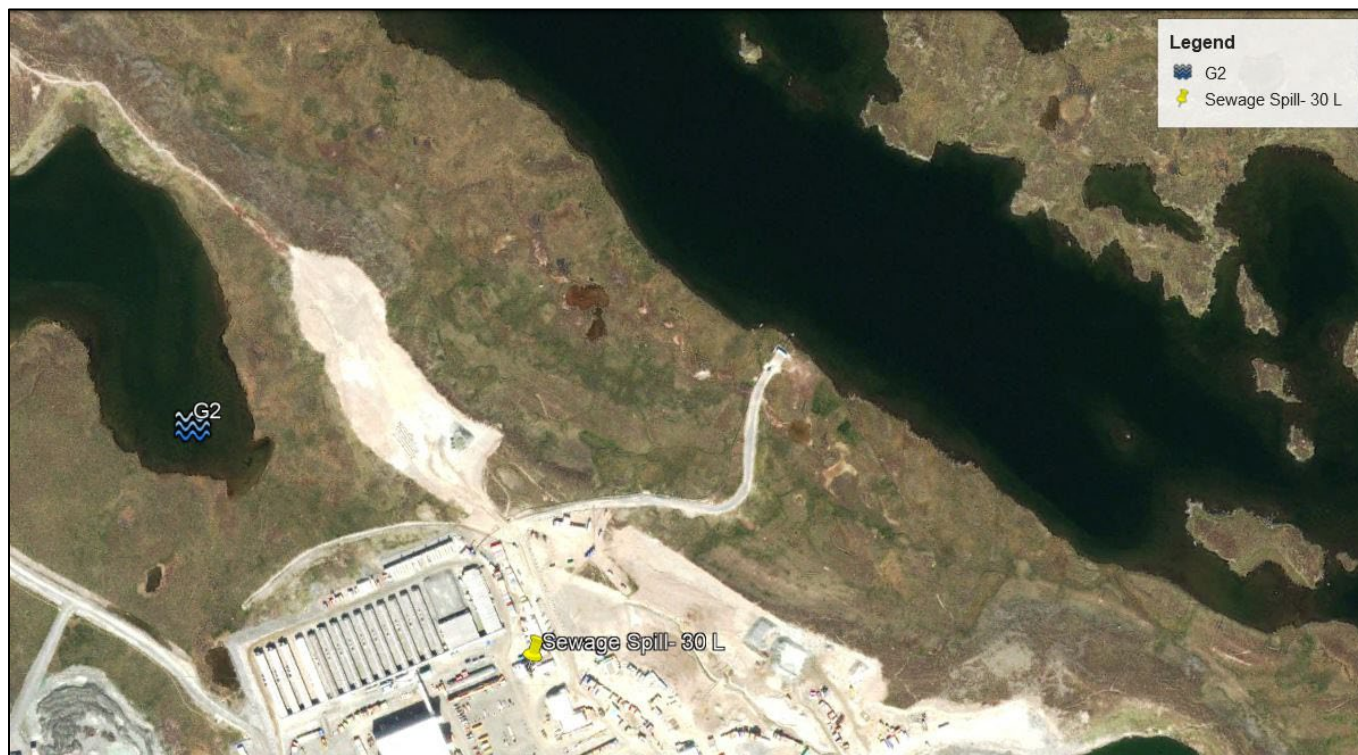
On October 18th, 2022, at approximately 8:15 am, an estimated 30 L of untreated sewage was spilled on the industrial pad due to a miscommunication between two operators during sewage transfer from the sewage treatment plant (STP) sludge tank and the sewage vacuum truck. No water bodies were impacted by this spill. The closest water body (G2) is approximately 370 meters northwest, as seen in Figure 1.

Figure 1: Location of the sewage spill and proximity to water bodies.

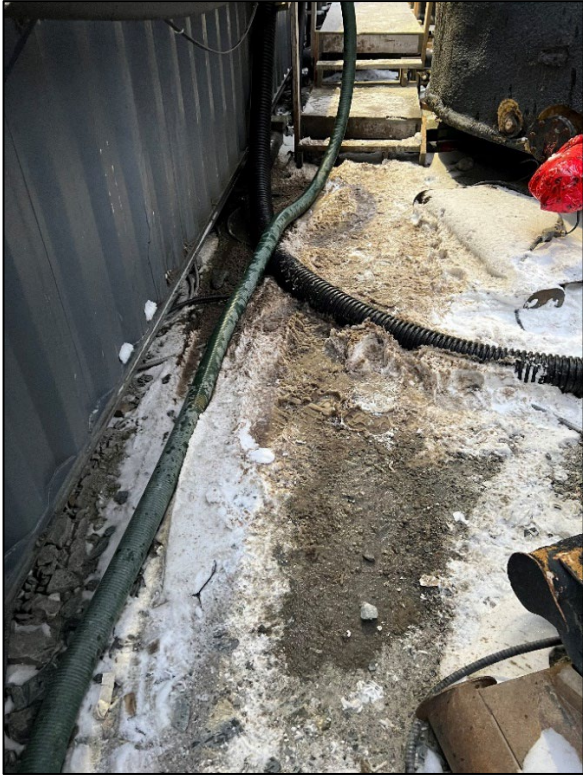
- Only one out of the two operators involved in the sewage transfer had a radio causing inadequate communication between them.
- The vacuum truck procedure was not followed.

Photo 1: Sewage spill area

Upon discovery of the spill, the operator stopped the power take off (PTO). The operator then proceeded to contact the environment department to inform them of the situation. All surface material was hand excavated and contained within a 76 L plastic tub. The material collected was then reworked through the main camp lift station for further treatment.

- Both vacuum truck operators will be provided radios for two-way communication.
- Vacuum truck procedure has been updated to further clarify the communication between operators including the need for both operators to have radios – the updated procedure was communicated to all vacuum truck operators.
- Reiterate the importance of not rushing to prevent workplace accidents from occurring

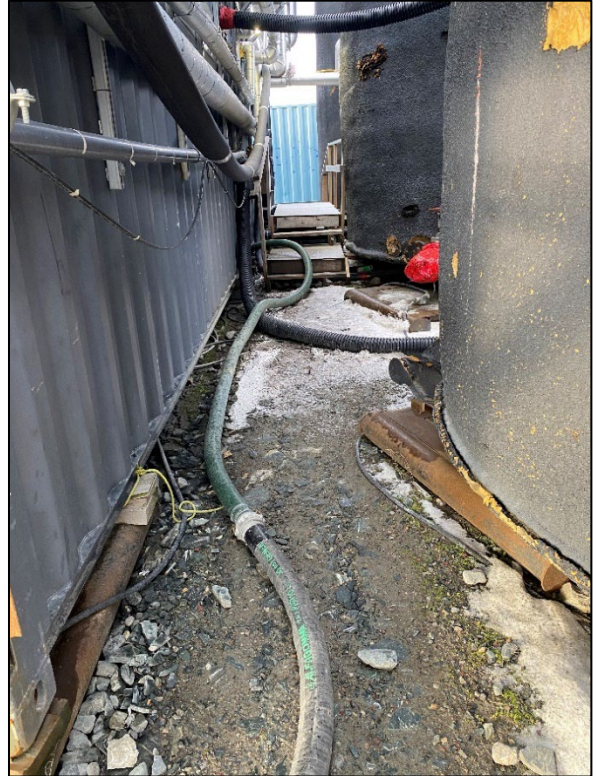
Photo 2: Spill remediation area
