Re.: Follow-up Report Spill #2022517 – Release of 800 L of wash bay water at the Meliadine Gold Project

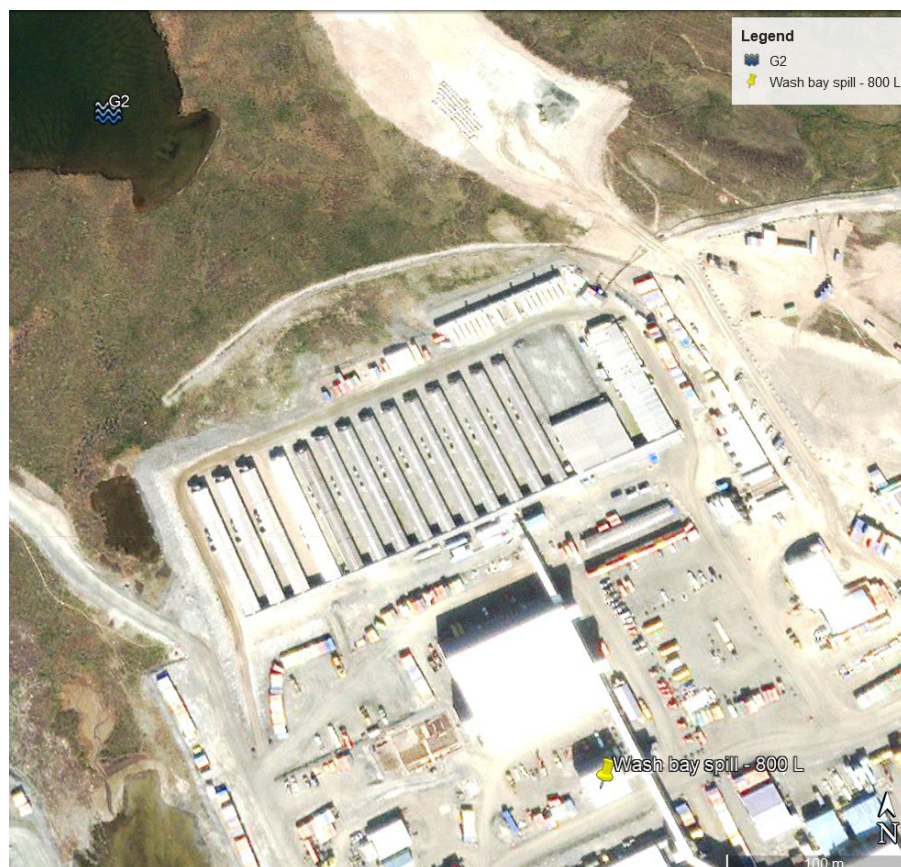
On November 2nd, 2022, at approximately 3:00 am, an estimated 800 L of wash bay water was spilled on the industrial pad due to a failed freshwater line in the wash bay. The freshwater was released into the wash bay sump causing the sump to overflow. The diluted wash bay sump water flowed out the overhead door and on to the industrial pad where it froze in place. No water bodies were impacted by this spill. The closest water body (G2) is approximately 325 meters northwest, as seen in Figure 1.

Figure 1: Location of wash bay spill and proximity to water bodies.

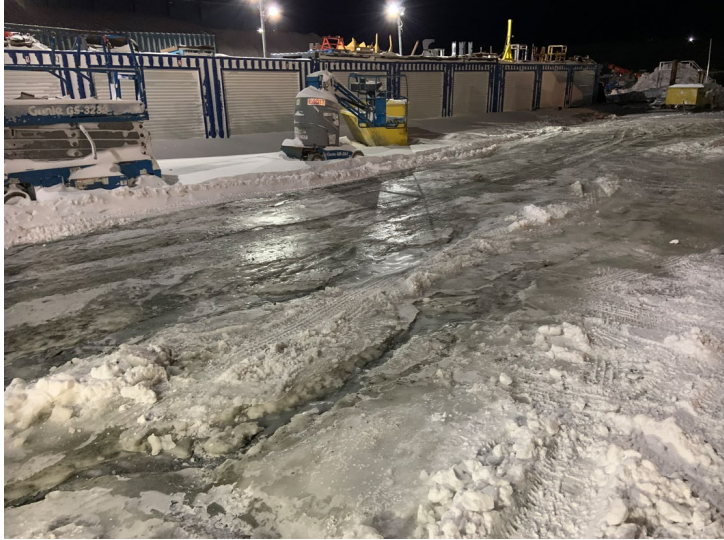
- A blizzard on November 1 caused the HVAC intake coils to plug with snow and ice resulting in low temperatures within the wash bay. This caused the freshwater line to fail.
- Low glycol level in the HVAC system reduced the effectiveness of the HVAC system.

Photo 1: Wash bay water spill area

- Preventative maintenance HVAC inspection will be conducted post blizzard;
- The freshwater line PC piping will be replaced with stainless steel piping ;
- The glycol level in the HVAC system was returned to 100%

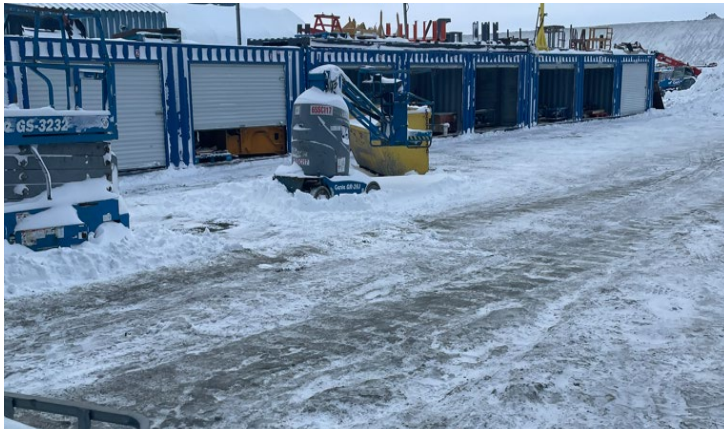
Photo 2: Spill remediation area

Upon discovery of the spill the freshwater valve was closed. The operator then proceeded to contact the environment department to inform them of the situation. The frozen material was cleaned up using a loader. The frozen wash bay material was then disposed of in Tiriganiaq Pit 2 its disposal location during normal operations.
