December 8, 2022

Re.: Follow-up Report: Spill #2022529 – Release of 10 L of Sewage at the Meliadine Gold Project

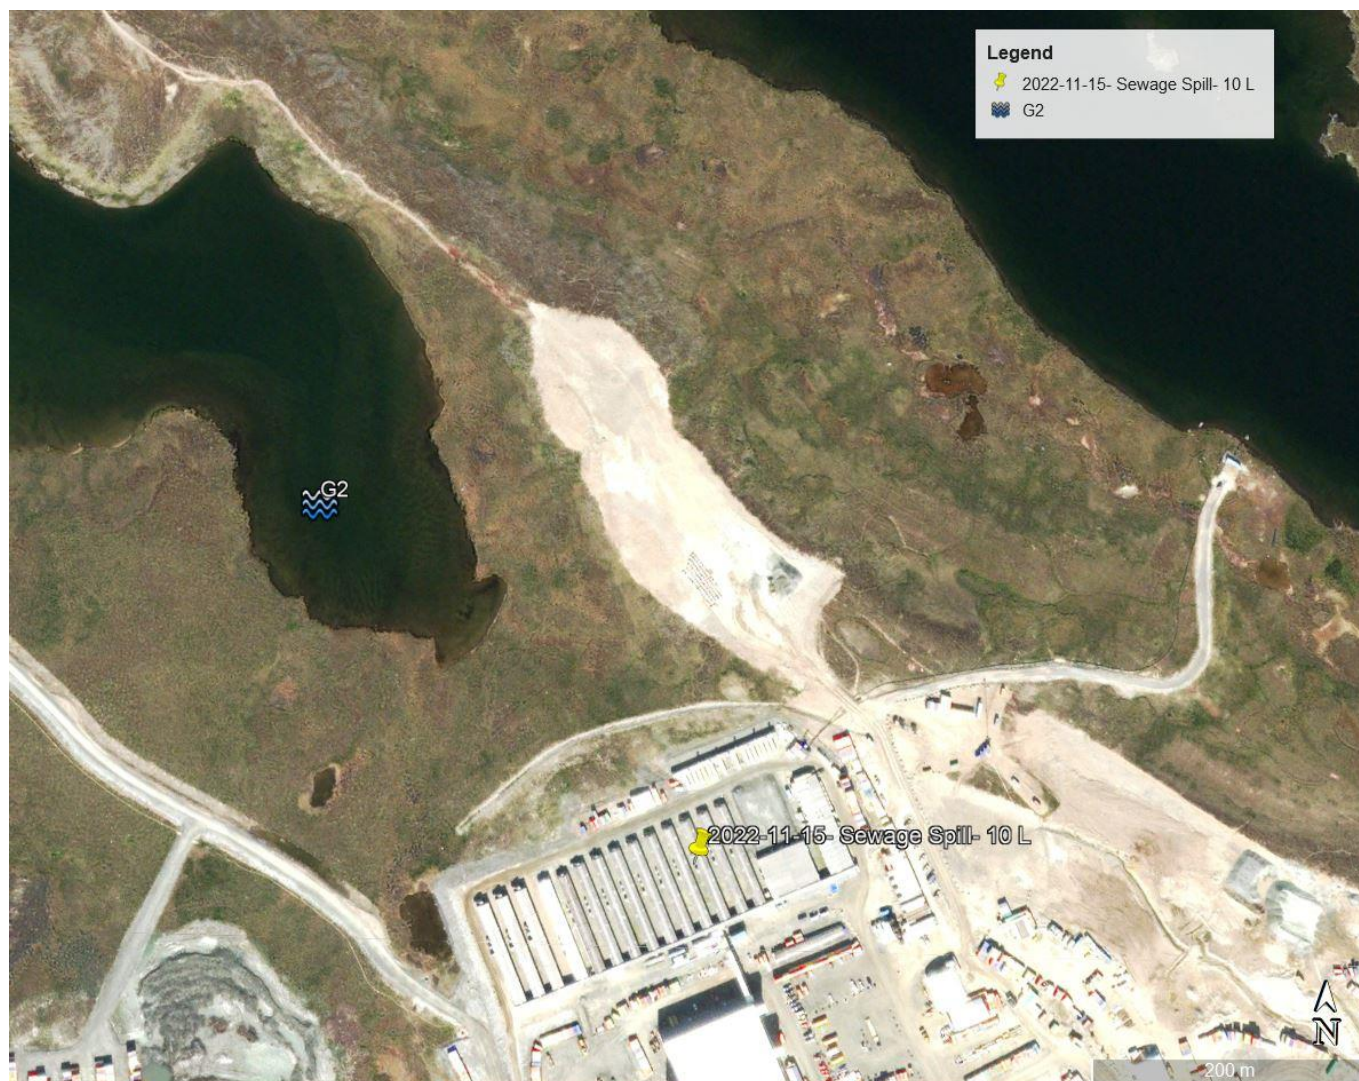
On November 15th, at approximately 6:00 am, an estimated 10 L of sewage was spilled on the industrial pad due to an overflow of the wing three lift station. No water bodies were impacted by this spill. The closest water body (G2) is approximately 222 meters northwest, as seen in Figure 1.

Figure 1: Location of sewage spill and proximity to water bodies.

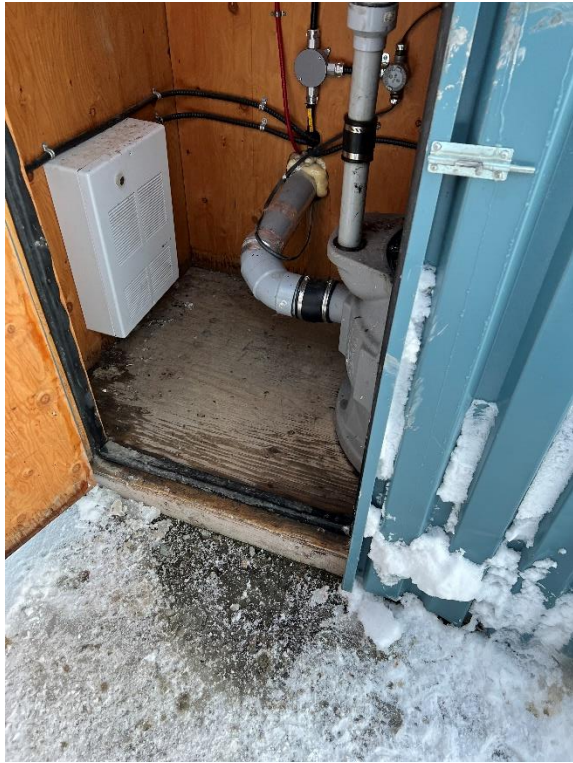
- Sewage grinder pumps became clogged with material preventing normal operations.

Photo 1: Wing three lift station spill

Upon discovery of the spill, a vacuum truck was dispatched to empty the lift station and recover the untreated sewage outside the lift station. Free liquid was pumped back into the main camp lift station. Absorbent pads were deployed to collect the remaining liquid and packaged for offsite disposal at a licensed disposal facility. The impacted surface was hand excavated and an estimated 15 kg of material was brought to Landfarm A as per section 3.4.4 of the Landfarm Management Plan.

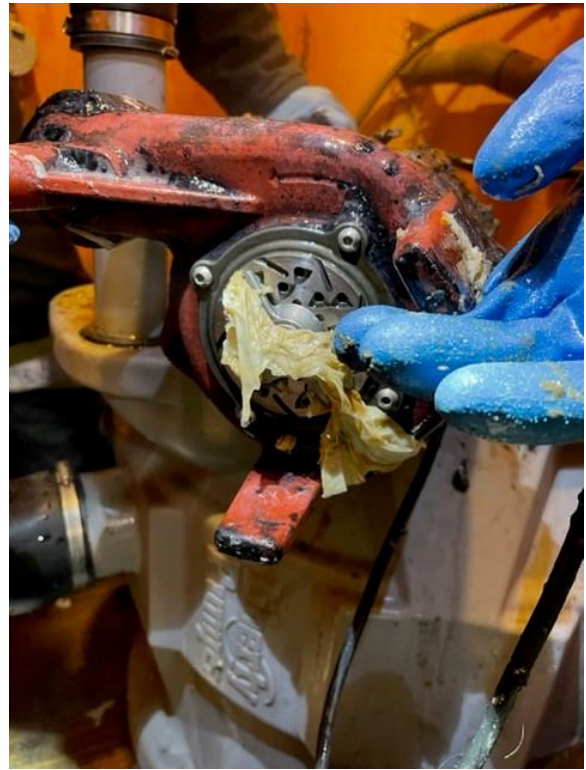
Photo 2: Wing three lift station grind pump blade

- Grinder pump blades are to be replaced at wing three lift station. These have been ordered and will be replaced upon arrival to the Meliadine site.
- Secondary containment has been installed around wing three and work is ongoing for each of the wing lift station.

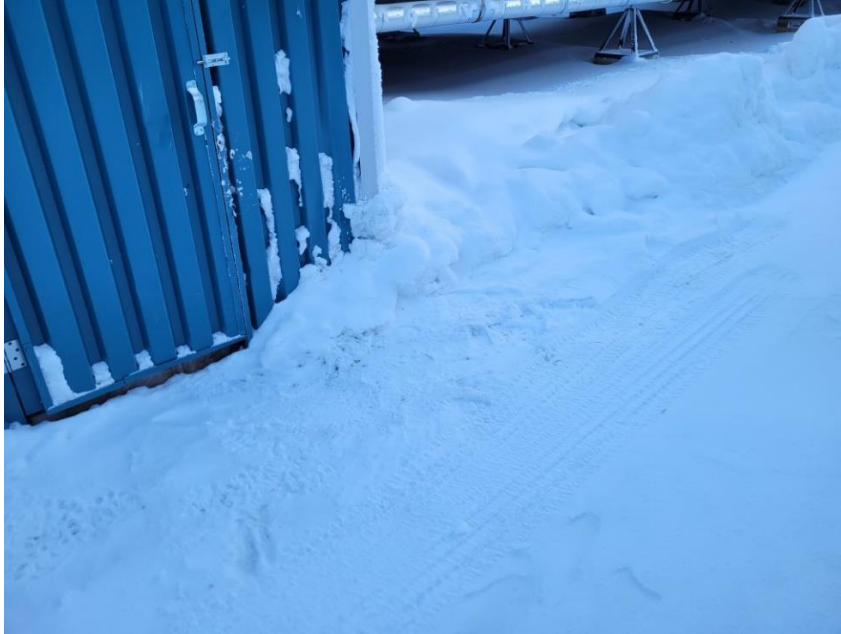
Photo 3: Ground area outside the wing three lift station.

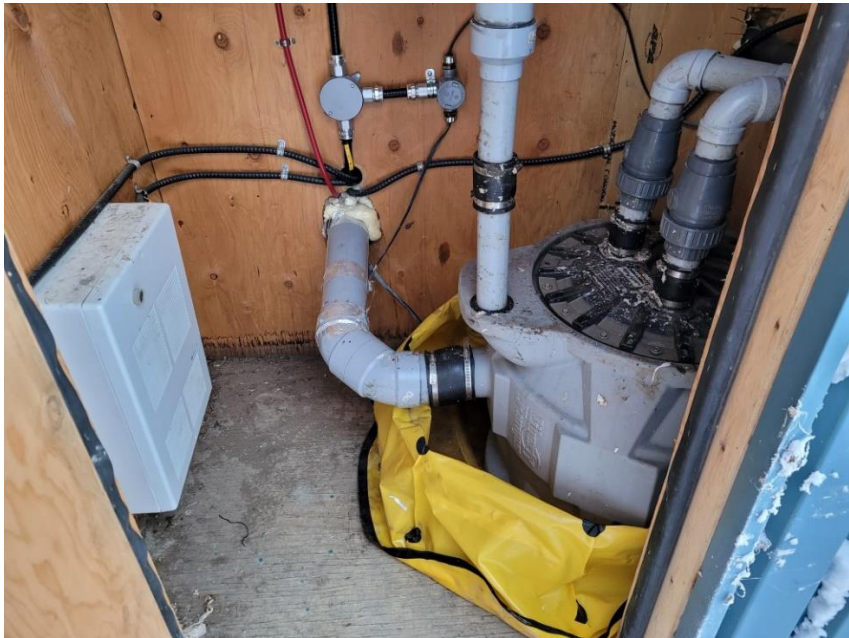
Photo 4: Wing three lift station with secondary containment installed.
