December 17<sup>th</sup>, 2022

## **Re.: Follow-up Report: Spill # 2022532 – Release of 5 L of Sewage at the Meliadine Gold Project**

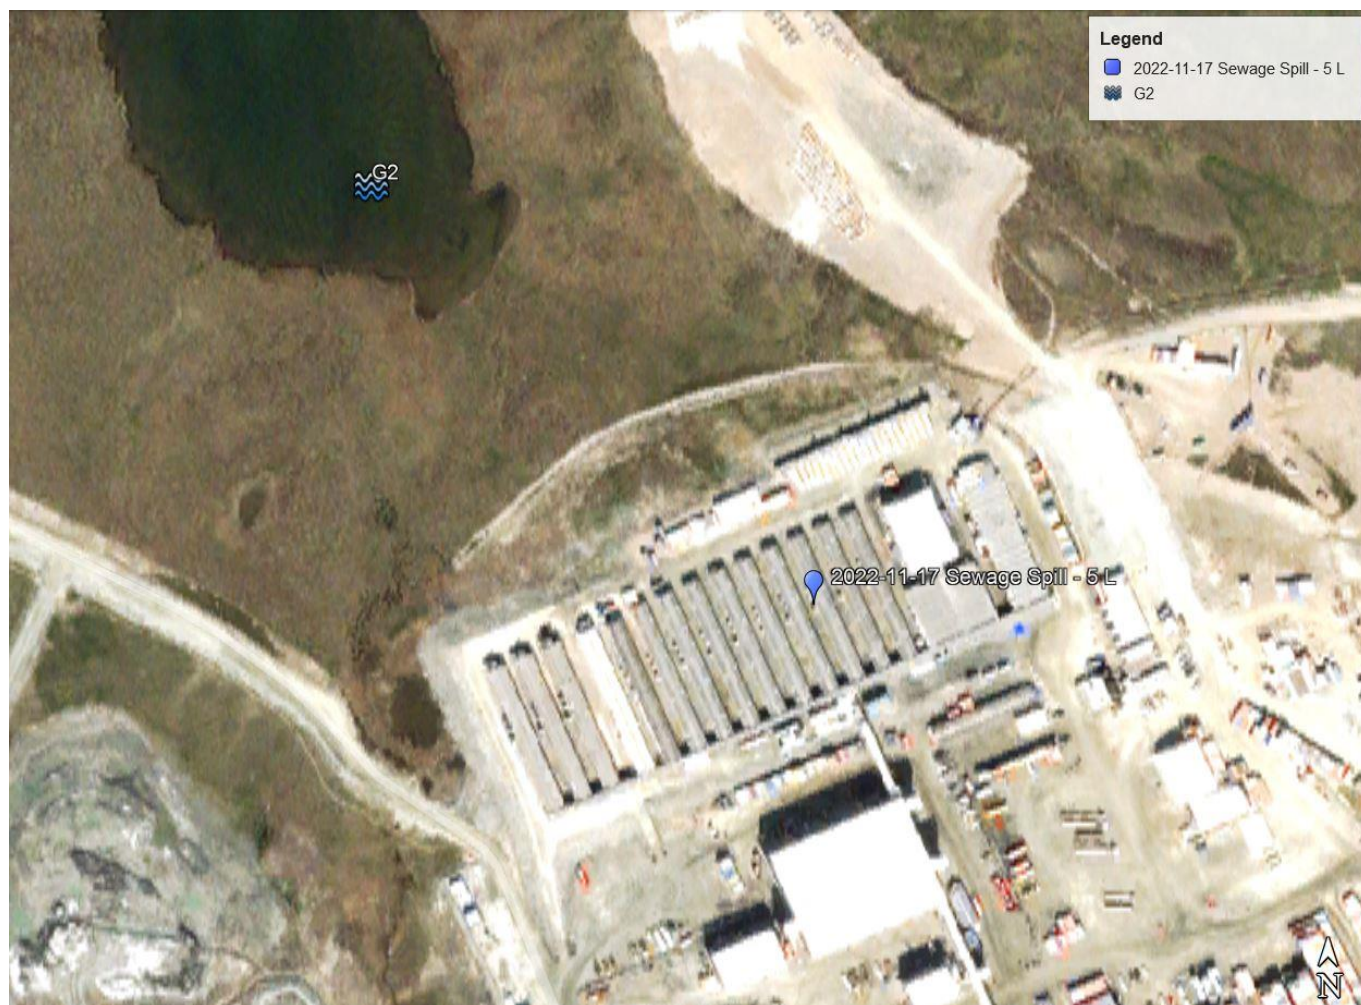
On November 17<sup>th</sup>, at approximately 8:00 am, an estimated 5 L of sewage was spilled on the industrial pad due to an overflow of the wing three lift station. No water bodies were impacted by this spill. The closest water body (G2) is approximately 222 meters northwest, as seen in Figure 1.

**Figure 1:** Location of sewage spill and proximity to water bodies.

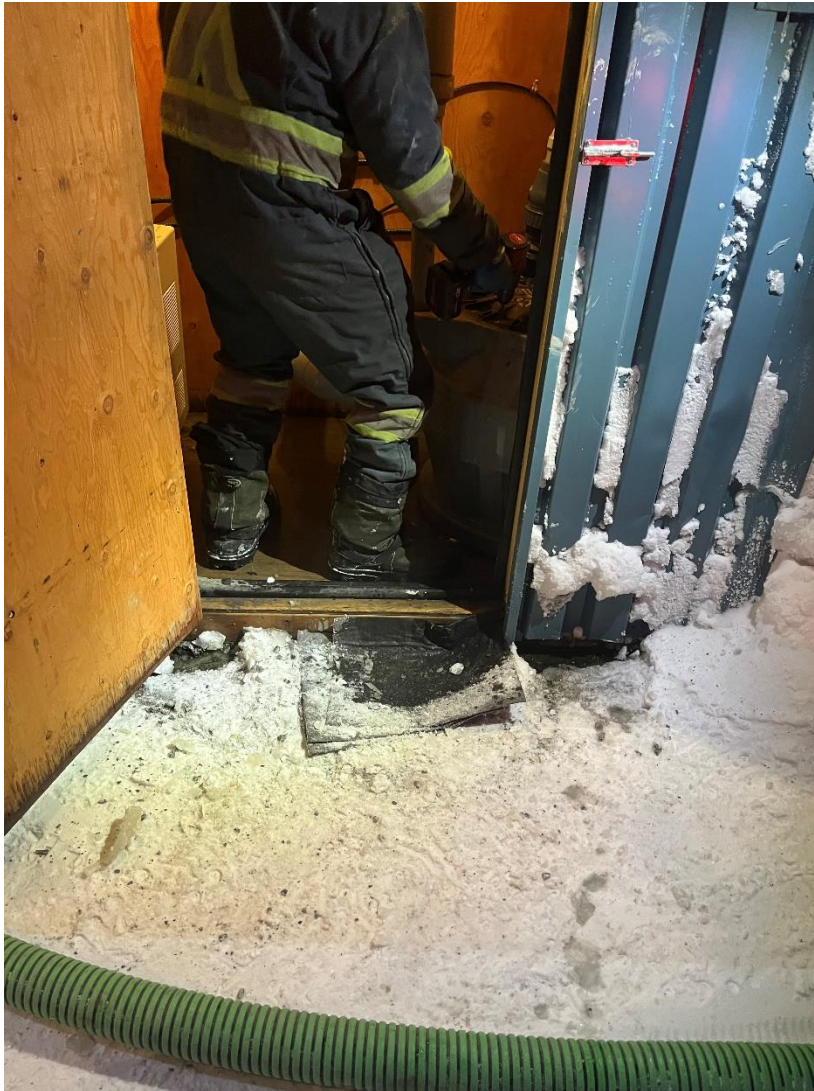
- Sewage grinder pumps became clogged with material preventing normal operations.

**Photo 1:** Wing three lift station 5 L spill

- Grinder pump blades are to be replaced at wing three lift station. These have been ordered and will be replaced upon arrival to the Meliadine site.
- Secondary containment has been installed around wing three and work is ongoing for each of the wing lift station.

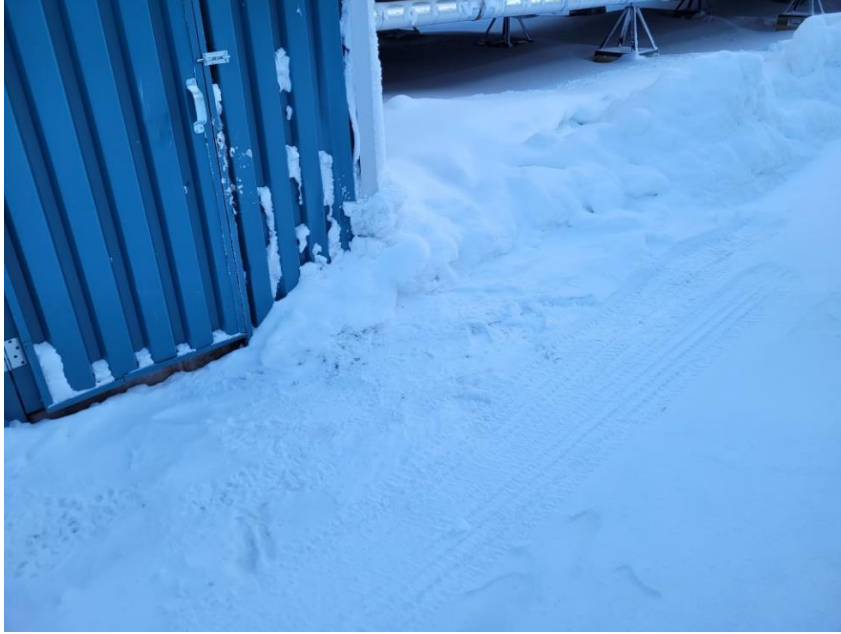
**Photo 2:** Ground area outside the wing three lift station, post cleanup.

Upon discovery of the spill, 10 L of contaminated snow was hand shoveled and placed in the main camp lift station for treatment. The solid material was cleaned up and 10 kg of material was placed in Landfarm A as the Landfarm Management plan.

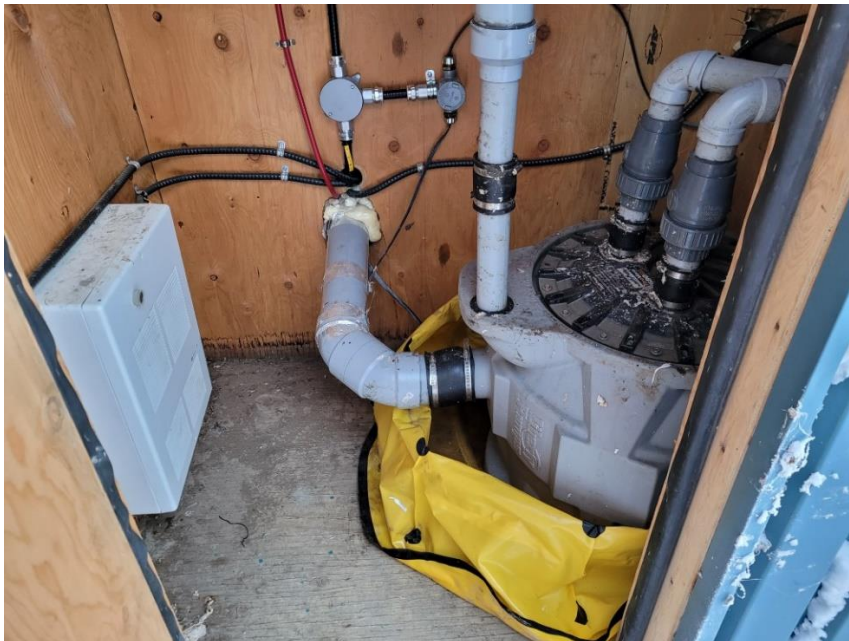
**Photo 3:** Wing three lift station with secondary containment installed post cleanup
