December 19<sup>th</sup>, 2022

## **Re.: Follow-up Report: Spill #2022533– Release of 1.5 m<sup>3</sup> of Emulsion at the Meliadine Gold Project**

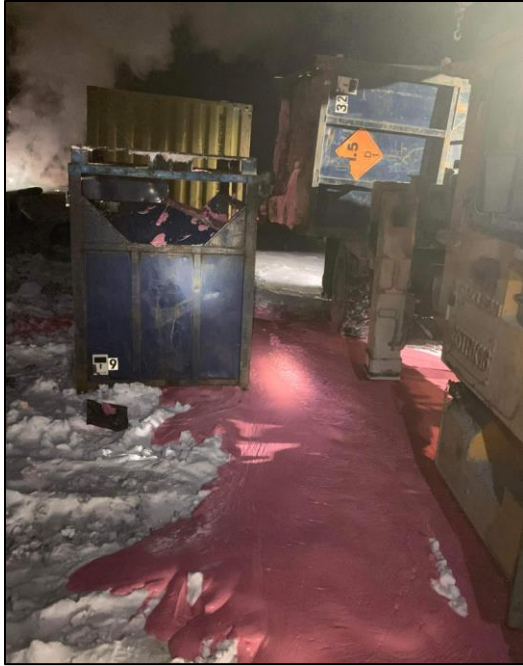
On November 20<sup>th</sup>, at approximately 4:00 am, an estimated 1.5 m<sup>3</sup> of emulsion was spilled on the industrial pad when loading a boom truck for transport to the underground mine. While placing an emulsion bin #1 on the boom truck with a loader (with forks attached) a previously loaded emulsion bin was accidentally pushed off the boom truck. This led to the operator accidentally raising the forks (versus tilting) on the loader causing the emulsion bin #2 being loaded to slide off the forks. The bin sustained damage upon contact with the ground leading to the release of emulsion.

**Photo 1:** Emulsion spill location

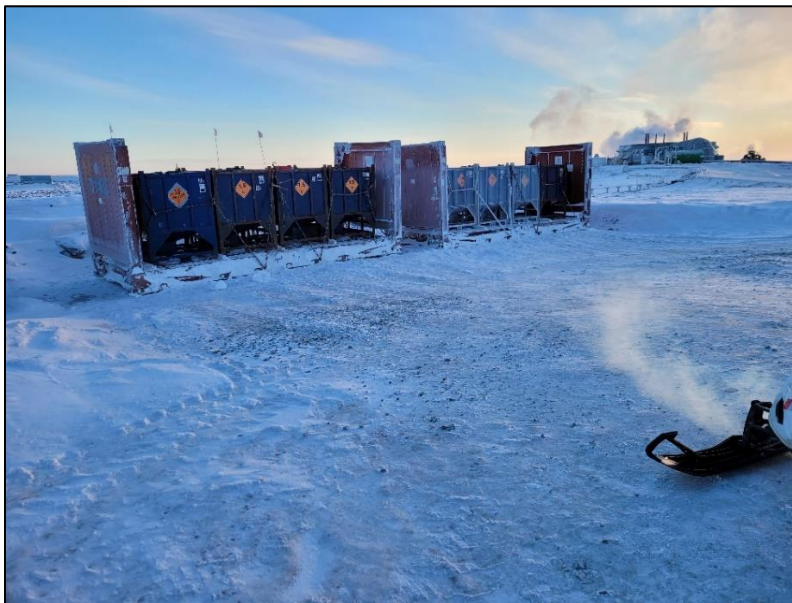
**Photo 2:** Emulsion spill remediation

Upon discovery of the spill, the emulsion was contained to the local area. The emulsion loading operation stopped and the remediation process started. Hand tools and heavy equipment were used to recover the spilled emulsion. The contaminated material was placed in quatrex bags and stored in a seacan for reprocessing at the emulsion production plant or for later use in the open pit blasting process.
