December 21, 2022

Re.: Follow-up Report: Spill # 2022542 – Release of 30 L of Sewage at the Meliadine Gold Project

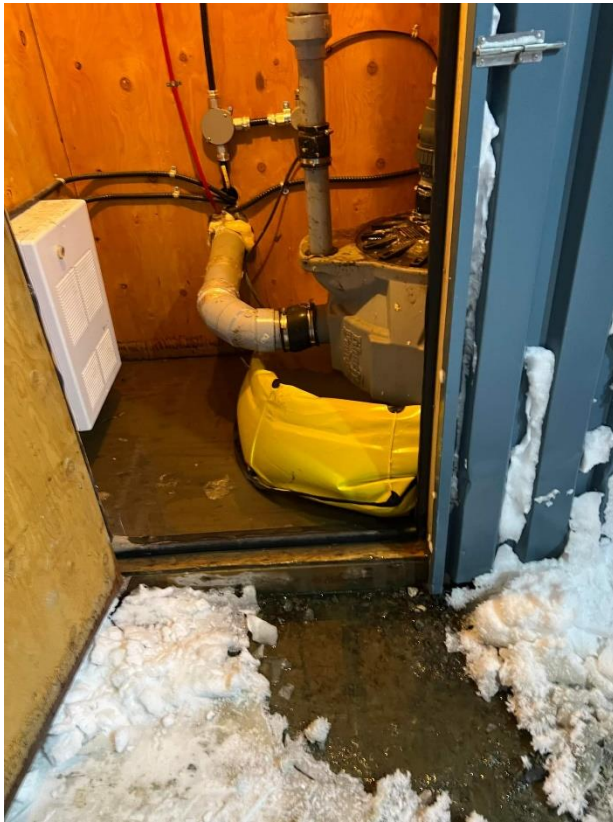
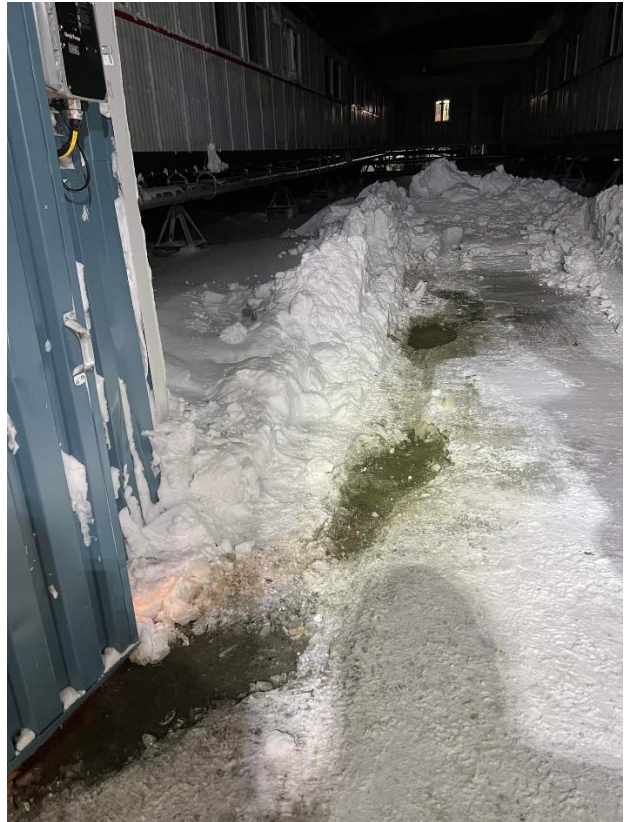
- Floats did not engage the pump as levels in the basin rose.
- Consequently, no alarms were triggered as the spill was occurring.
- The secondary containment in place overflowed as no alarms were triggered.

Photos 1&2: Wing three lift station 30 L spill

- New floats were installed.
- Tests were conducted to ensure the new floats are operating properly.
- Once the floats were installed, alarms were tested and operated as per design.
- Lift station inspections were increased to two times per day to verify proper operation.
- A formal lift station preventative maintenance program and associated work orders was developed.

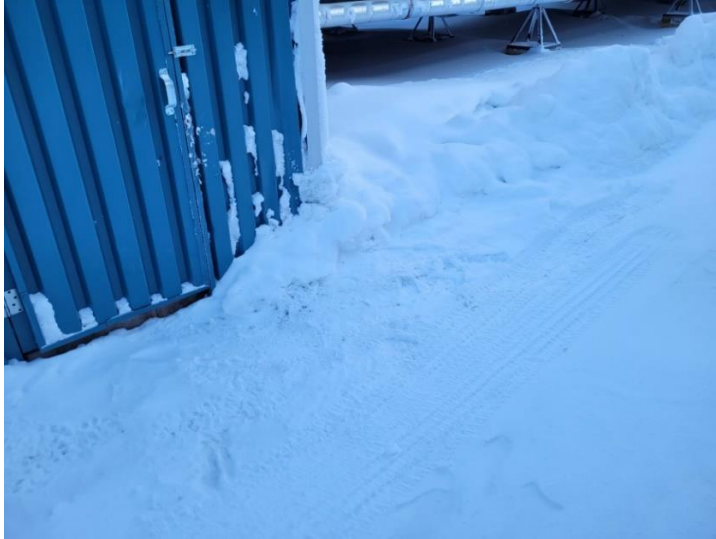
Photo 3: Ground area outside the wing three lift station, post cleanup.

Upon discovery of the spill, personnel noticed the pump was not running and manually engaged the pump to reduce the level in the lift station. Personnel requested a vacuum truck to recover the liquid untreated sewage spilled outside the lift station. Hand tools were used to clean up the frozen material and placed in a drum for disposal at Landfarm A as per section 3.4.4 of the Landfarm Management plan.

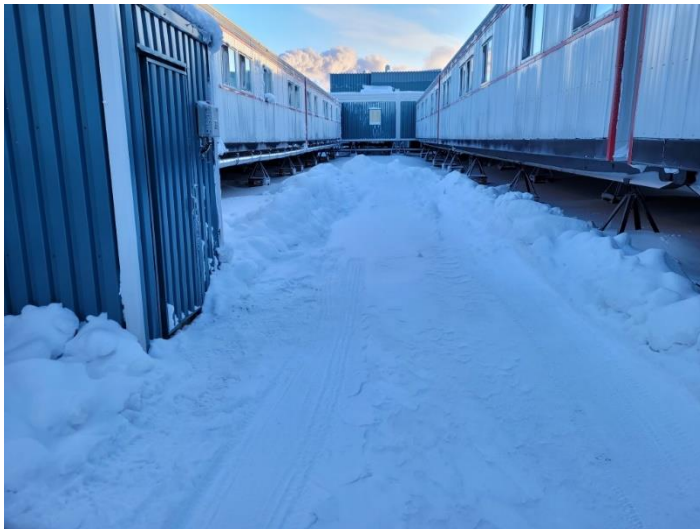
Photo 4: Ground area outside the wing three lift station.
